An Investigation of the Therac-25 Accidents

Nancy G. Leveson, University of Washington

Clark S. Turner, University of California, Irvine

A thorough account of the Therac-25 medical electron accelerator accidents reveals previously unknown details and suggests ways to reduce risk in the future.

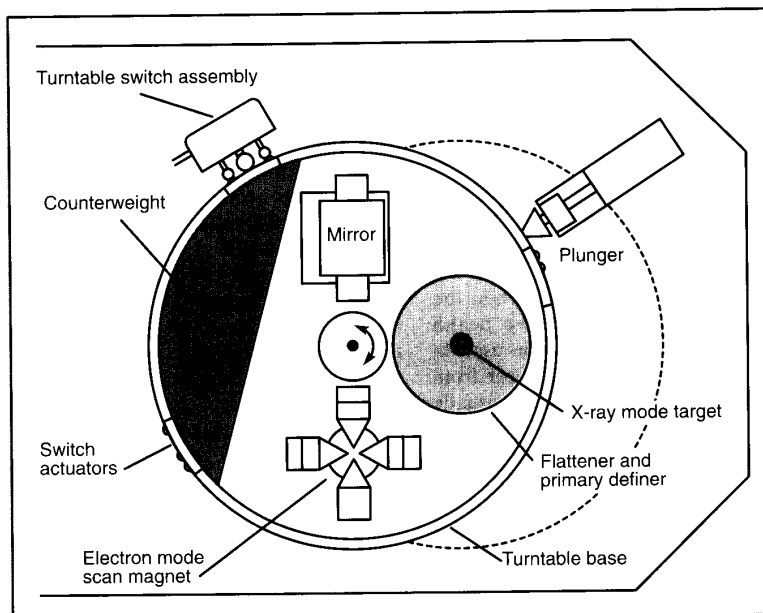
Figure B. Upper turntable assembly.

crossswitch codes (which could be caused by a single open-circuit fault on the switch lines) could produce an ambiguous position message for the computer.

hazard of dual-mode machines: If the turntable is in the wrong position, the beam flattener will not be in place.

No accelerator beam is expected in the field-light position. A stainless steel mirror is placed in the beam path and a light simulates the beam. This lets the operator see precisely where the beam will strike the patient and make necessary adjustments before treatment starts. There is no ion chamber in place at this turntable position, since no beam is expected.

cate turntable position that tolerated a 1-bit error: The code would still unambiguously reveal correct position with any one microswitch failure.

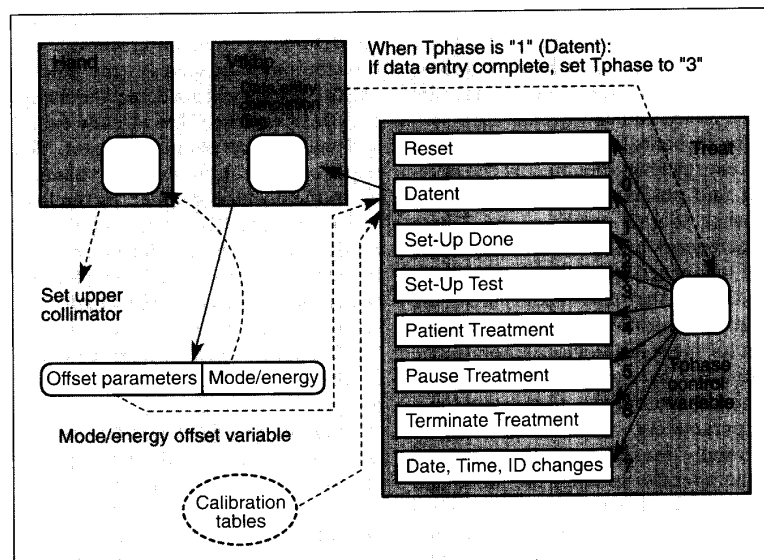
Figure 2. Tasks and subroutines in the code blamed for the Tyler accidents.

One of Treat's subroutines, called Datent (data entry), communicates with the keyboard handler task (a task that runs concurrently with Treat) via a

shared variable (Data-entry completion flag) to determine whether the prescription data has been entered. The keyboard handler recognizes the completion of data entry and changes the Data-entry completion variable to denote this. Once the Data-entry completion variable is set, the Datent subroutine detects the variable's change in status and changes the value of Tphase from 1 (Data Entry) to 3 (Set-Up Test). In this case, the Datent subroutine exits back to the Treat subroutine, which will reschedule itself and begin execution of the Set-Up Test subroutine. If the Data-entry completion variable has not been set, Datent leaves the value of Tphase unchanged and exits back to Treat's main line. Treat will then reschedule itself, essentially rescheduling the Datent subroutine.

Upon exit from the Magnet subroutine, the data-entry subroutine (Datent) checks the data-entry completion variable. If it indicates that data entry is complete, Datent sets Tphase to 3 and Datent is not entered again. If it is not set, Datent leaves Tphase unchanged, which means it will eventually be rescheduled. But the data-entry completion variable only indicates that the cursor has been down to the command line, not that it is still there. A potential race condition is set up. To fix this, AECL introduced another shared variable controlled by the keyboard handler task that indicates the cursor is not positioned on the command line. If this variable is set, then prescription entry is still in progress and the value of Tphase is left unchanged.

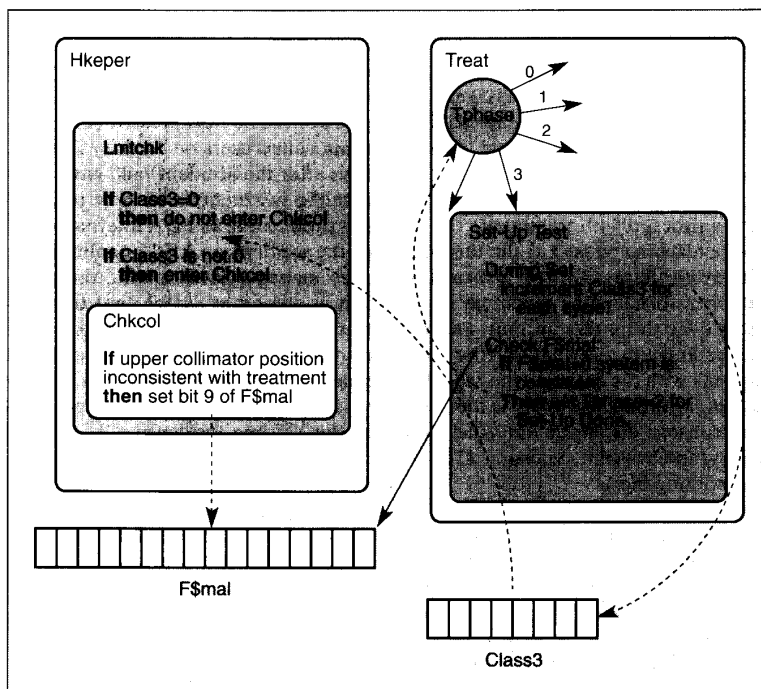
Figure 4. Yakima software flow.

The second Yakima accident was again attributed to a type of race condition in the software — this one allowed the device to be activated in an error setting (a "failure" of a software interlock). The Tyler accidents were related to prob-

lems in the data-entry routines that allowed the code to proceed to Set-Up Test before the full prescription had been entered and acted upon. The Yakima accident involves problems encountered later in the logic after the treatment monitor Treat reaches Set-Up Test.
