AURIX™ TC38x errata sheet

Marking/Step: (E)ES-AE, AE

10587AERRA

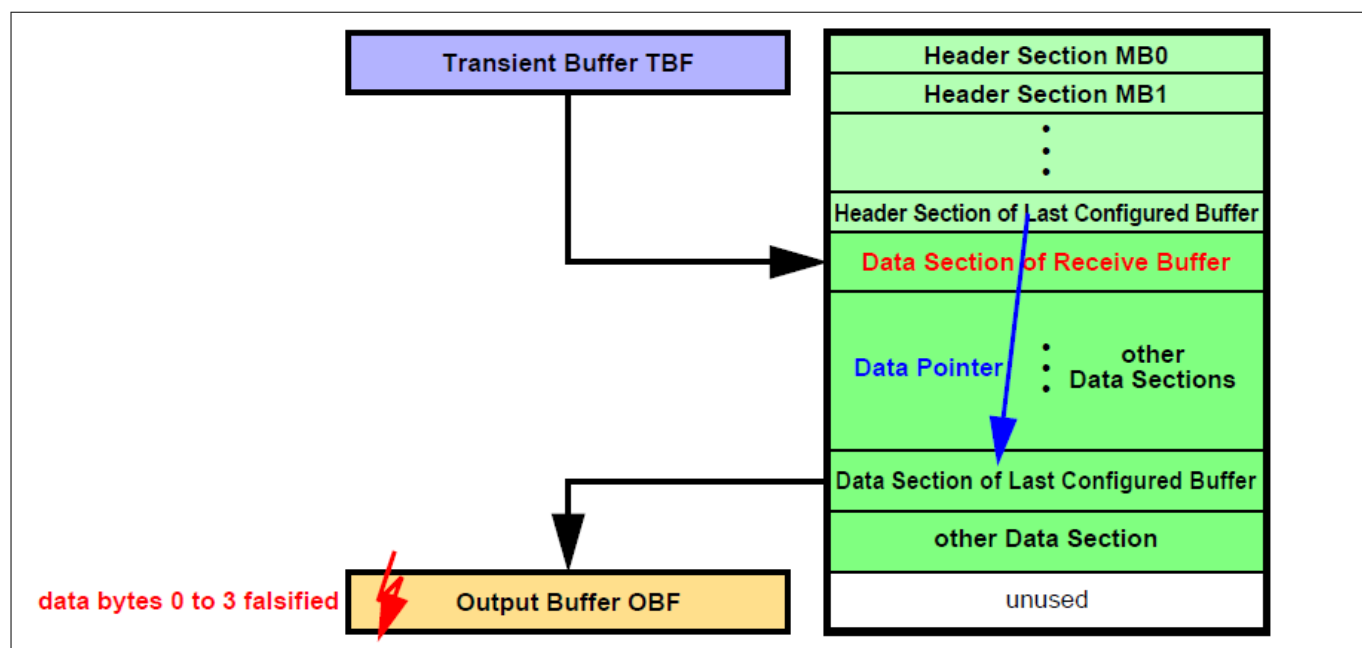
Figure 2 Message buffer transfer from Message RAM to OBF

When the message buffer has its payload configured to maximum length (PLC = 127), the OBF word on address 00h (payload data bytes 0 to 3) is overwritten with unexpected data at the end of the transfer.

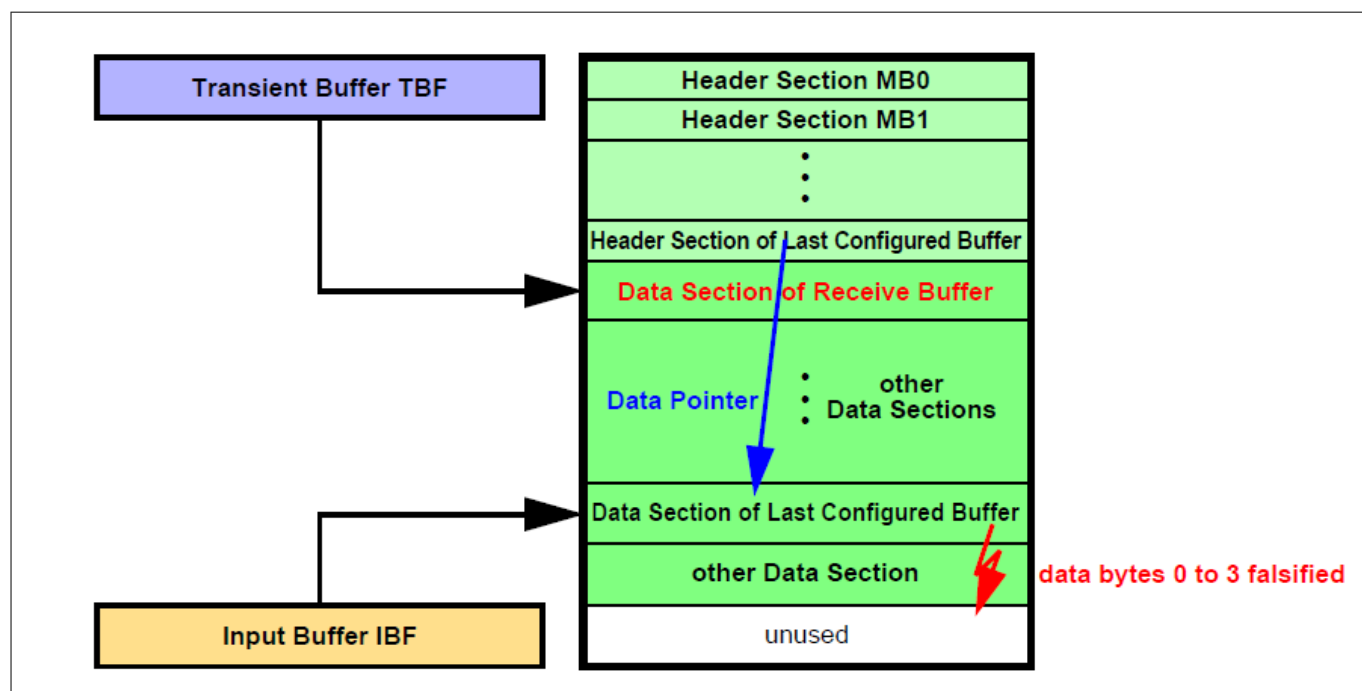
Figure 3 Message buffer transfer from IBF to Message RAM

After the Data Section of the selected message buffer in the Message RAM has been written, one additional write access overwrites the following word in the Message RAM which might be the first word of the next Data Section.

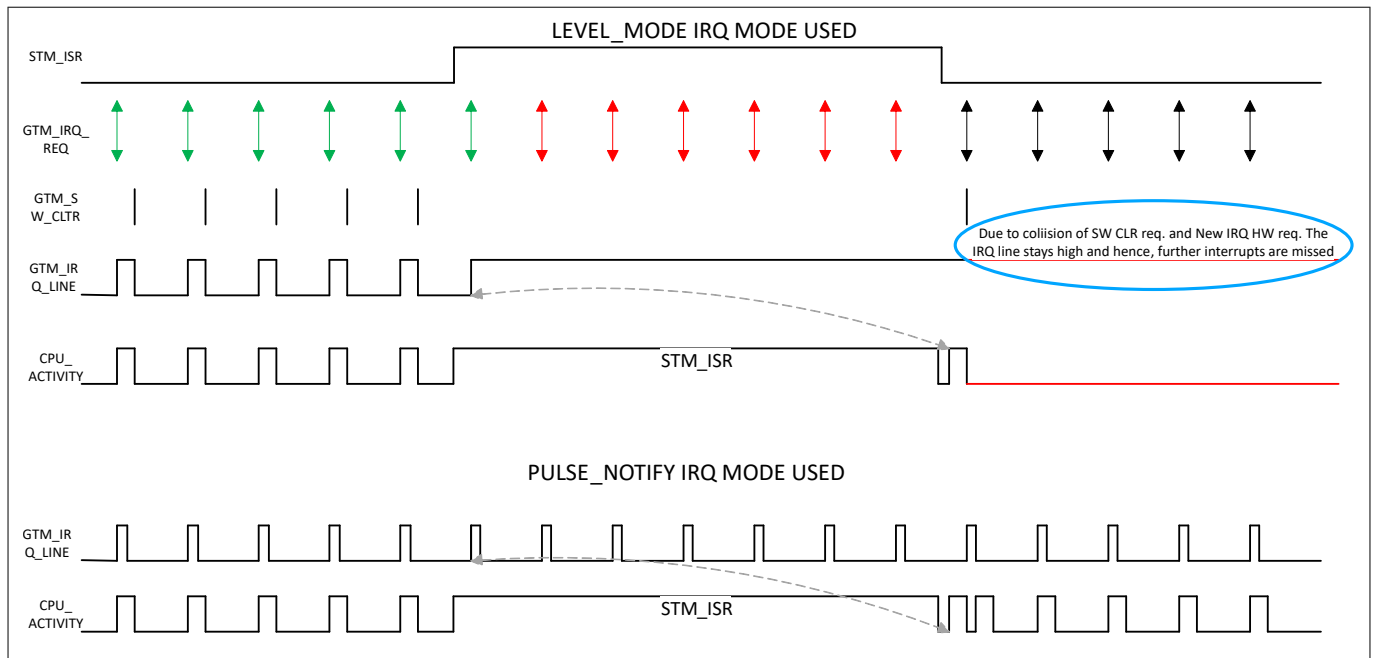
Figure 12 Interrupt Level vs. Pulse-Notify mode - Corner Case Example

Hence, in Level Mode, in some scenarios where another interrupt request is generated by GTM while the ISR handle also requests a SW clear, then, as the interrupt event is dominant over the clear event (for simultaneous interrupt and clear events), GTM_IRQ_XXX is not cleared and remains high. As a consequence, the IR observes no transition on GTM_IRQ_XX. Thus, any forthcoming interrupt events in this scenario are lost as there is no chance to release the CPU IRQ when a collision happens as shown in Figure below.
