BANGLADESH UNIVERSITY OF ENGINEERING AND TECHNOLOGY

Research Title : Low cost microwave based plasma generation.

Report

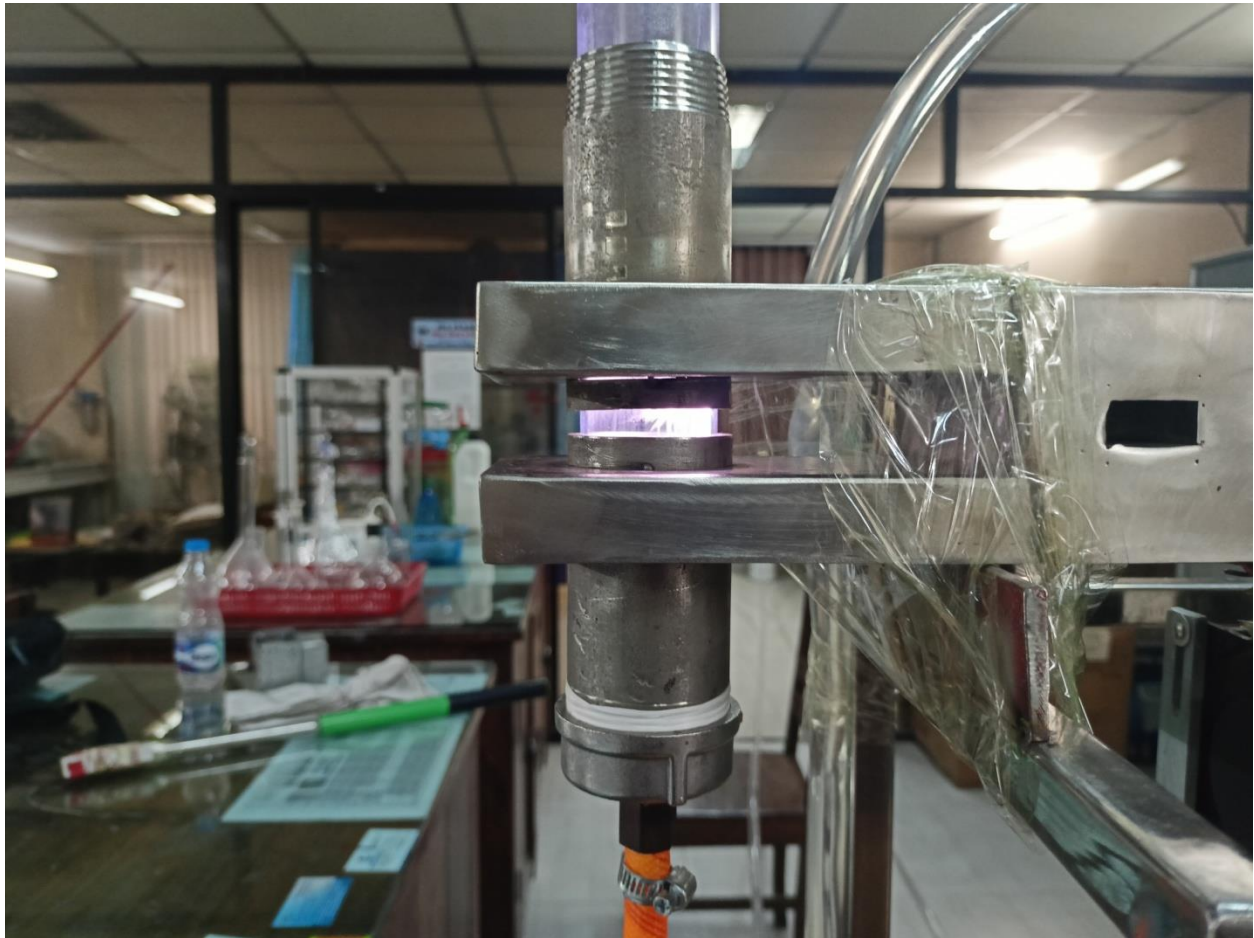
Figure-2: Auto ignited plasma

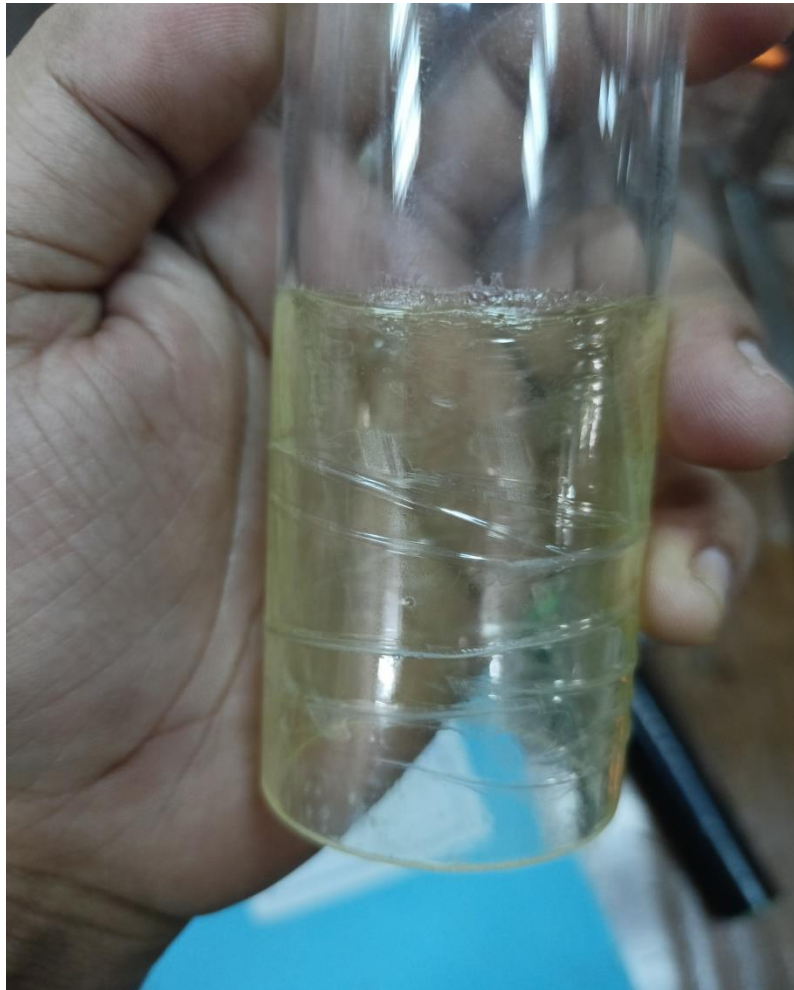
- Checked Magnetron. It was okay.
- Checked Quartz tube. Tube was fine but heated up as containing plasma which caused **burn of the scotch tape (bottom side of the tube)**.
- Didn't check the cooling chamber for the complexity.

Figure-3: Damaged scotch tape.

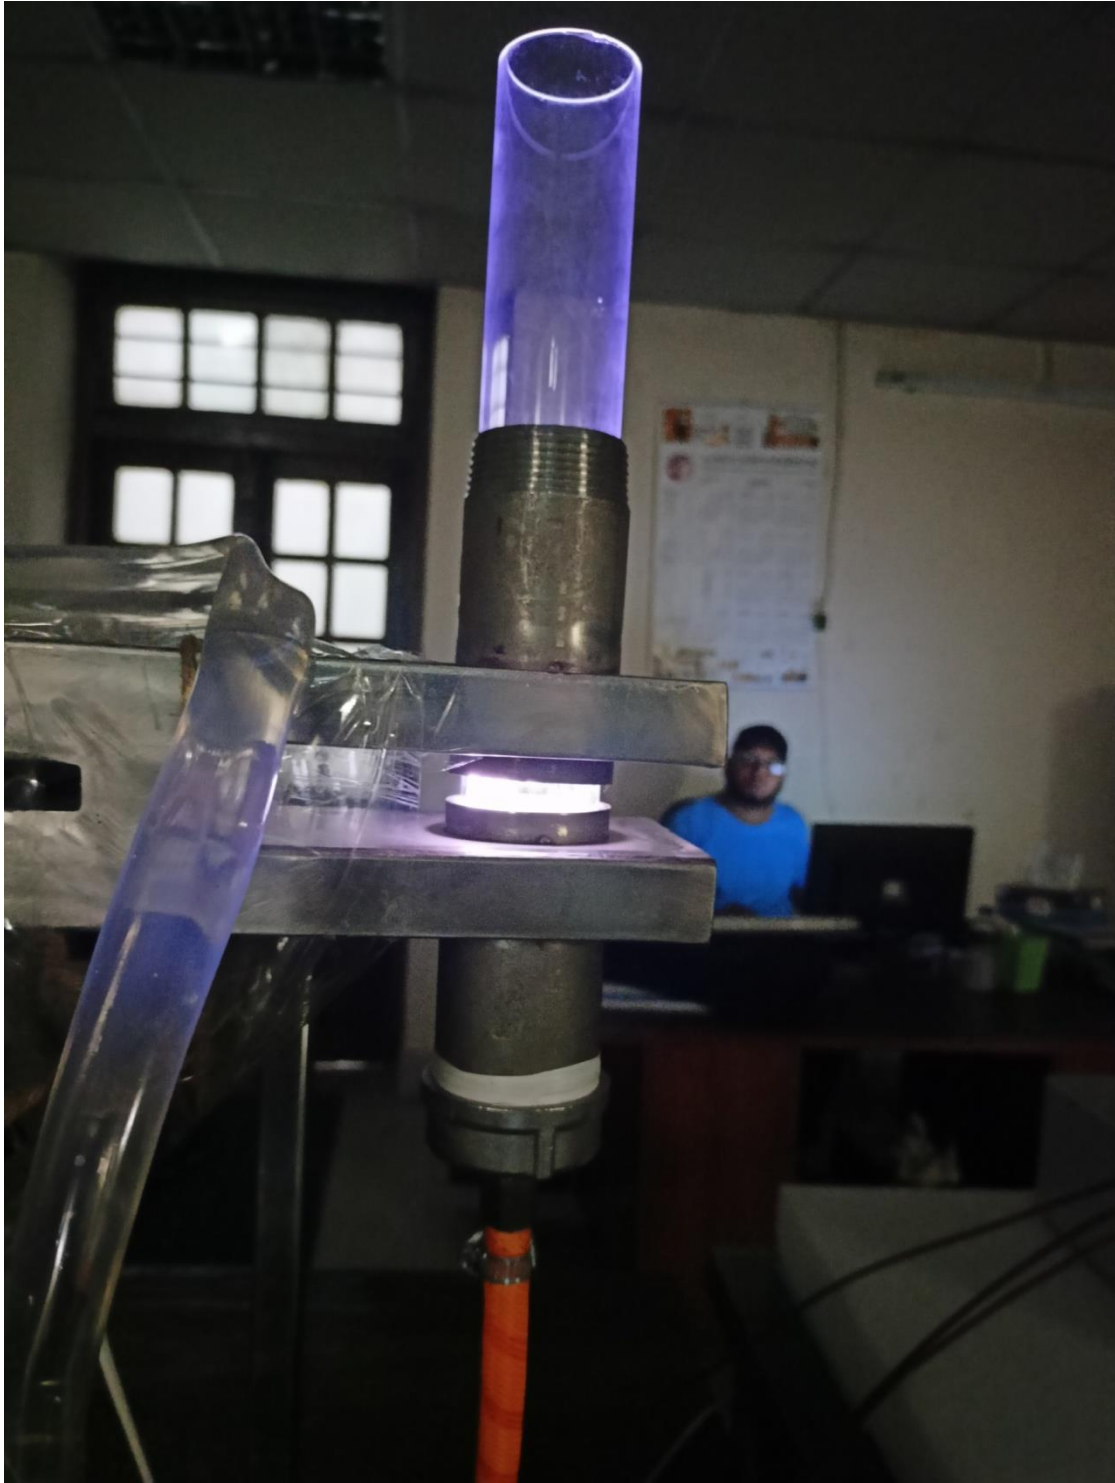
- Plasma wasn't auto generated. When an ignitor placed in the plasma chamber, plasma was found like before.
- Apparently, didn't notice any significant change in the plasma (Color & density) while changing the gas flow.

Figure-4: Plasma after using ignitor.

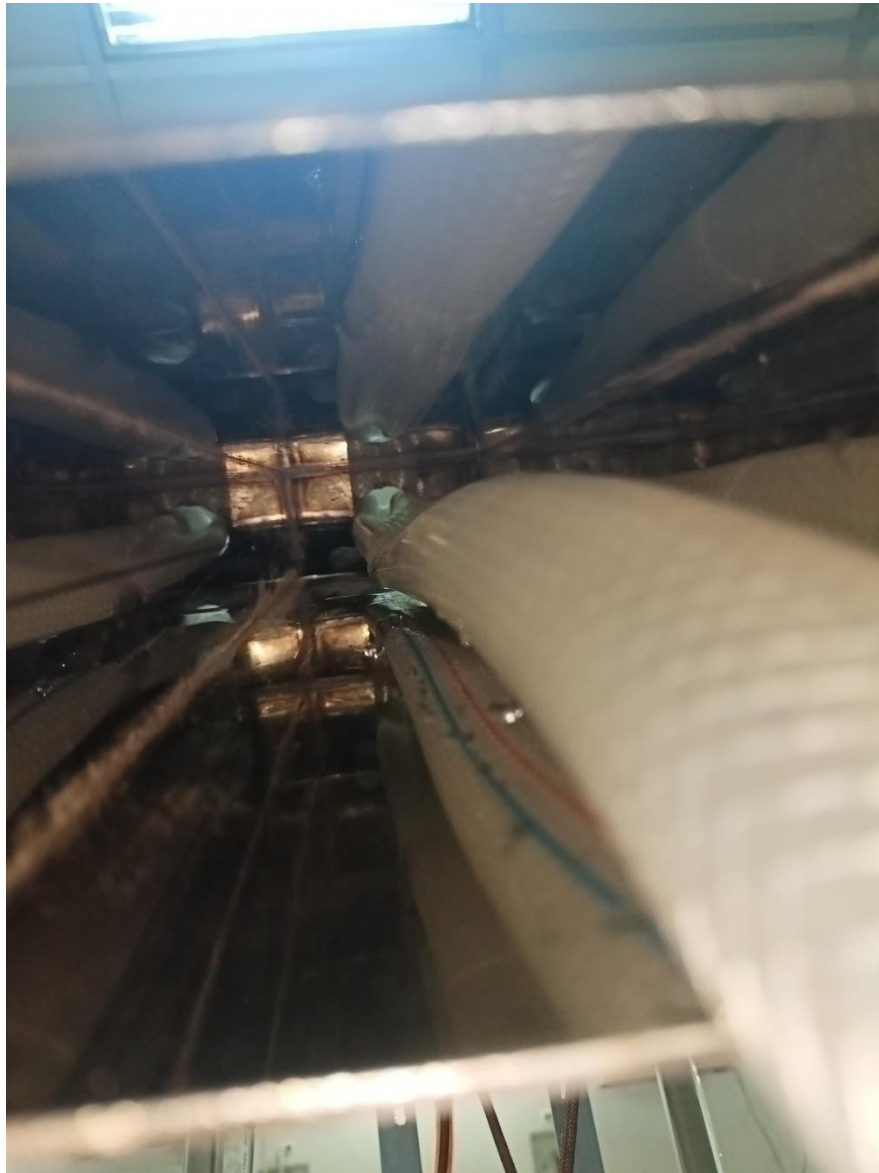
- After system was fully turned off, **leakage water found in the cooling chamber**. A small part of the **pipe got damaged (seems like burned)** which caused leakage water.

Figure-5: Damaged pipe inside cooling chamber

- **Electric Field intensity:** Higher E field intensity inside the cooling chamber can damage the pipe.
- **Touching the waveguide:** As waveguide contains circulating H field inside, which causes body current of the waveguide material. Possibly this can be a reason also.

- ✚ Test should be done using new 1-1.5 KW magnetron for comparing plasma's state.
- ✚ Measuring of temperature of Plasma.
- ✚ Water cooling pipe should be modified. High voltage magnetron is situated just below the pipe. Any Leakage water can destroy magnetron at running condition.
- ✚ Water supply from nearby source will be more helpful for running condition.

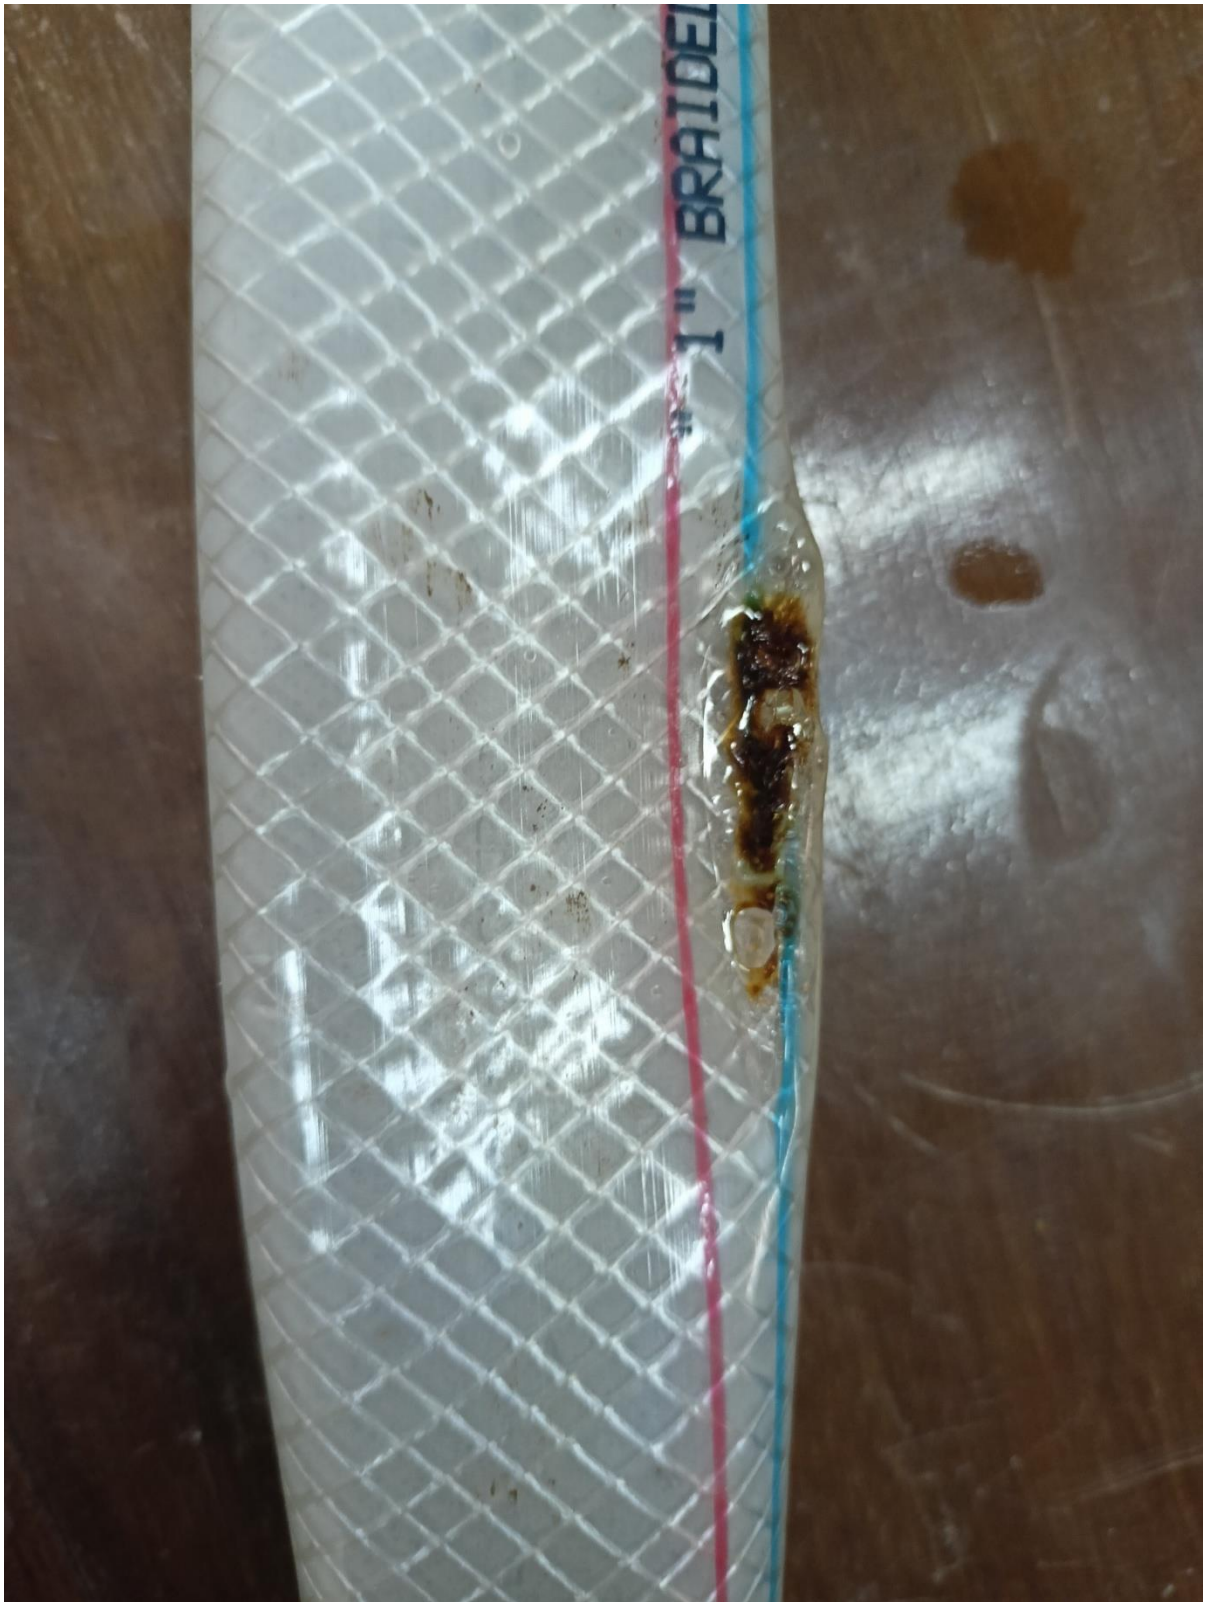
Figure-6: Damaged part of the cooling pipe
