To : MV Aballe /JR Dacalano**February 14, 2023****Thru : RB Nazareno****From : JRH Marquez/ IT Salenga, Jr.****Subject: SMC RMI Key Performance Metrics, Projects and Activities.**

Submitting for your appreciation a compilation of Key Performance Indicators (January, 2023) as agreed and stipulated in our maintenance agreement, as follows:

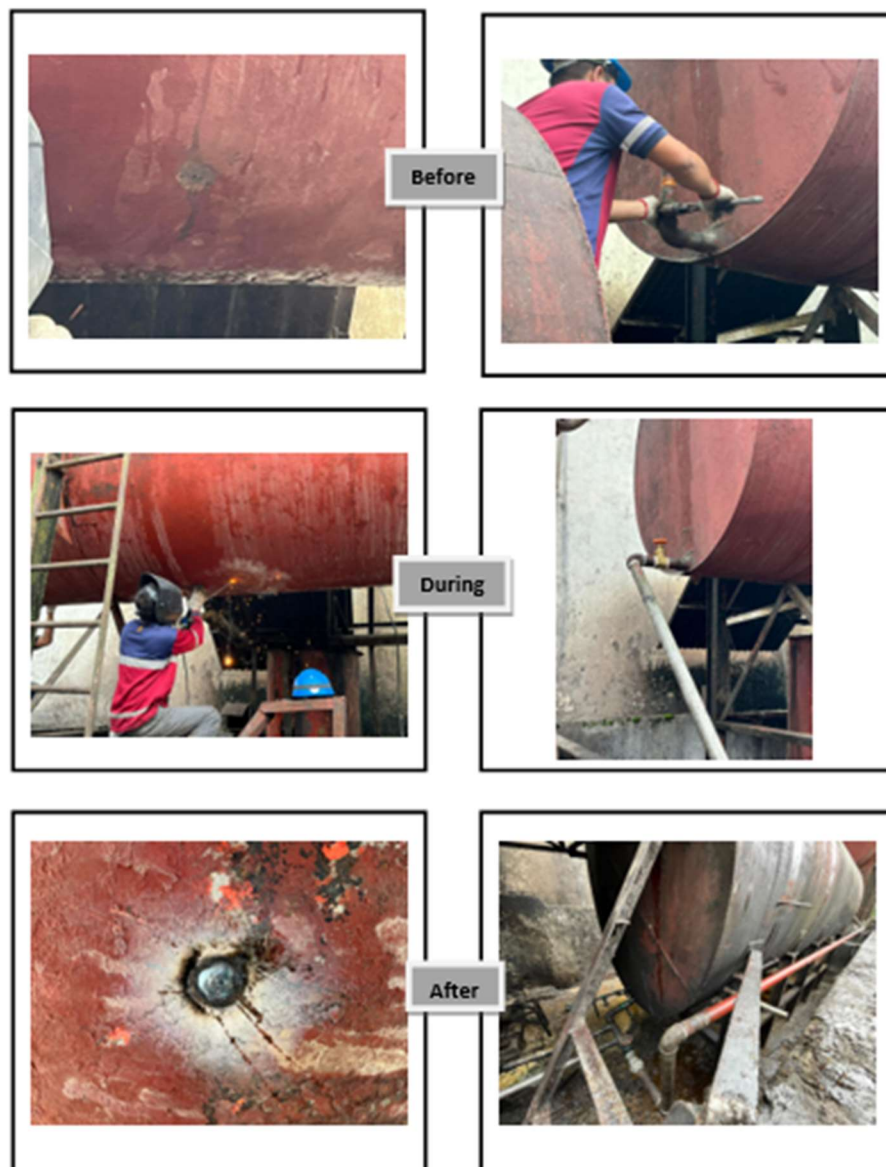
1. Patch-welding of holes on molasses tank and replacement of pipe line to oil transfer pump.

To prevent leaks and for new oil storage tank.

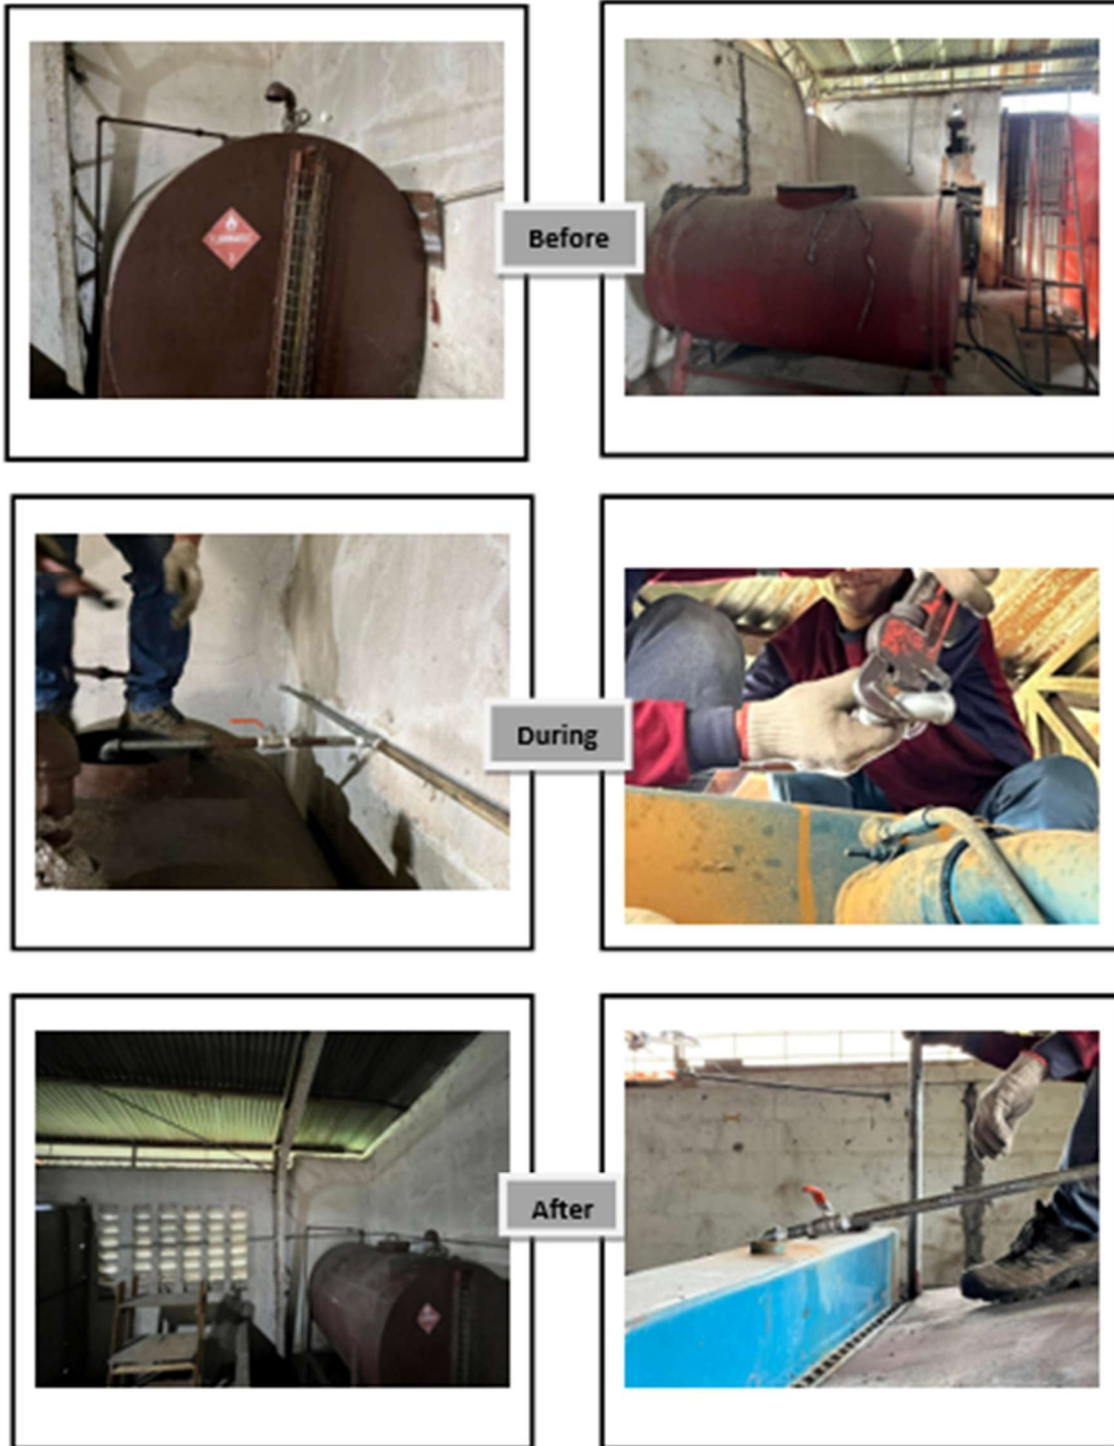
2. Installation of new diesel and water pipe system from diesel tank to “Cummins” generator set.

To ease access for diesel and water whenever needed.

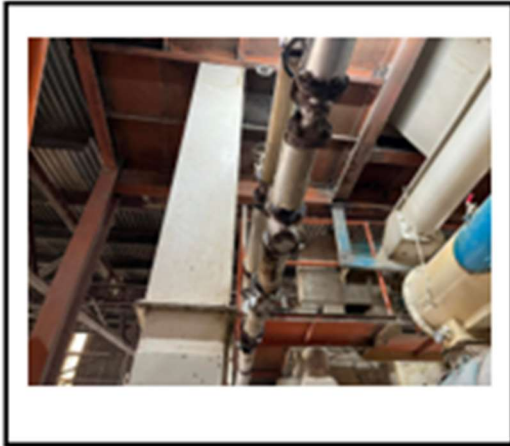
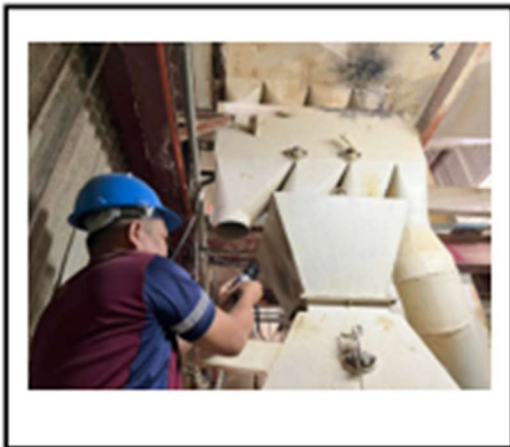
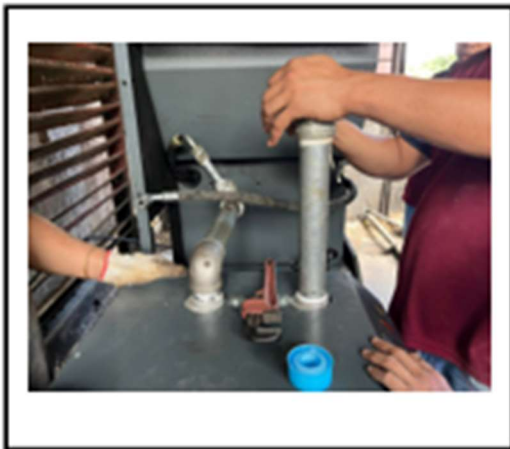
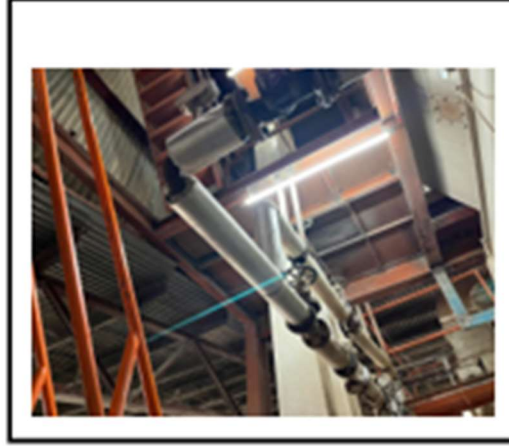
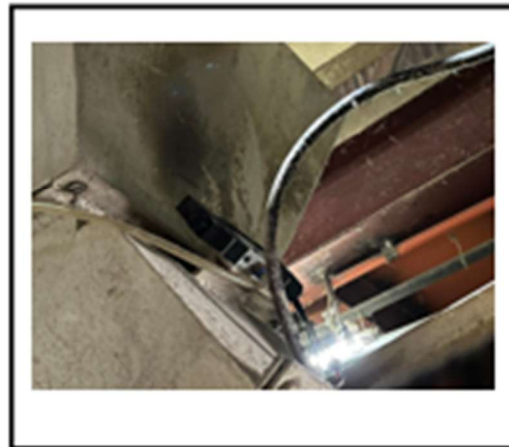
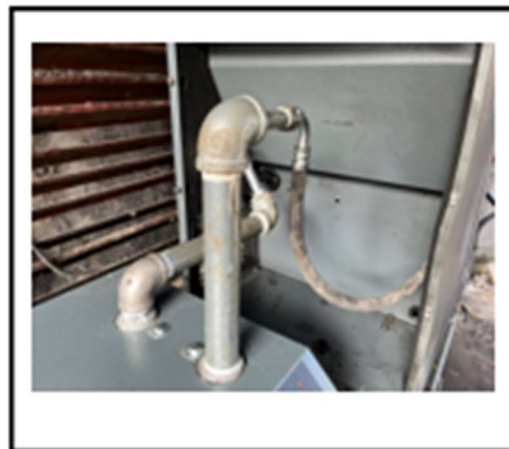
3. Servicing of various plant equipment.

For plant corrective and preventive maintenance.

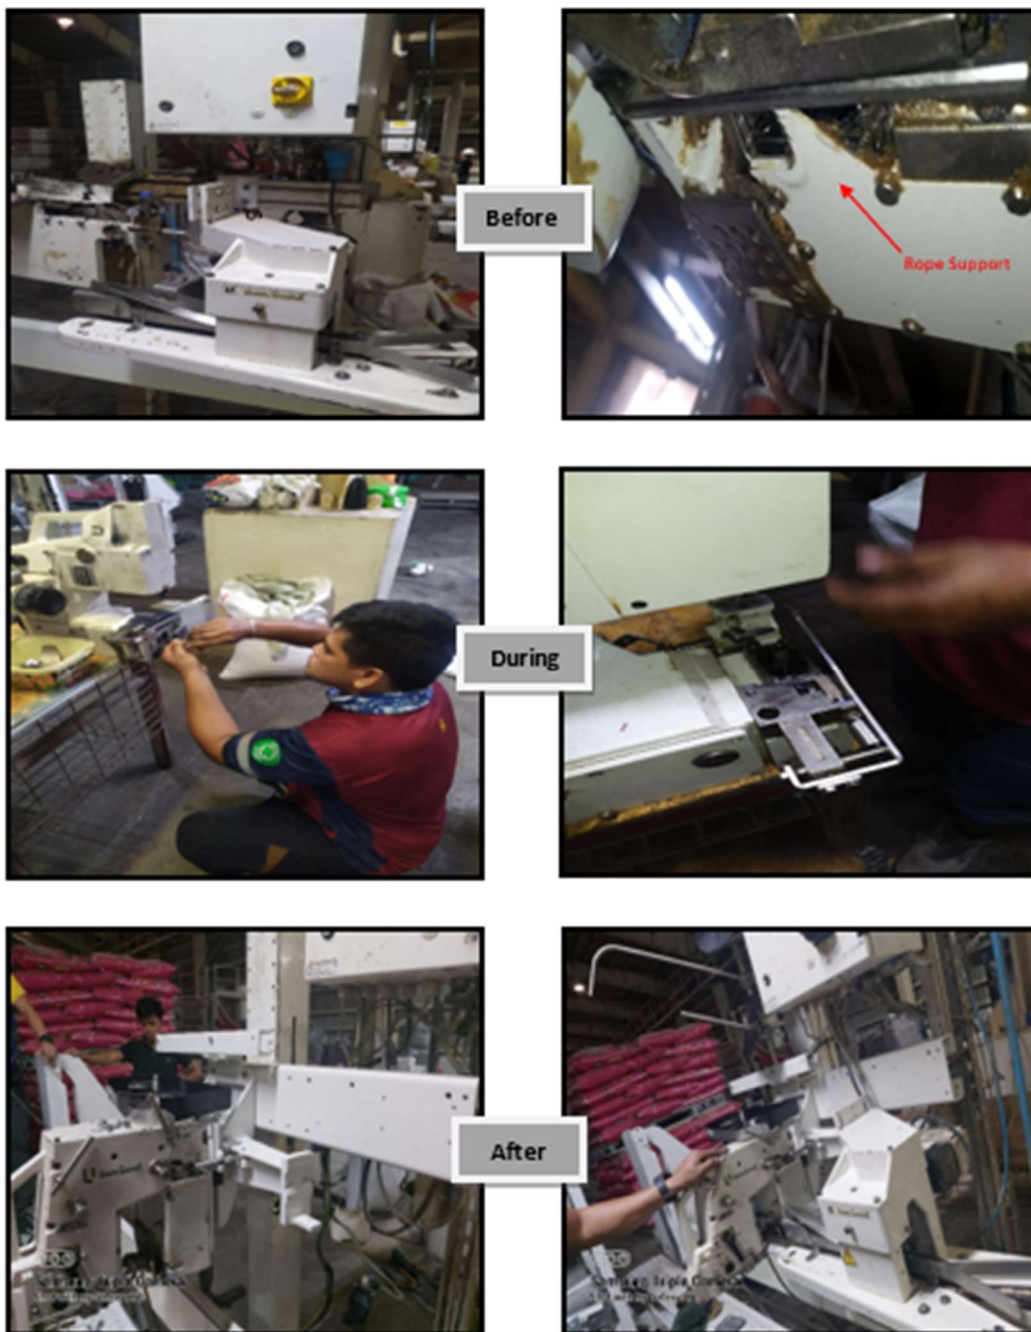
1. Replacement of bellows on various sewing machines at bagging lines 1, 3 & 4.
Support modification at bagging line 3.

To avoid oil leakage from each machine and have better support at bagging line 3.

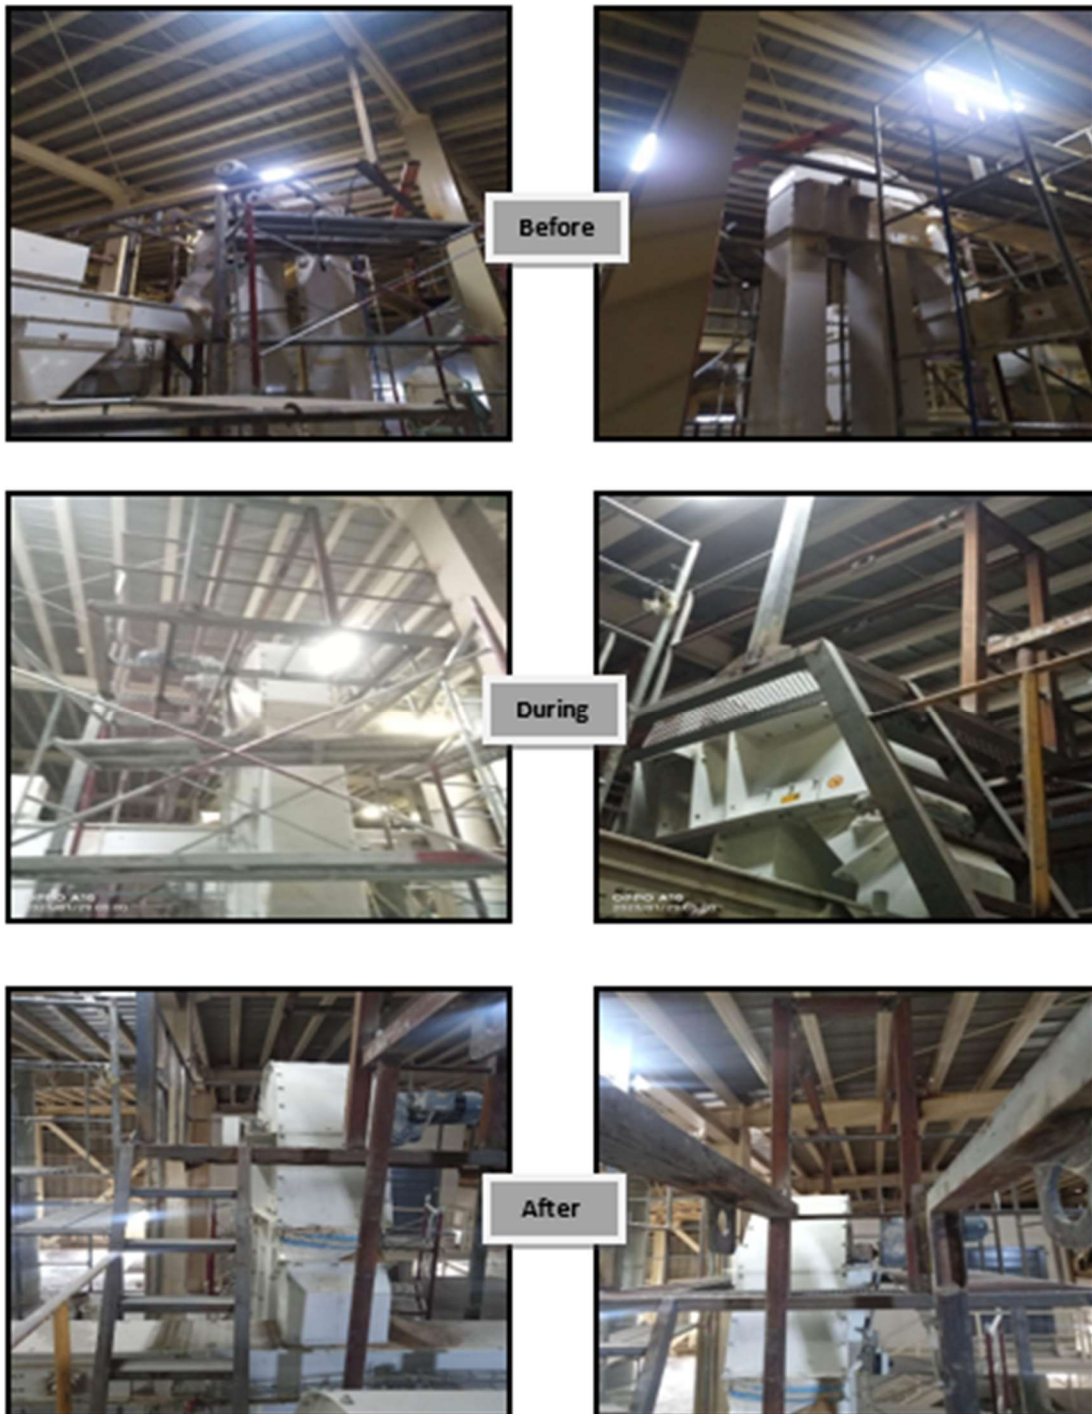
2. Fabrication of bucket elevator platform for A-1850 MGEL.

To ease access when replacing head pulley.

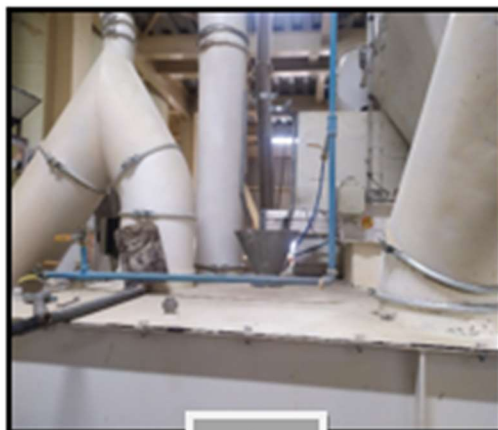
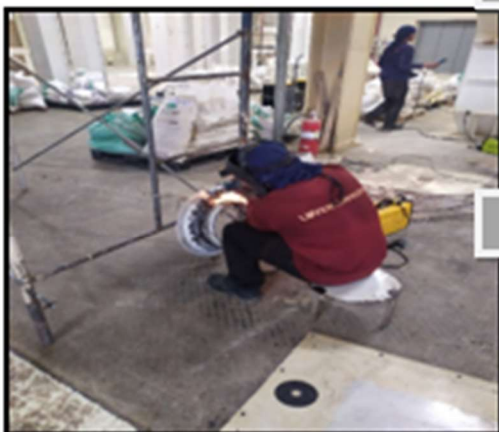
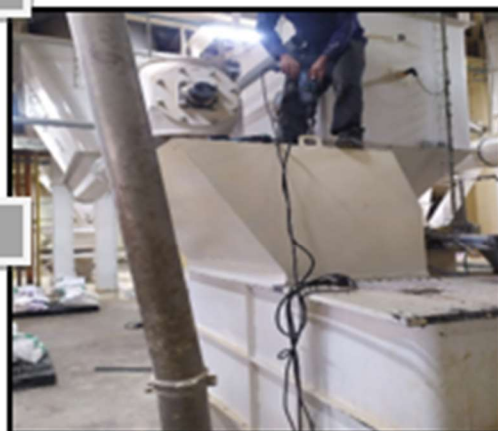
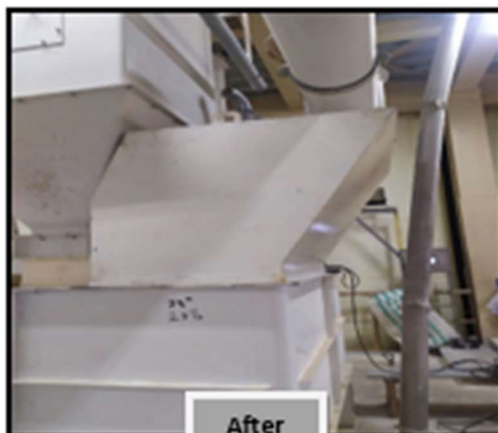
3. Installation of hopper at 4th floor holding bin.

For better dispensing.

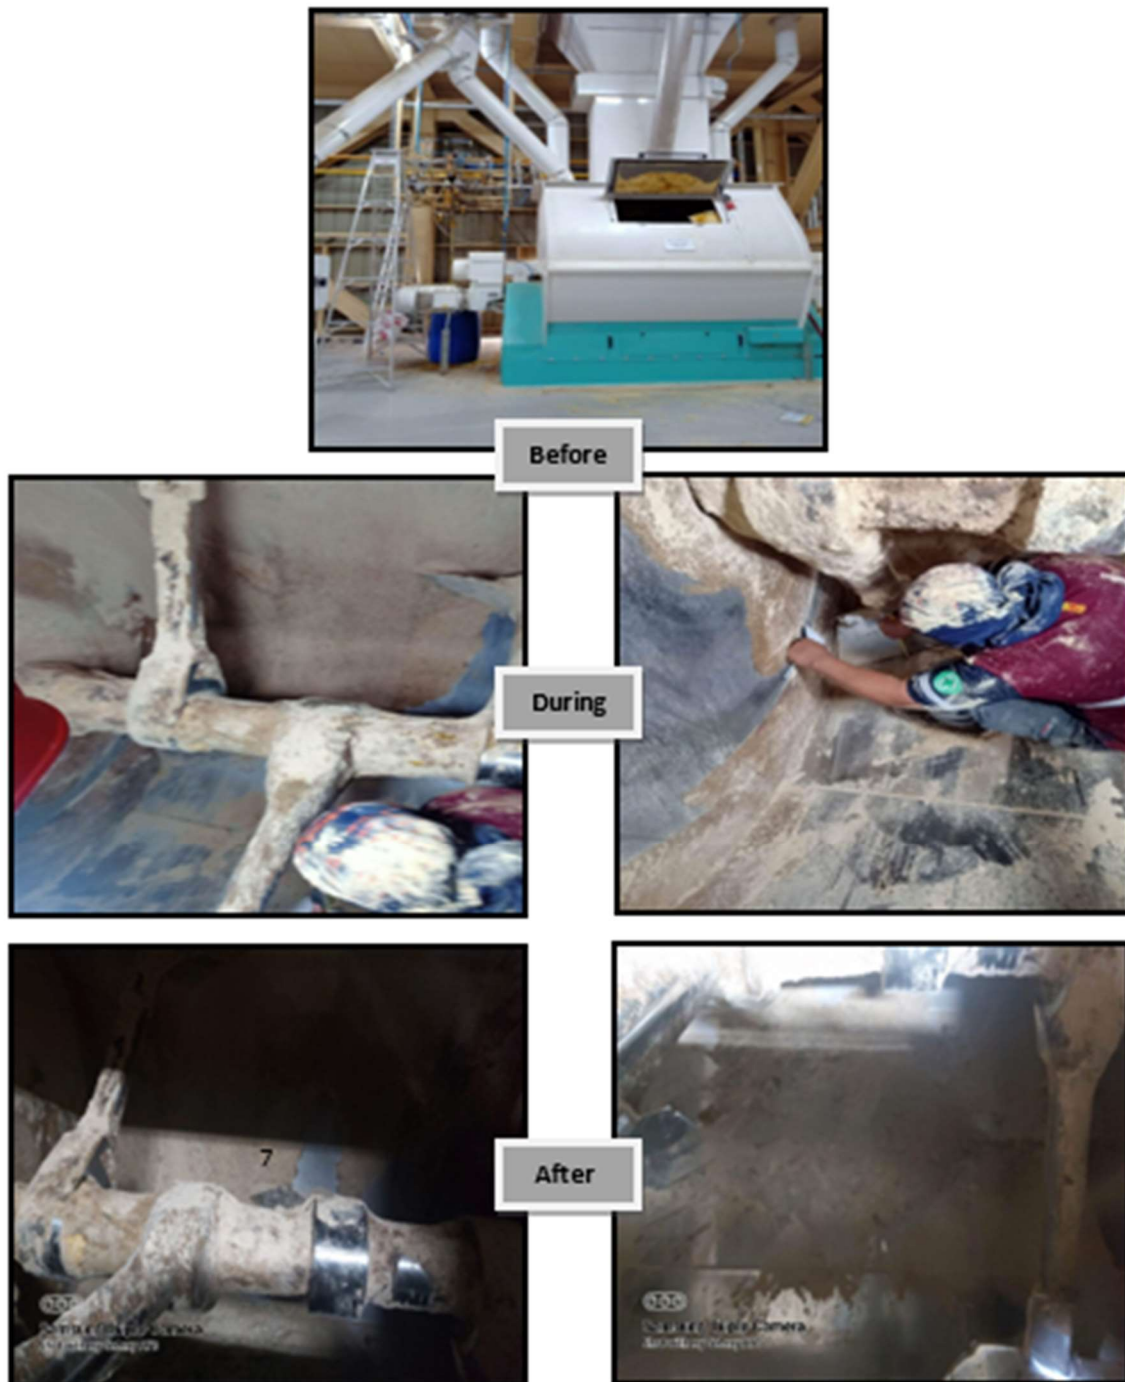
4. Inspection of paddle clearance at mixing line 1-2.

To ensure standard clearance is met by the paddles for smooth operation of the machine.

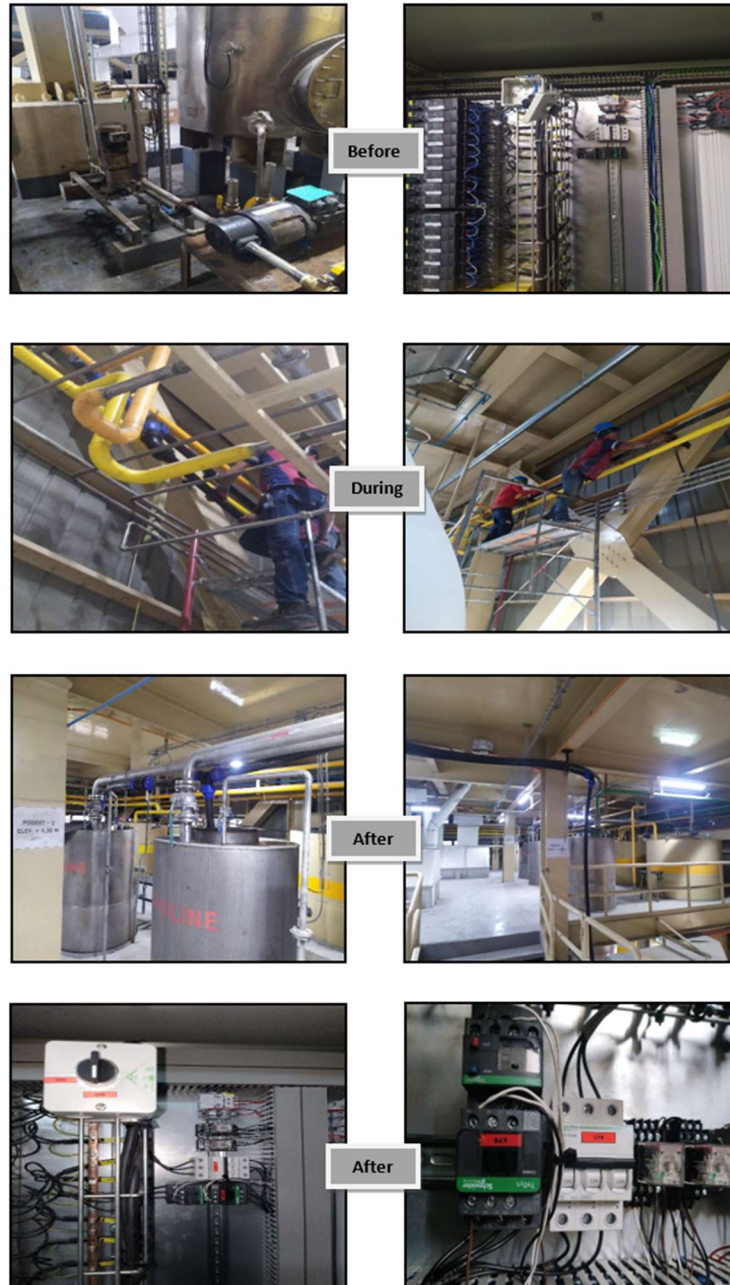
1. Hauling of DPEF Press roll from ground floor to 3rd floor production tower

This was done as part of projects for Tower 2. SMCRMI modified and installed east Slurry Pipeline connection to Resolve the problem of low Injection of yeast slurry during operation which results in lesser batching compared to the standard output.

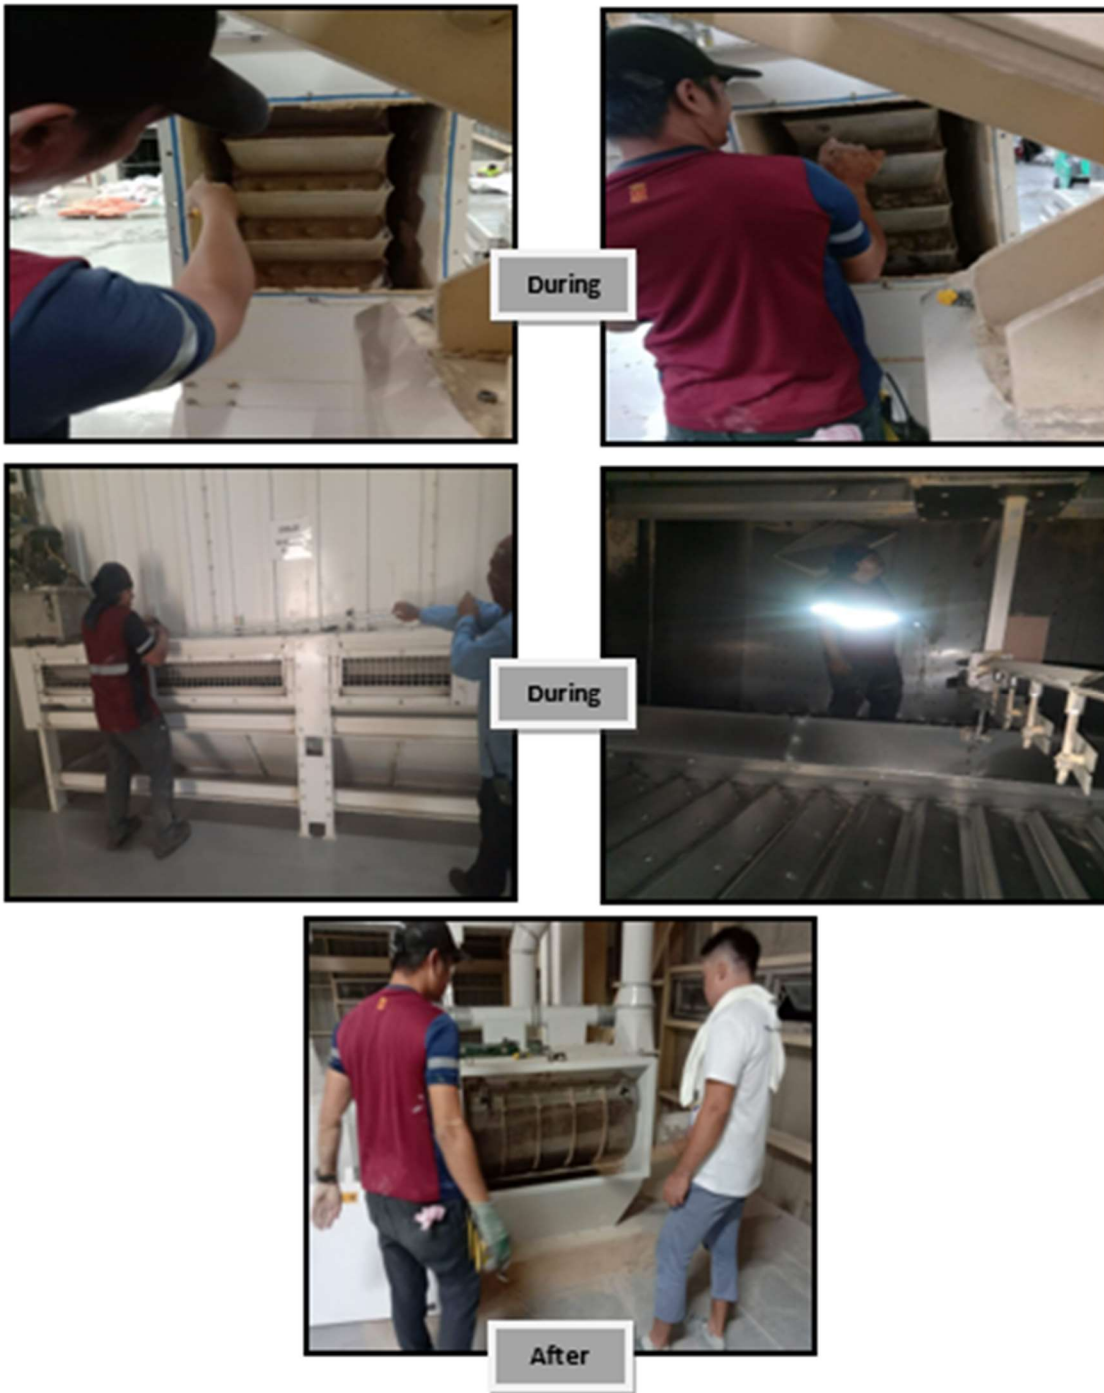
2. Servicing and cleaning of various machines.

This was done as part of In-service and Out-Service preventive maintenance planned to ensure smooth running of machines.

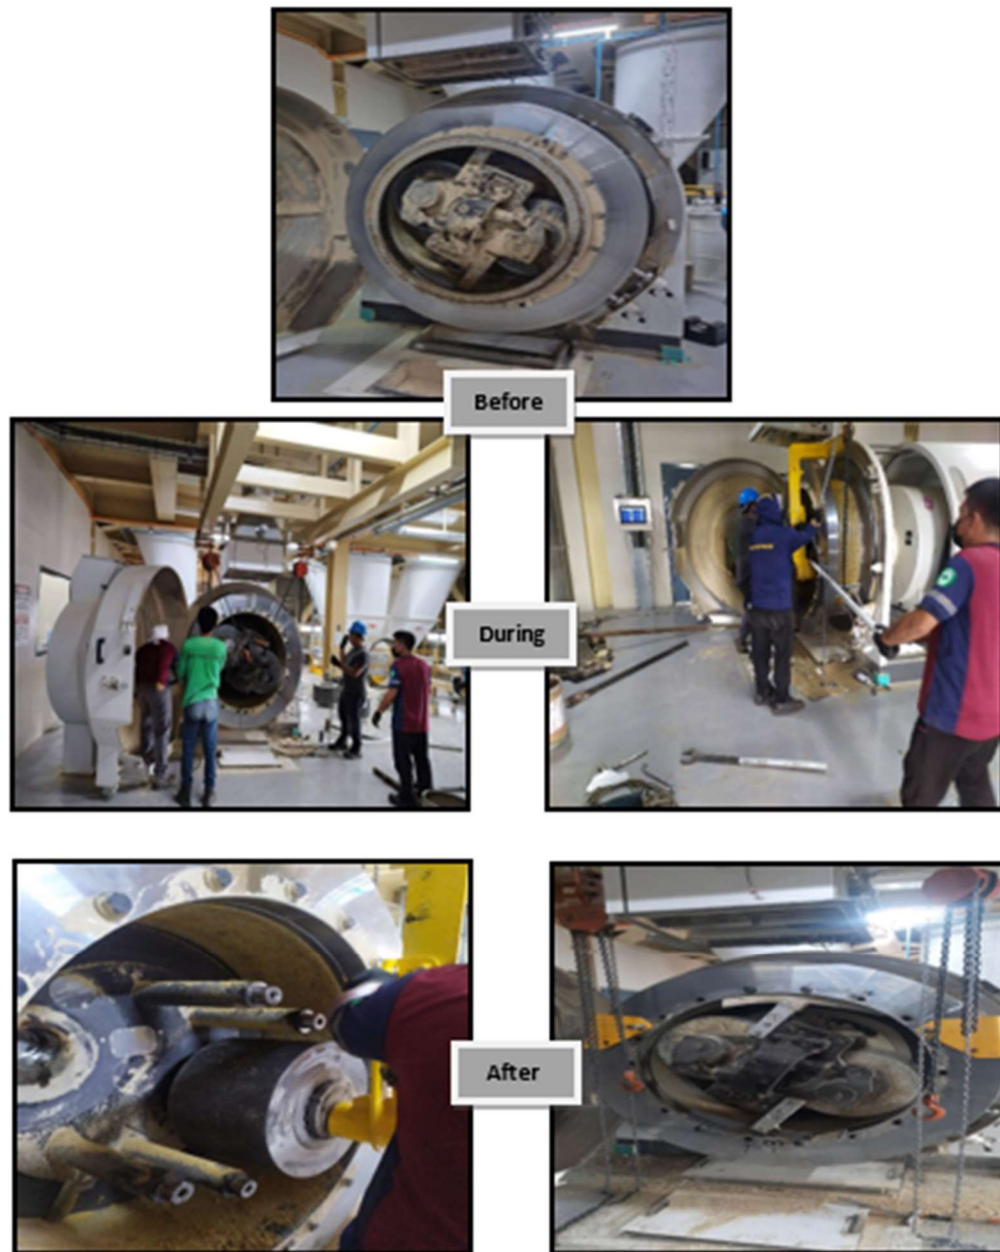
3. Replacement of pellet mill rolls for DPEF.

This was done during the Scheduled Preventive Maintenance Activity in which the production hit the target allocation within a week. SMCRMI replaced 2 pcs DPEF press roll assembly as requested by production due to the worn-out condition of the press roll groove.

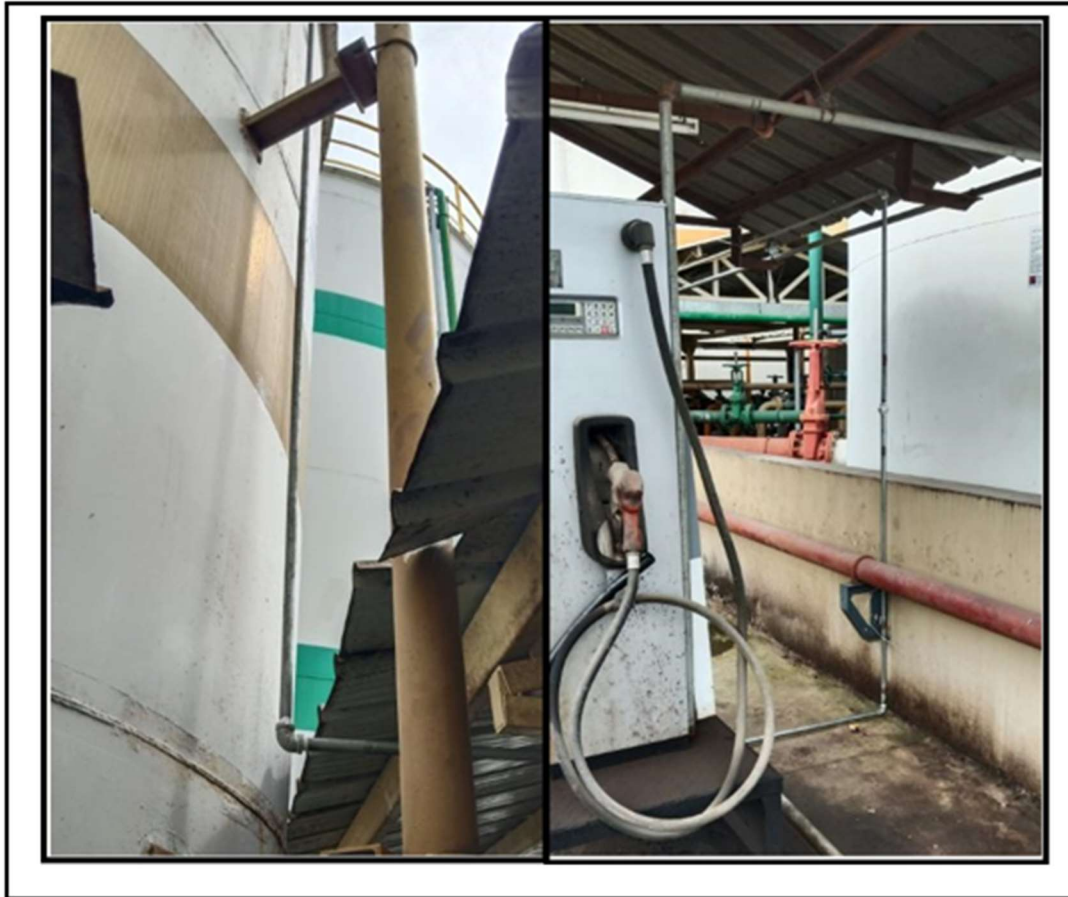
1. Fabrication of return piping line for diesel dispenser.

For requirement compliance by Petron.

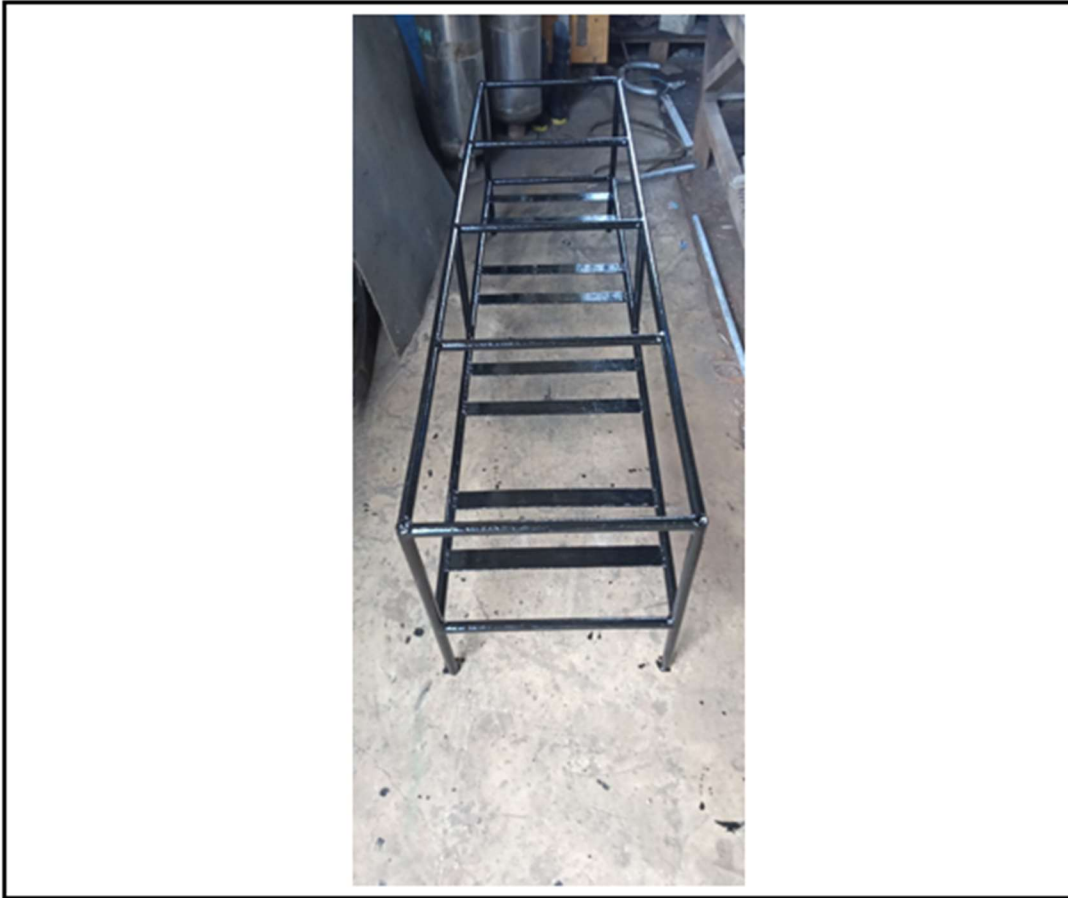
2. Fabrication of tower 2 wire cover.

For organization of trash bins.
