WOOD DESTROYING PESTS AND ORGANISM INSPECTION REPORT

| Building No. 1952 | Street Camargo Drive | City San Jose | ZIP 95132 | Date of Inspection 6/17/2022 | Number of Pages Page 1 of 10 |
| General Description: This is a one story single family dwelling with wood and stucco exterior. | | | | Inspection Tag Posted: Subarea Other Tags Posted: | |

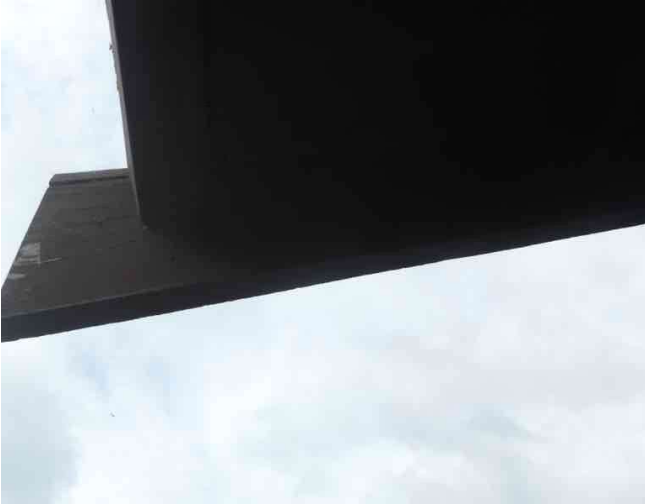
Photo 01

1A. FINDING: The roof sheathing as indicated on the diagram is damaged by fungus. The contributing moisture source appears to have been caused by a failure of the roof covering. (See Photo 1)

RECOMMENDATION: Remove and replace the damaged wood members to correct this condition. This bid includes repair of the roof covering if disturbed by our repairs. If existing gutters need to be removed to perform the repairs then our bid also includes reinstallation of original gutters. If it becomes necessary or desirable to install new gutters this will be done only if authorized and at an additional cost. The guarantees on the roof covering are limited to the areas where the repairs were performed.

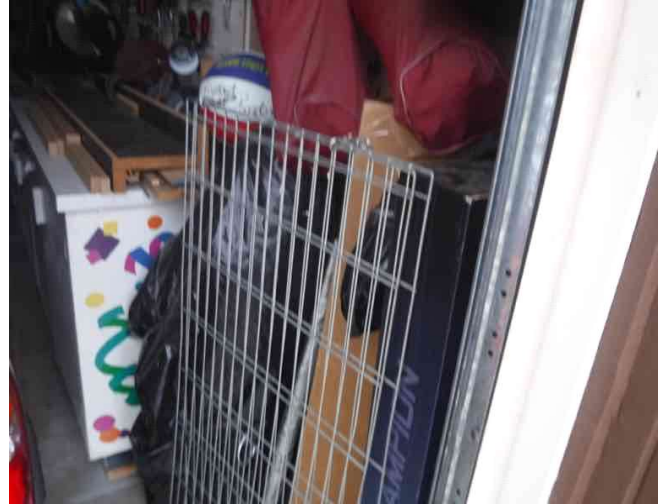
Photo 02

3A. FINDING: We were unable to inspect a portion of the interior of the garage due to stored personal property. (See Photo 2)

RECOMMENDATION: The owner should move the storage away from the garage walls to allow for further inspection. All findings, recommendations, and bids will be issued in a supplemental report.

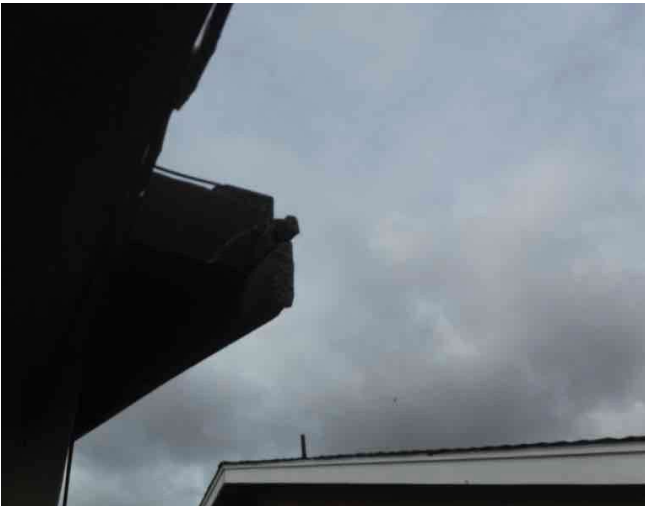
Photo 03

1B. FINDING: The barge rafter(s) as indicated on the diagram are damaged by fungus. The contributing moisture source appears to be exposure to the weather. (See Photo 3)

RECOMMENDATION: Remove and replace a section of the damaged barge rafter(s) to correct this condition. This bid includes repair of the roof covering if disturbed by our repairs. If existing gutters need to be removed to perform the repairs then our bid also includes reinstallation of original gutters. If it becomes necessary or desirable to install new gutters this will be done only if authorized and at an additional cost. The guarantees on the roof covering are limited to the areas where the work was performed.

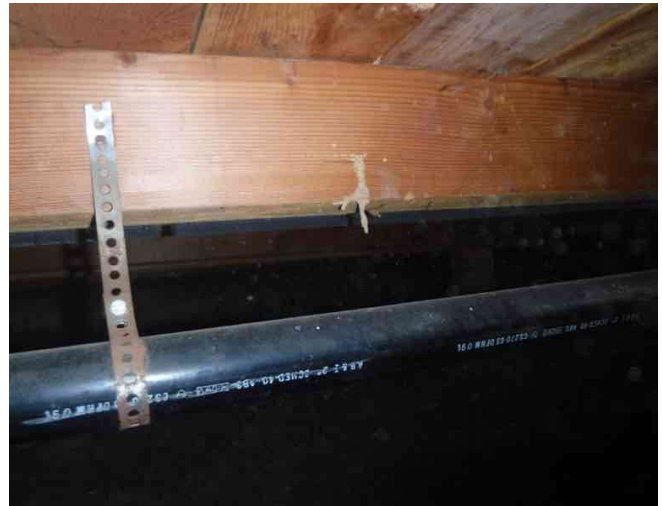
Photo 04

1C. FINDING: Subterranean termites were noted throughout the structure. (See Photo 4) (See Photo 6) (See Photo 7)

RECOMMENDATION: Chemically treat the entire structure at probable termite entry points for the control of Subterranean termites with Termidor HE(Fipronil:5-amino-1-(2,6-dichloro-4-(trifluoromethyl) phenyl)-4-((1,R,S)-trifluoromethyl)sulfinyl)-1-H-pyrazole-3-carbonitrile and break down and brush away all subterranean termite migratory tubes. In conventional construction, this may include, but is not limited to, rodding or trenching the soil around the foundation walls, piers, and plumbing pipes in the subarea; rodding or trenching the soil around the exterior foundation; drilling attached slabs such as patios, porches, sidewalks, or driveways that abut the structure; drilling brick or stone veneer that extends below grade level; treating voids in the foundation walls or piers. The holes drilled into any concrete slab, while performing the treatments, will be plugged with mortar. It will be the owners responsibility to have these areas repaired to match the existing surfaces as desired. HomeGuard Inc. assumes no liability for any damage to concealed pipes, finished floors, tiles or bricks. NOTE: In order to perform this treatment the property must be vacant for the period during and 3 hours after the treatment has been completed. HomeGuard will use a ground fault device to hopefully prevent drilling through any pipes, conduit or electrical wiring however if this were to happen it will be the owners responsibility and expense to repair any damage done.

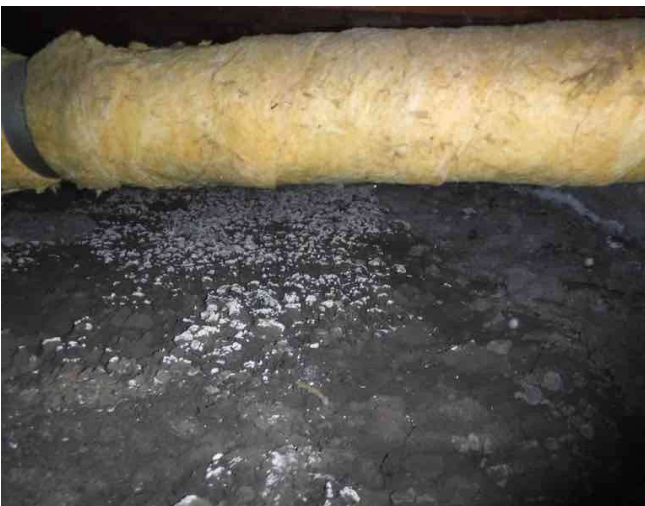
Photo 05

3B. FINDING: We are unable to inspect the substructure area due to a lack of clearance under the structure. Therefore no portion of the subarea was inspected. The crawl space contains important structural components. (See Photo 5)

RECOMMENDATION: Further inspection is recommended. Dig trenches under the structure to allow a partial inspection of the perimeter of the structure and issue a supplemental report with findings, recommendations, and bids.

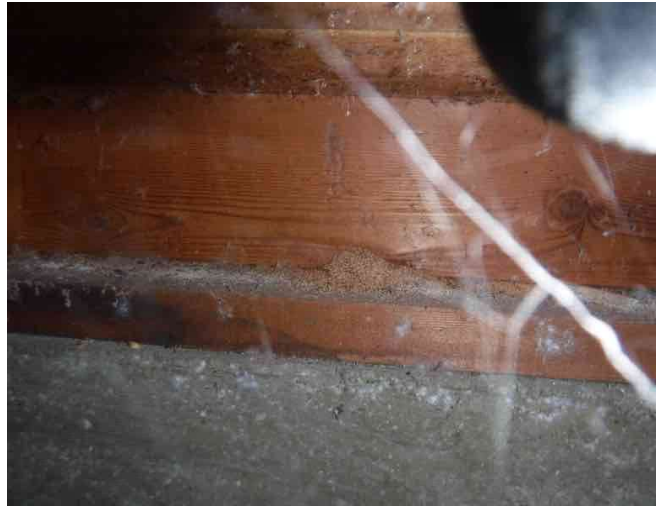
Photo 08

1D. FINDING: Infestation by Drywood Termites was noted at the subarea. (See Photo 8) (See Photo 9)

1E. FINDING: Drywood termite pellets were evident as noted in the above recommendation. (See Photo 8) (See Photo 9)

RECOMMENDATION: Due to the nature of these infestations, it will be necessary to seal the entire structure and fumigate it with Vikane (sulfuryl fluoride), using Chloropicrin as a warning agent. The entire structure must be vacant for this process. It is the owners responsibility to make any preparations required by the fumigators or to have someone to do so at a separate expense and to have the gas turned back on when the fumigation is complete. "NOTICE: The charge for service that this company subcontracts to another registered company may include the company's charges for arranging and administering such services that are in addition to the direct costs associated with paying the subcontractor. You may accept HomeGuard Incorporated's bid or you may contract directly with another registered company licensed to perform the work.

RECOMMENDATION: Remove and/or mask over all accessible termite pellets. It is possible for the drywood termite pellets to sift down or reappear in these areas where they have been masked over.

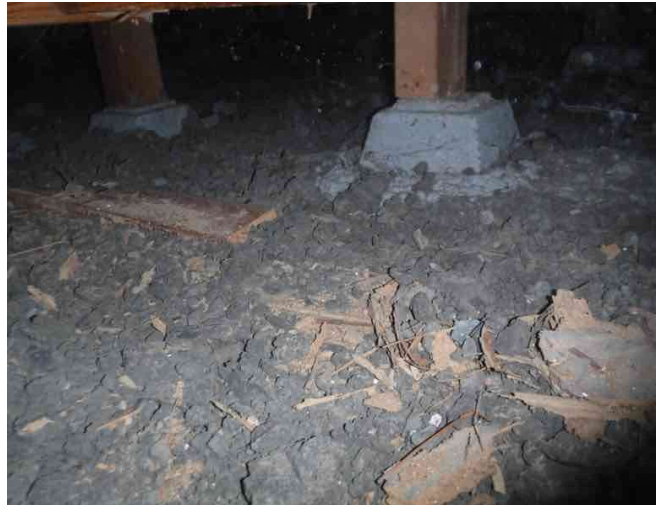
Photo 10

1F. FINDING: There is cellulose debris in earth contact in the substructure area and evidence of subterranean termites was noted in the cellulose debris. (See Photo 10)

RECOMMENDATION: Remove the cellulose debris of a size that can be raked from the substructure area.
