## Home Inspection Report

**1952 Camargo Drive, San Jose**

**Esteban Vasquez**  
June 17, 2022

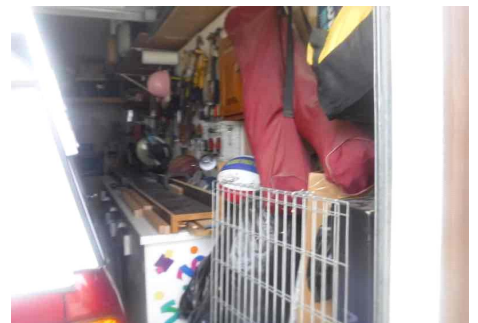
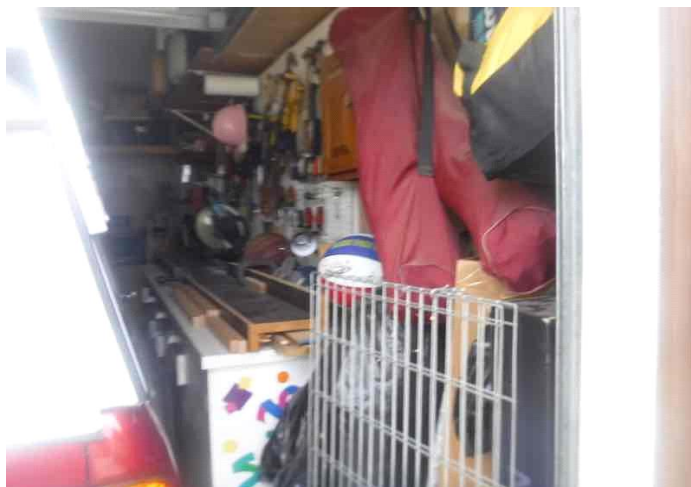
Photo 08

Personal storage was blocking access to the interior of the garage. Therefore, the area is considered inaccessible and was not fully inspected. With access and an opportunity for complete inspection, conditions in need of attention may be discovered. Ideally, the personal belongings should be removed so the area may be inspected. (See Photo 8) (See Photo 9)

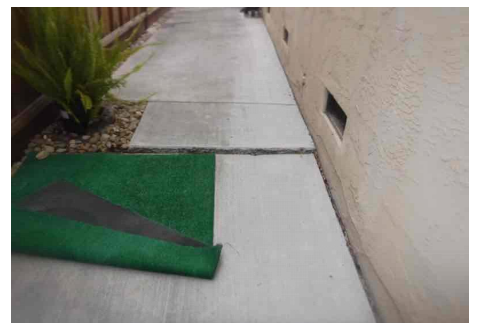
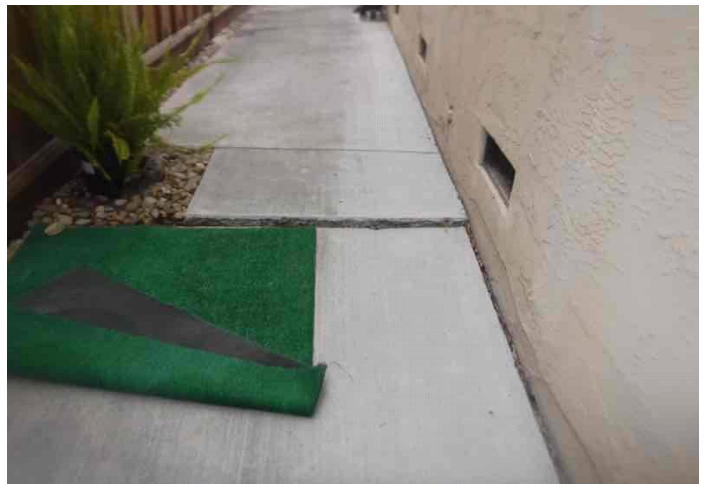
Photo 06

1. The door between the garage and the house did not have an automatic closing mechanism. The door between the garage and the interior of the house should be fitted with an automatic closing mechanism. This will reduce the potential of toxic automobile gases entering the house and serves as a fire break. (See Illustration 3G) (See Photo 10)
2. Personal storage was blocking access to the interior of the garage. Therefore, the area is considered inaccessible and was not fully inspected. With access and an opportunity for complete inspection, conditions in need of attention may be discovered. Ideally, the personal belongings should be removed so the area may be inspected. (See Photo 8) (See Photo 9)
3. The uneven walkway section(s) at the left side present a trip hazard. This condition should be corrected for improved safety. (See Photo 6)

- ! 2. The uneven walkway section(s) at the left side present a trip hazard. This condition should be corrected for improved safety. (See Photo 6)
- ! 3. Water damage was observed to the roof eaves/sheathing at more than one location of the structure. We recommend the services of a licensed general contractor and/or structural pest control company. (See Photo 1) (See Photo 3)

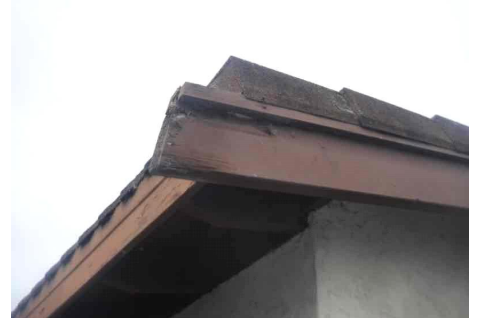
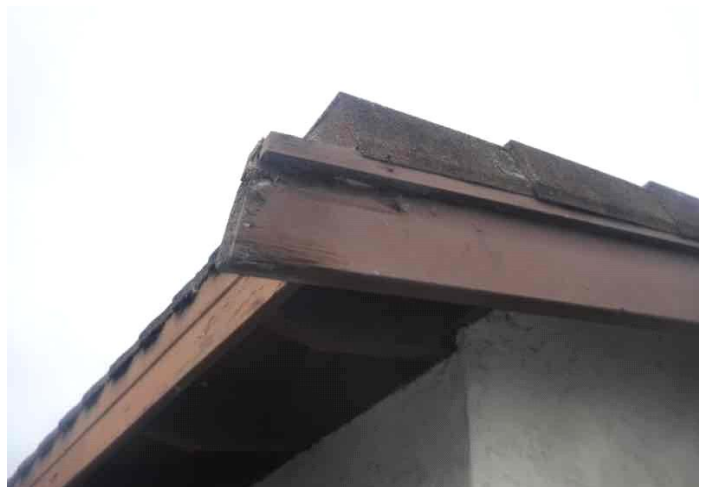
Photo 04

5. Water damage was observed to the rafters at more than one location of the structure. We recommend the services of a licensed general contractor and/or structural pest control company. (See Photo 4) (See Photo 5)

- ! 4. Water damage was observed to the rafters at more than one location of the structure. We recommend the services of a licensed general contractor and/or structural pest control company. (See Photo 4) (See Photo 5)

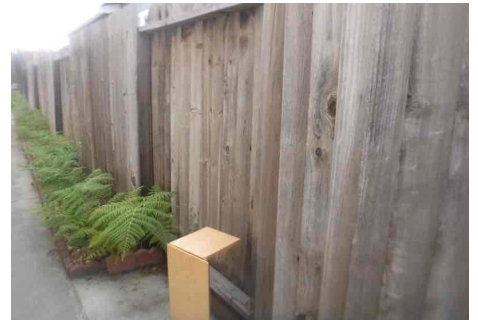
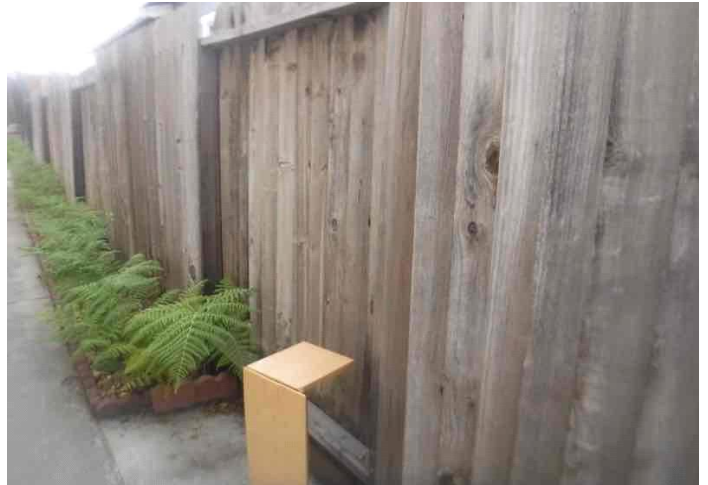
Photo 02

6. The fence is in satisfactory condition, however one or more fence posts are loose at the right side. We recommend all loose, damaged or deteriorated posts be reinforced or replaced as necessary. (See Photo 2)

- ! 5. The fence is in satisfactory condition, however one or more fence posts are loose at the right side. We recommend all loose, damaged or deteriorated posts be reinforced or replaced as necessary. (See Photo 2)

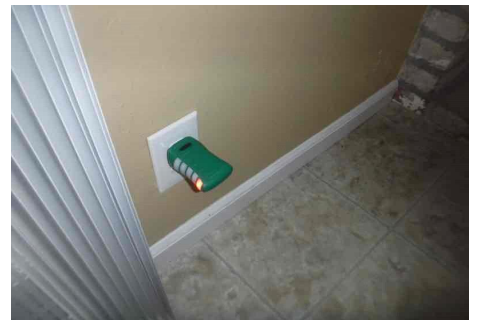
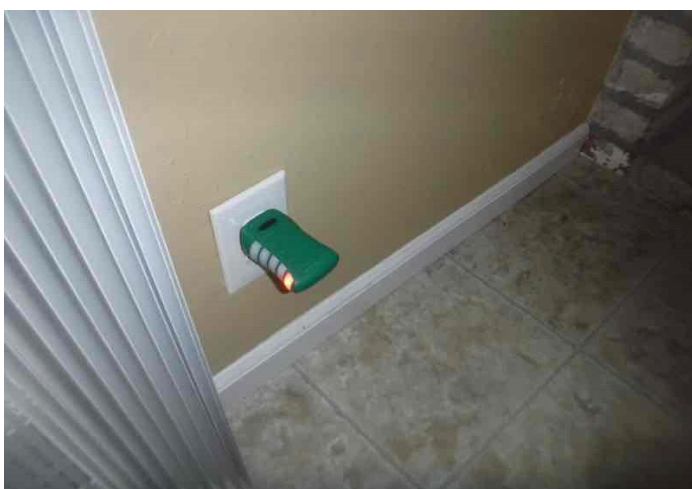
Photo 11

7. One or more outlets at the family room have reversed polarity, i.e. the hot and neutral connection inside the outlet are wired backwards. These outlets and the circuit should be investigated and corrected. Based upon our inspection of a representative number of outlets, we recommend testing of every outlet at a later date. Repairs or rewiring are recommended at all deficient locations. (See Illustration 4M) (See Photo 11)

- ! 1. One or more outlets at the family room have reversed polarity, i.e. the hot and neutral connection inside the outlet are wired backwards. These outlets and the circuit should be investigated and corrected. Based upon our inspection of a representative number of outlets, we recommend testing of every outlet at a later date. Repairs or rewiring are recommended at all deficient locations. (See Illustration 4M) (See Photo 11)

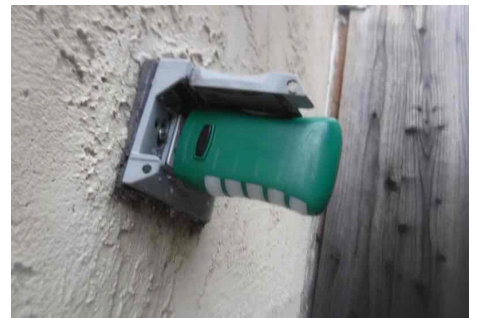
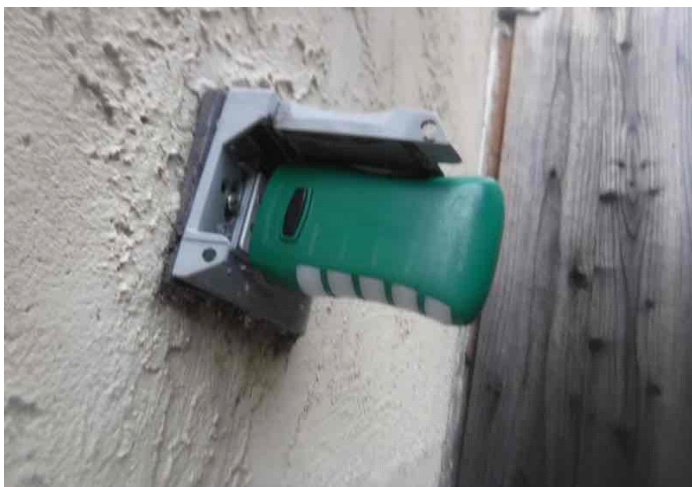
Photo 07

8. One or more outlets at the exterior left side and the rear patio were inoperative at the time of our inspection. Possibly due to turned off switches which were not located during our inspection. These outlets and circuits should be investigated and corrected as necessary. Based upon our inspection of a representative number of outlets, we recommend testing of every outlet at a later date. Repairs or rewiring are recommended at all deficient locations. (See Photo 7) (See Photo 13)

- ! 2. One or more outlets at the exterior left side and the rear patio were inoperative at the time of our inspection. Possibly due to turned off switches which were not located during our inspection. These outlets and circuits should be investigated and corrected as necessary. Based upon our inspection of a representative number of outlets, we recommend testing of every outlet at a later date. Repairs or rewiring are recommended at all deficient locations. (See Photo 7) (See Photo 13)

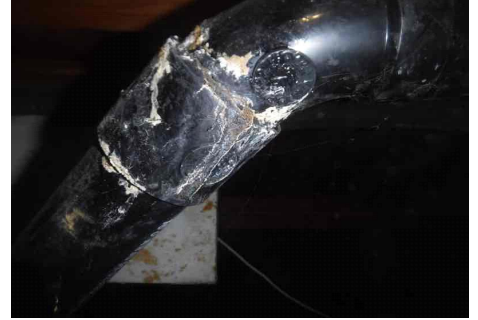
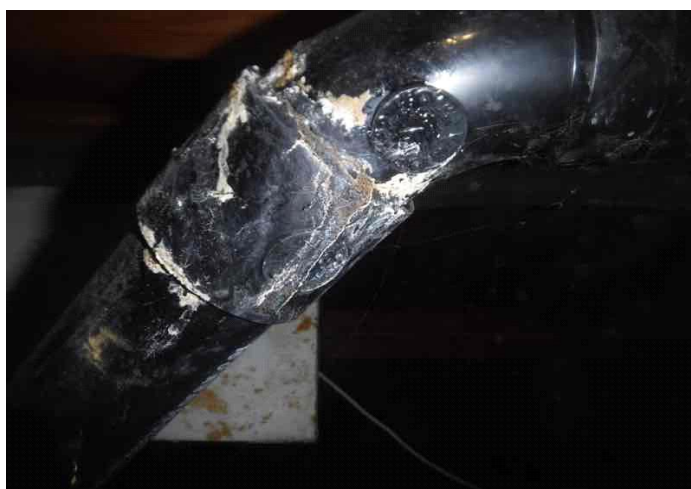
Photo 12

9. There is a cracked and leaking Plastic drain pipe under the kitchen. This is a potential health hazard. We recommend the piping in question be repaired or replaced. (See Photo 12)

- ! 1.** There is a cracked and leaking Plastic drain pipe under the kitchen. This is a potential health hazard. We recommend the piping in question be repaired or replaced. (See Photo 12)

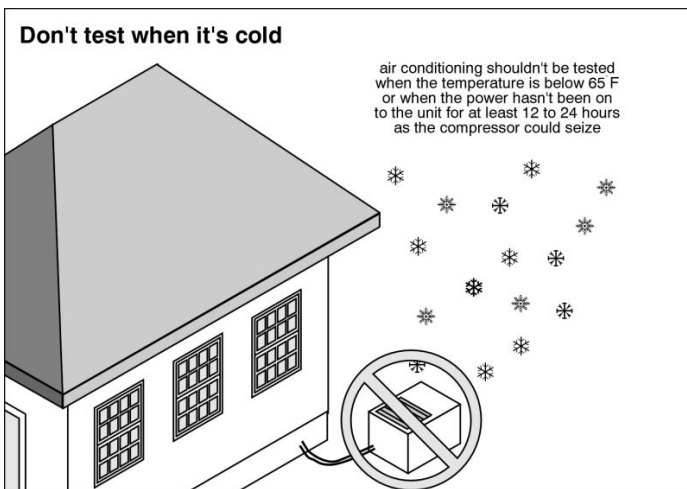
Illustration 6A

The air conditioning system could not be tested as the outdoor temperature was below 65 degrees F. (See Illustration 6A)

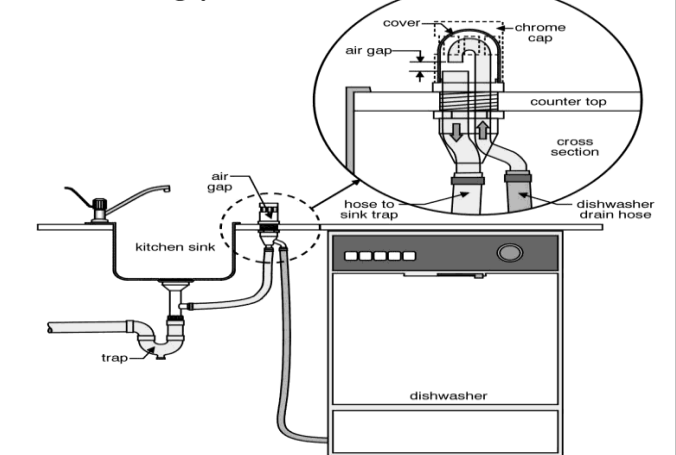
Illustration 9G

9. The kitchen countertop shows evidence of typical minor wear.
10. The dishwasher lacks an air gap device. Air gaps are standard equipment to assure a separation between supply and waste water of the dishwasher. It is advised that one be installed. (See Illustration 9G)
11. The kitchen cabinet shows evidence of typical minor wear.
