高通RF技术期刊2016-03-31

Qualcomm Technologies, Inc.

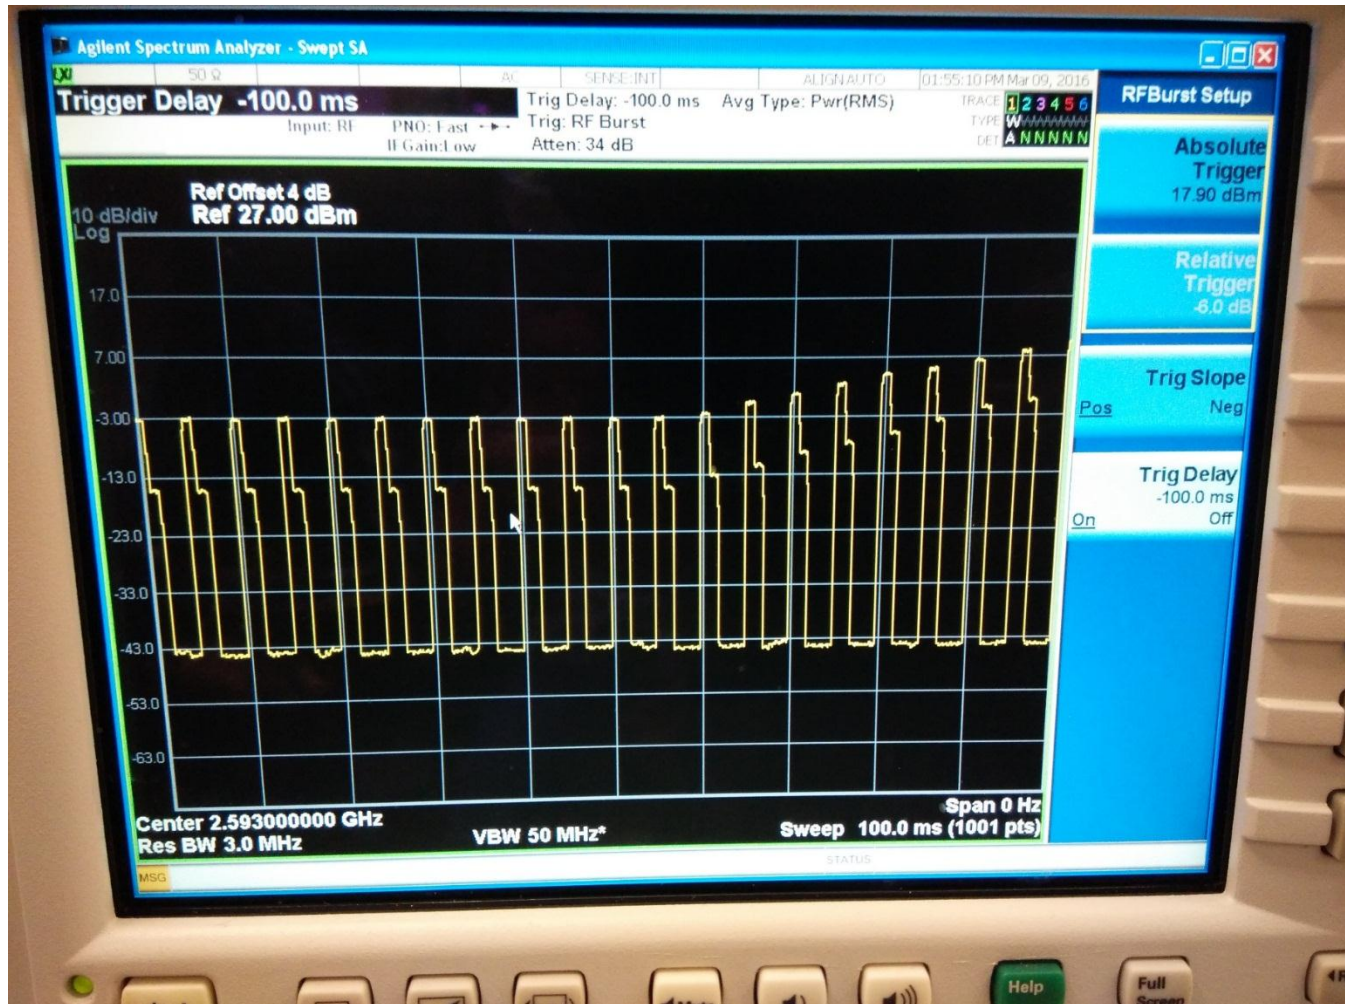
- **Platform:** All with MIPI RFFE
- **适用平台：** All with MIPI RFFE
- **Symptom:** UE failed to pass TDD LTE B38/40/41 power control relative power tolerance (3GPP 36.521-1, 6.3.5.2) test case. UE TX power didn't increase monotonously with 1dB step during ramp up test.
- **问题描述：** 手机在TDD LTE B38/40/41 功率控制-相对功率控制容限(TS 36.521, 6.3.5.2)测试失败。在Ramp Up测试中，手机发射功率并不是步进1dB单调上升。
- **Analysis:** By using the spectrum analyzer, we can see the TX power in sub-frame 2 and 7 is much larger than sub-frame 3 and 8 (see result in next slide). But according to 3GPP, the TX power in sub-frame 3 and 8 should be 1dB larger than sub-frame 2 and 7.
- **问题分析：** 通过频谱仪可以看出，手机在第2和第7子帧的功率远大于第3和第8子帧（测试结果详见下一页）。但是根据3GPP规范，手机在第3和第8子帧里的功率应该是比第2和第7子帧分别增加1dB。

- We use B41 as an example. B41 failure spectrum.
- 我们用B41做为例子。下图是B41测试失败时截取的频谱。

- **Solution:** Remove the ASM part configure for TDD band's Tx driver code in RFC.
-
- **解决办法:** 删除TDD频段Tx驱动部分关于ASM的配置代码。

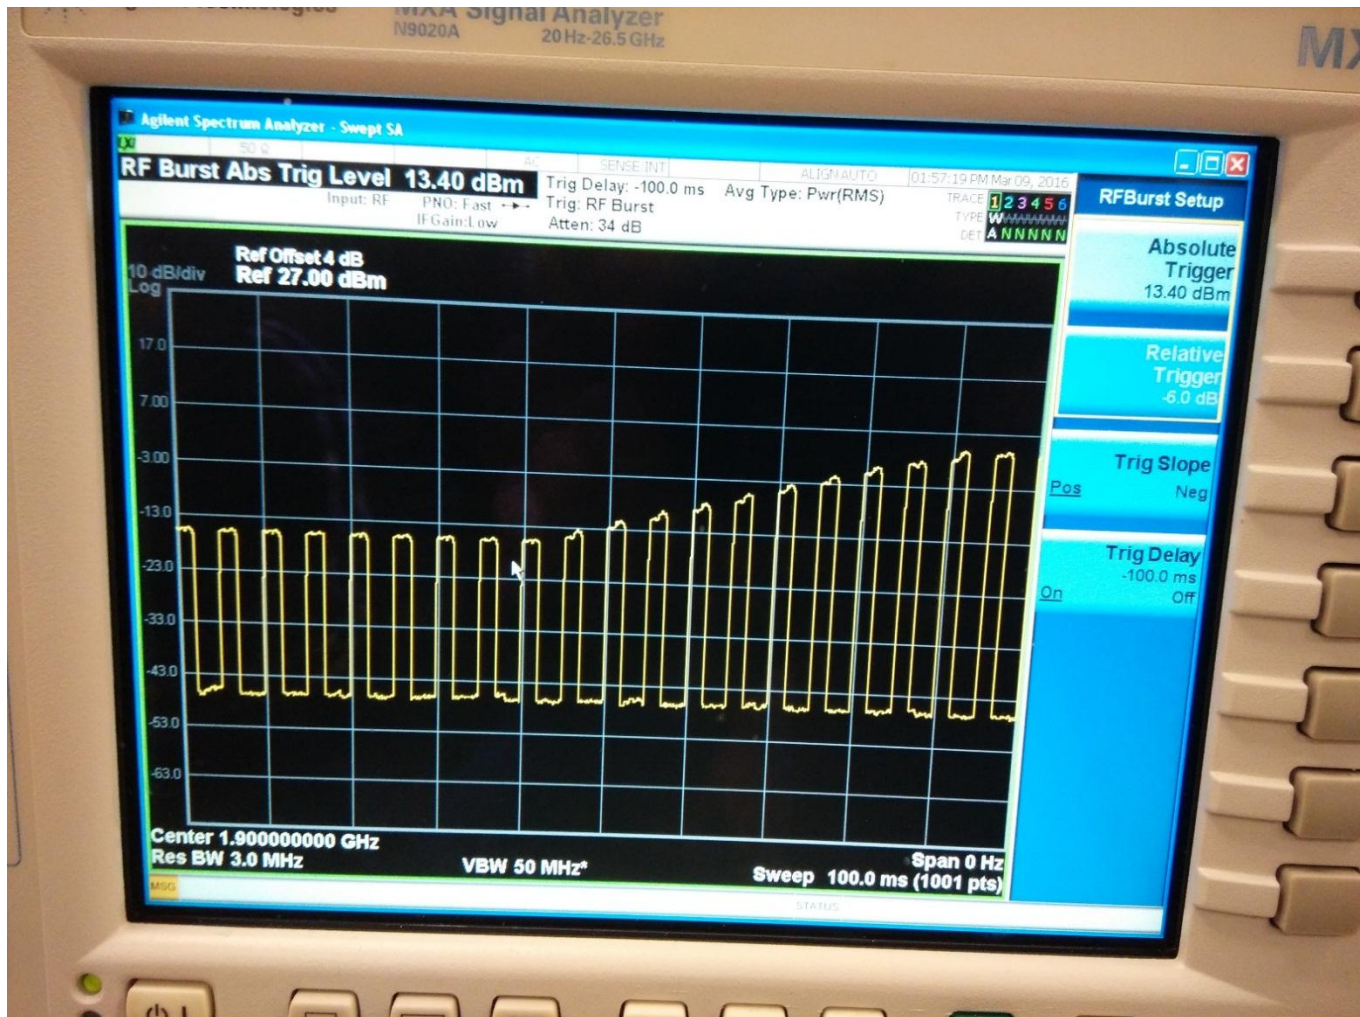
- B39 pass spectrum.
- B39测试通过时的频谱。

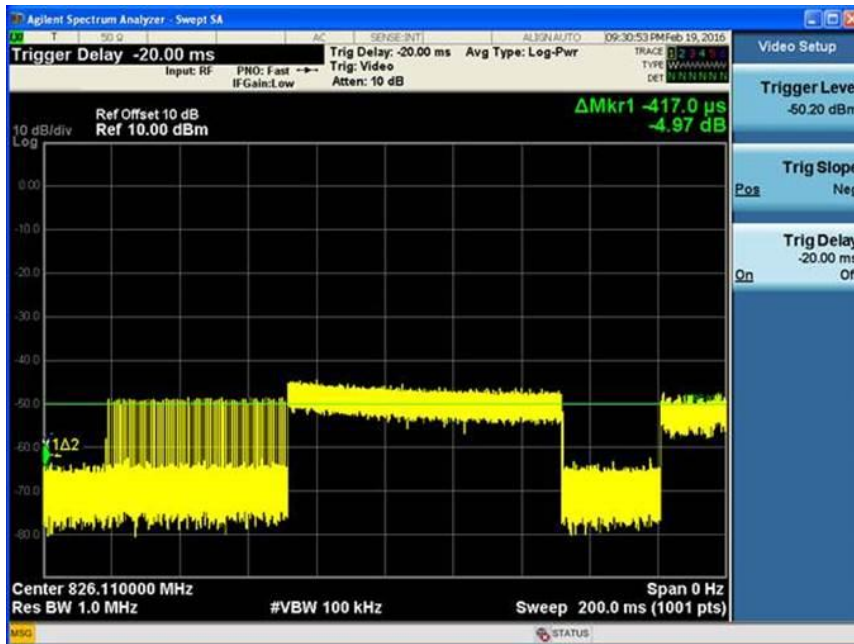
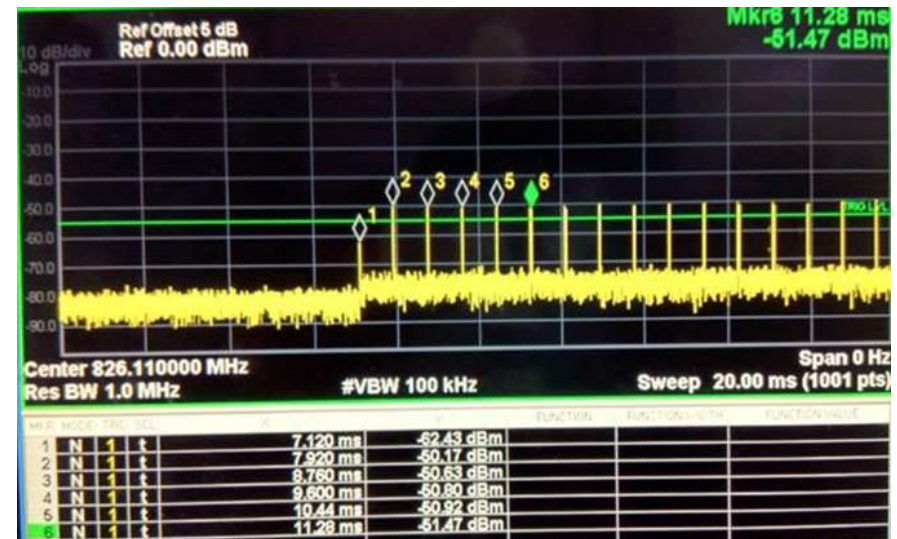
- **Platform:** MSM8996/MDM9x40
- **适用平台：** MSM8996/MDM9x40
- **Symptom:** HDR test case 4.3.1 Open Loop Output Power fails Test1 (@-25dBm). The measured Tx power is below the lower limit.
- **问题描述：** HDR 测试项4.3.1 开环发射功率 Test1 (@-25dBm)失败。测试仪器测量到的功率低于测试门限下限。

- **Analysis:** Use spectrum analyzer to capture probe power, could find spurs before access probe. The first spur is about -62dBm which matches the TE report value. For Test1, the TE lor is -25dBm, the TE trigger level is quite low and thus the false alarm caused by the spur leads to the failure.
- **问题分析：** 通过用频谱分析仪抓取时域上的发射功率信号，可以看到在access probe之前出现较多的毛刺。其中第一个毛刺的功率大约在-62dBm，符合测试仪器的测量值。Test1中，测试仪器的lor设置为-25dBm，因而发射功率的trigger level相对较低，由于毛刺引起虚警从而导致测试失败。

- **Analysis:** Meanwhile by comparison that different designs which adopt different PAs have different behavior. Those PAs which have larger gain (e.g. 20dB) at low gain state will fail the case, while those with less gain could pass. The reason is the larger gain PAs will amplify the spurs to a significant level which will trigger the TE as detection of access probe and report the measurement and then lead to failure.
- **问题分析：** 同时通过比较发现采用不同PA的设计方案表现不一。那些在低增益状态下能够提供较大增益（例如 20dB）的PA方案会导致测试失败，而增益较小的PA方案则可以通过测试。原因在于较大增益的PA能够将毛刺放大到足够大，触发测试仪器认为access probe已经开始，从而进行测量和报告，导致测试失败。
- **Solution:** Submit case to RFSW team with test report, spectrum analyzer plot and test log as well as PA spec to confirm the issue and apply CR#982324.
- **解决方案：** 提case到RFSW team，提供测试报告，频谱分析仪截图，测试log和PA器件手册已确认问题，再申请CR#982324。

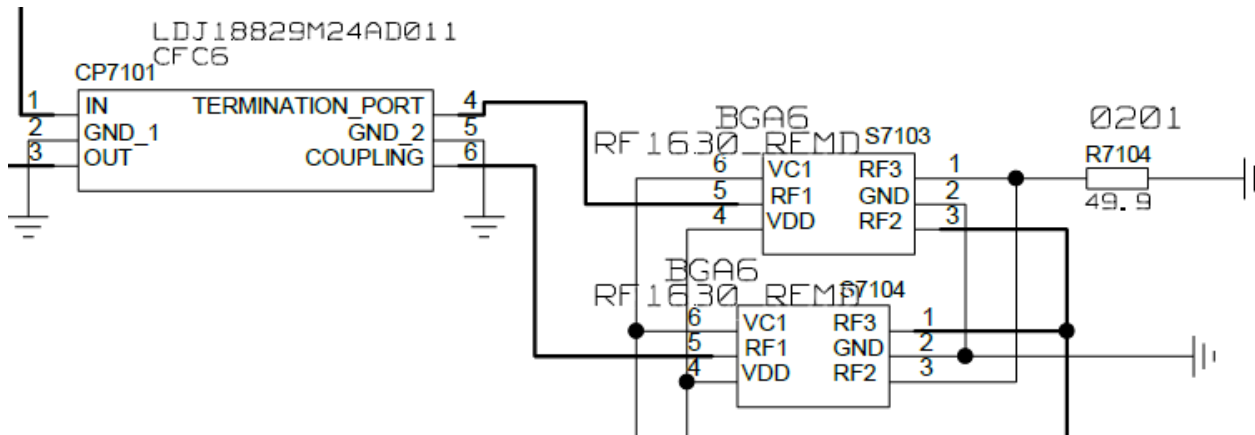
1. Improper coupler selection, which will pull FB 50 ohm to 8 ohm.

1. Coupler选型错误，导致coupler不在50 ohm。

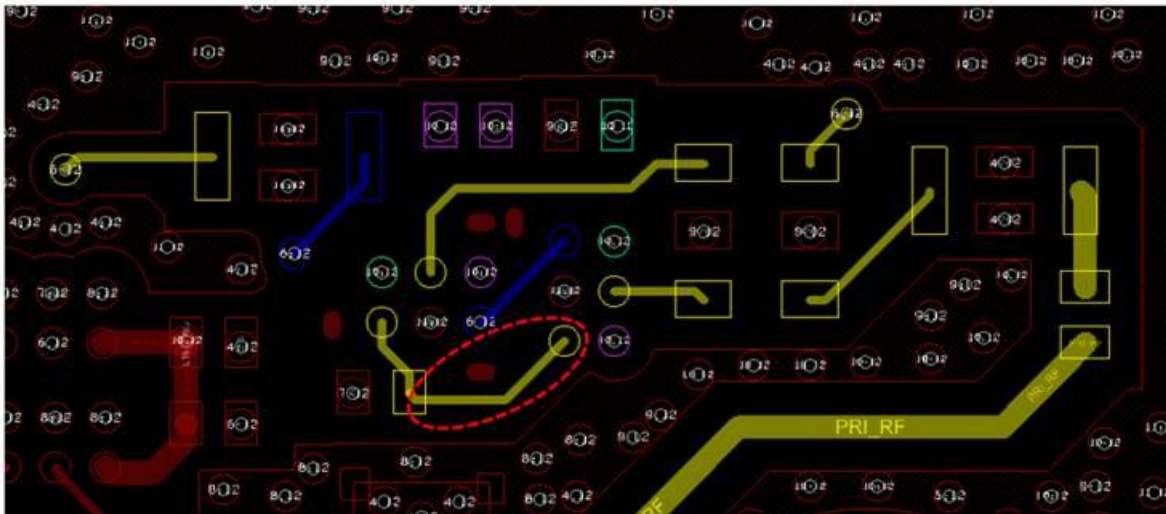
2. RF open-circuit stub on the reverse path termination resistor when forward coupling path is selected (red oval). It could affect fwd coupling factor at higher frequencies.

2. FB path正向工作的时候，红色标记的线路会辐射蓝色部分，影响正向高频信号耦合因子。

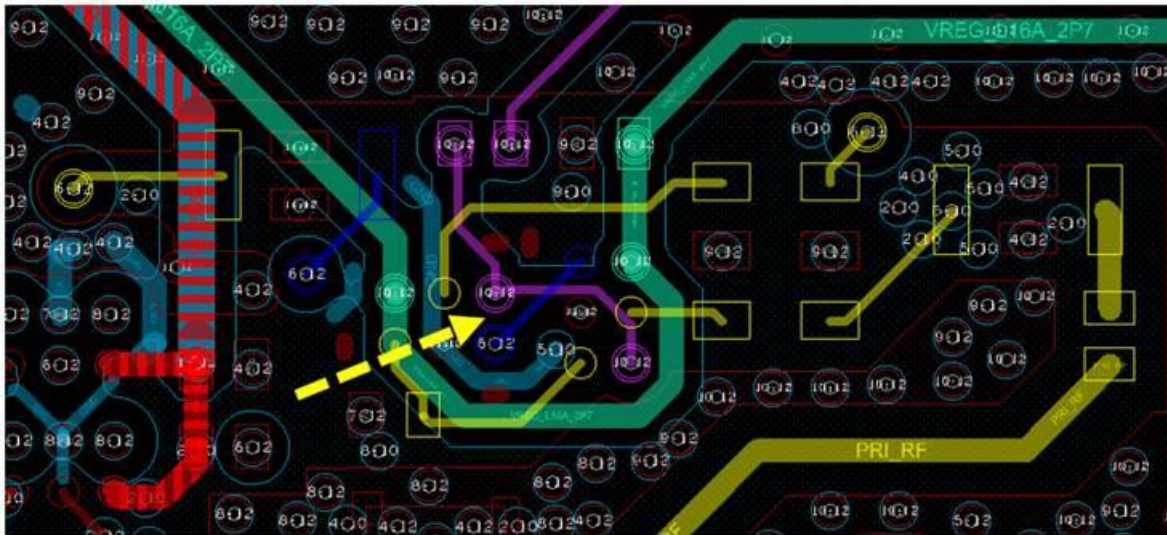
3. Potential via-to-via coupling between FBRx path and GRFC control line (yellow arrow). May couple digital noise into FBRX path (fwd and rvs directions).

3. GRFC控制信号的过孔可能会影响FBRx信号。

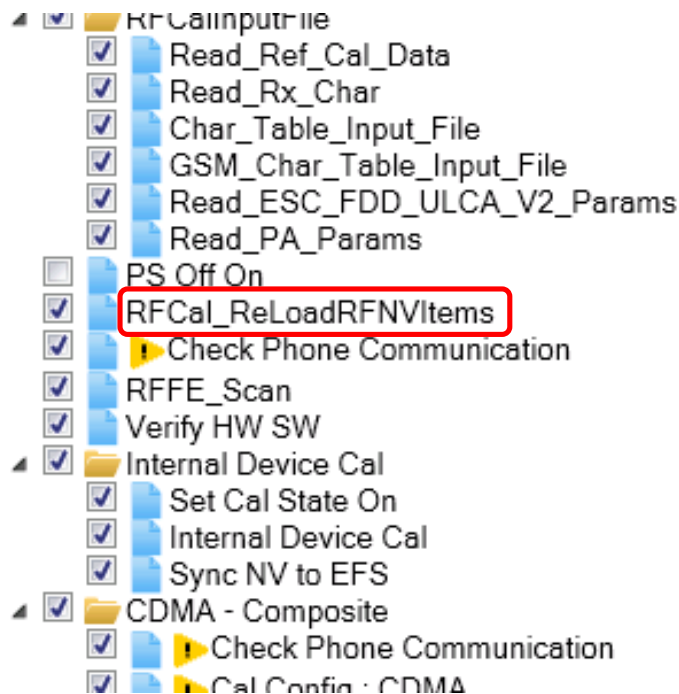
- **Platform:** MSM8996
- **适用平台：** MSM8996
- **Symptom:** crash happens as below during UE calibration.
- **问题描述：** UE在做校准时出现如下死机现象。
 - Coredump
 - =====
 - rfgsm_core_tx.c:666 rfgsm_core_tx_sleep: TX Device 6 Pwr Down (ON->LPM) failed for band 1
 - -000|qurt_exception_raise_nonfatal()
 - -001|err_Fatal_internal3()
 - -002|err_Fatal_internal2()
 - -003|rfgsm_core_tx_sleep()
 - -004|rfgsm_mc_tx_sleep()
 - -005|rfgsm_dispatch_tx_sleep_req()
 - -006|rfgsm_req_dispatch()
 - -007|rfgsm_req_dispatcher()
 - -008|rf_cmd_process()
 - -009|rf_task_1()
 - -010|TASK_ENTRY()
 - -011|rex_os_thread_entry_func()
 - -012|_pthread_stub()
 - -013|qurt_trampoline()
 - ----|end of frame

- **Solution:** Add RFCal_ReLoadRFNVItems node after PS Off On in Xtt tree
- **解决方案：**在校准tree中PS Off On节点之后添加 RFCal_ReLoadRFNVItems节点

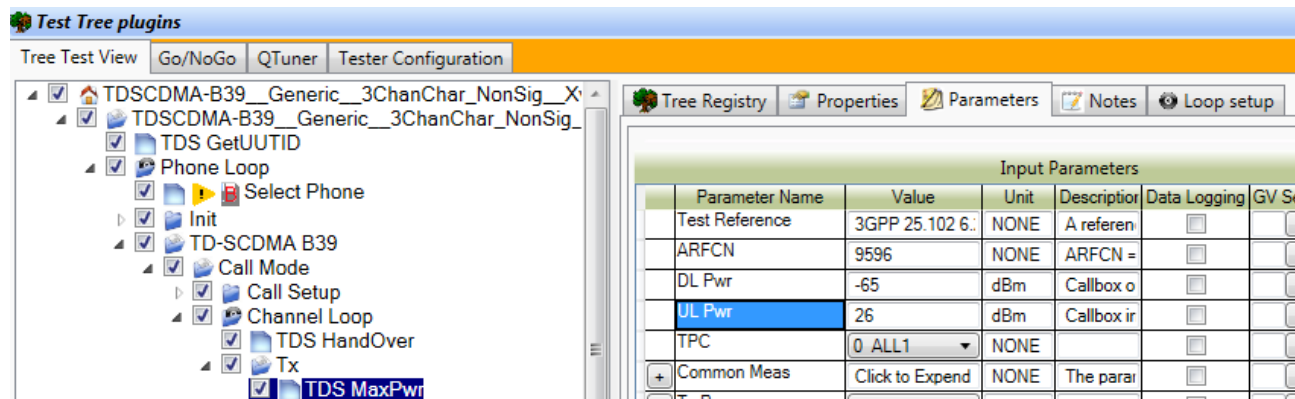
- **问题描述：**有些板子在CMW500上做TDSCDMA非信令测试的时候，高中低信道的最大功率不平坦，并且最大功率偏低。
- **Analysis:** From failure log, we can see that the error b/w HDET and TxAGC are applied to MTPL, but not applied to TxAGC. Thus TxAGC does not increase as MTPL accordingly, which result in Tx max power is not accurate.

- 00:12:40.360 rf_tdscdma_core_txplim.c 00895 RFTXPLIM-ACQ:00005,Gain:04,LimitErr:02.62,Filtered:00.65,MTPL:944.03
- From FW log, TxAGC override flag is enabled in the failure log, which result in max power is always limited to 24dbm

- **Solution:** Set UL max power to a higher value than target power (like 26 dBm) in NS XTT to avoid this issue
- **解决方案：**在NS测试的时候可以把最大功率设的大一点(例如26 dBm)
