高通RF技术期刊2016-02-29

Qualcomm Technologies, Inc.

1. WTR29x5 TDS Spur Issue Consideration
2. WTR29x5_DA_matching_for_TDSCDMA
3. RF_CLK/IQ/DAC connection in Thor platform
4. Use QRCT IQ capture to debug GSM desense issue
5. Wrong NV definition in QXDM about
RFNV_GSM_Cx_GSM<band>_ENH_TEMP_COMP_I
6. GSM BER failure under strong signal level
7. QPA calibration issue - caused by WTR IQ rosin joint

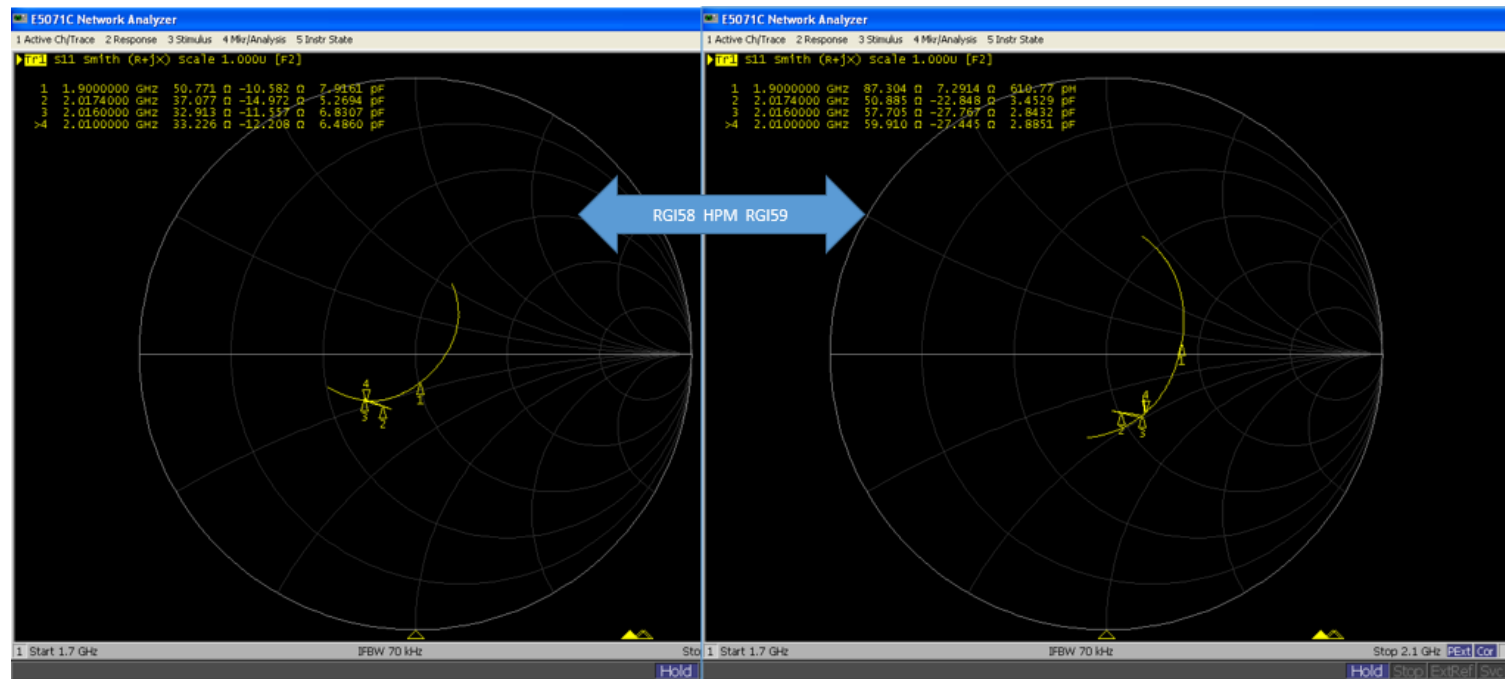
- **Analysis:** According the WTR29x5 design, the expected power delta is 1dB per each RGI, but measured power is a little different, shown as below. Customer can get similar data if testing power at DA output pin with pigtail. So the reason should be DA output matching.
 - TDSCDMA B34 Low Power Mode, RGI62-RGI61= 1.49dB
 - TDSCDMA B34 High Power Mode, RGI59-RGI58= 0.52dB
- **Root Cause:** Checked impedance of WTR29x5 DA4 port, the impedance shift obviously between RGI62/61 at LPM and between RGI59/58 at HPM. So the DA output matching is able to change RGI power delta.

- **Solution:** Tune the DA output matching to 50ohm to balance the special RGI impedance.
- **解决办法：**调试WTR DA的输出匹配到50ohm，来平衡特殊RGI的阻抗变化。

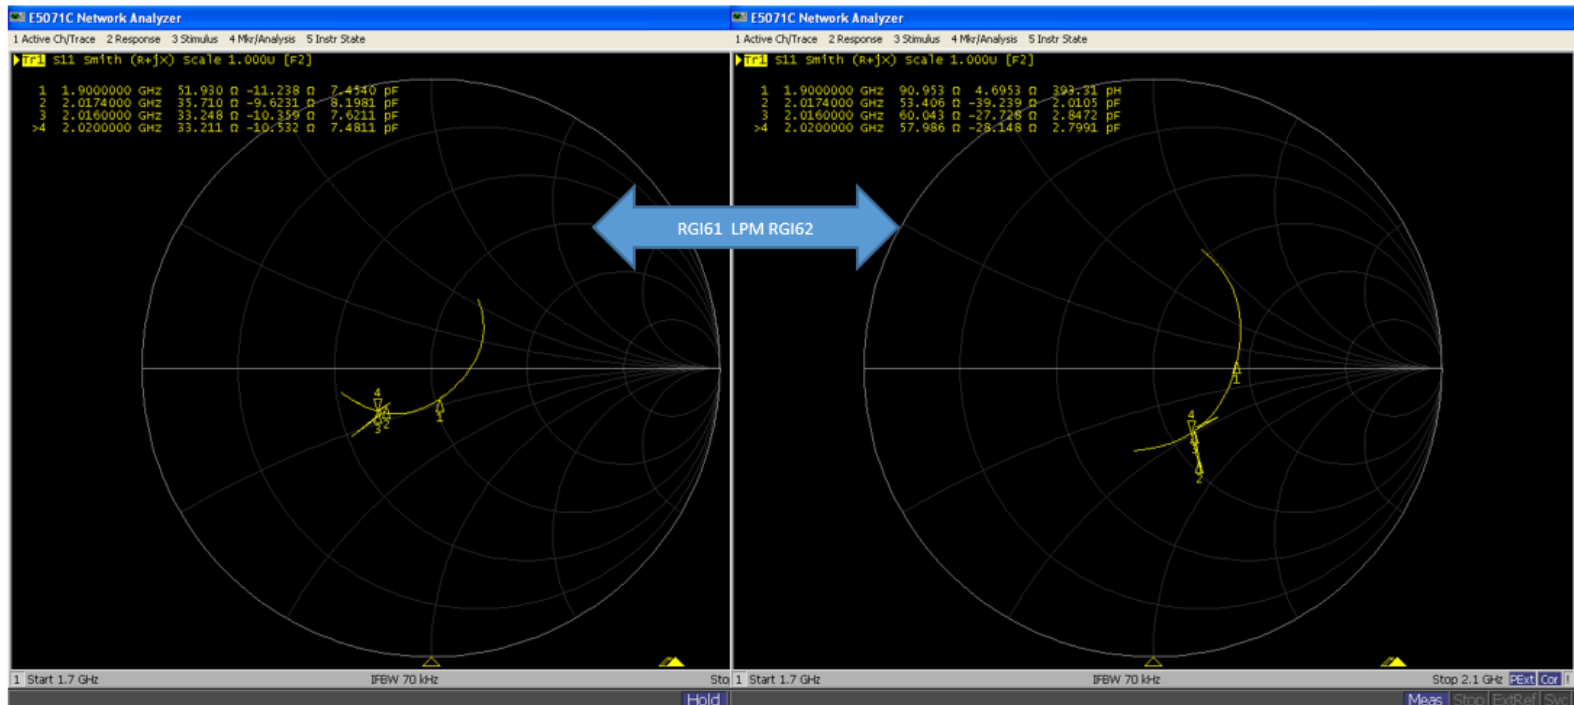
- **问题分析：**根据WTR29x5的设计，这几个相邻RGI的期望功率差值为1dB，但实际测量值略有差异。测试值如下。客户从WTR 的DA输出口测量到的功率也符合如下差值。所以问题的原因应该是WTR输出匹配。
 - TDSCDMA B34 Low Power Mode, RGI62-RGI61= 1.49dB
 - TDSCDMA B34 High Power Mode, RGI59-RGI58= 0.52dB
- **原因：**测量WTR29x5的DA4端口阻抗，发现DA阻抗在RGI62/61(LPM)和RGI59/58(HPM)之间有偏移。所以输出阻抗可以很大程度的影响功率的差值。

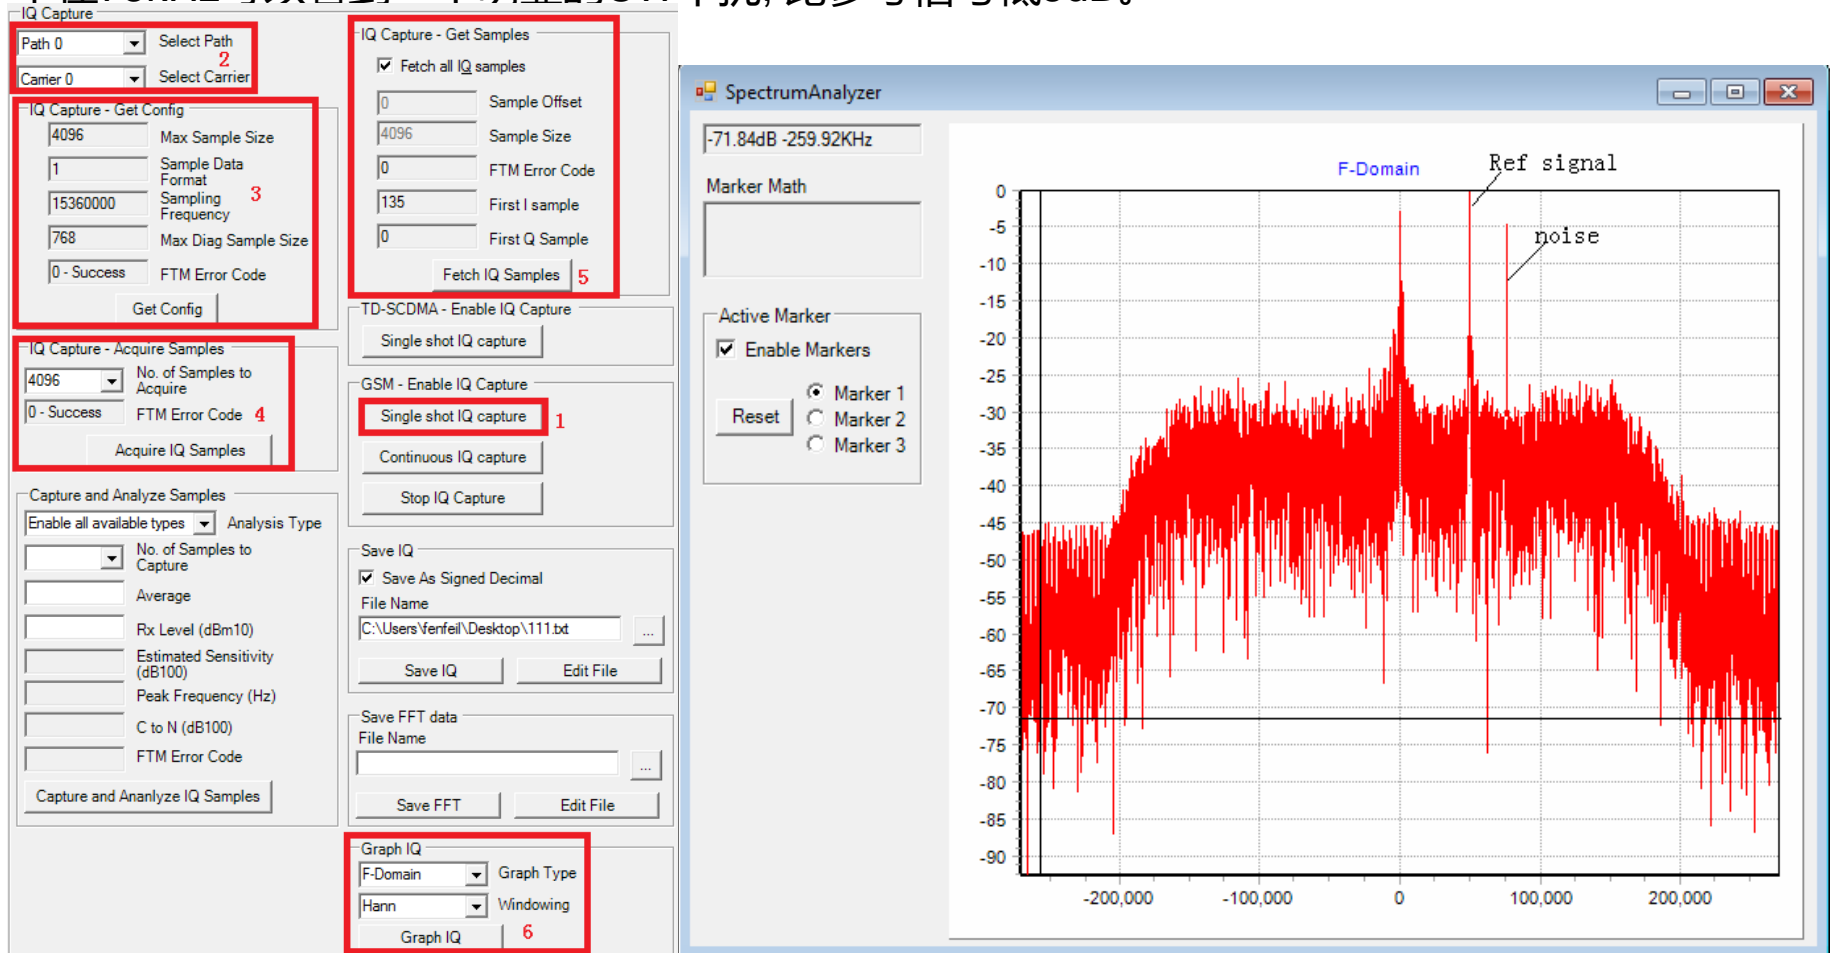
4. We can see the 50kHz offset CW signal if we add -110dBm CW at antenna port. In the example figure, we can also see a 75kHz offset noise with 5dB lower level than the reference CW signal.

如果天线口加了偏移50kHz的-110dBm的CW信号作为参考，可以看到该CW信号的频谱。另外图中在75kHz可以看到一个明显的CW干扰，比参考信号低5dB。

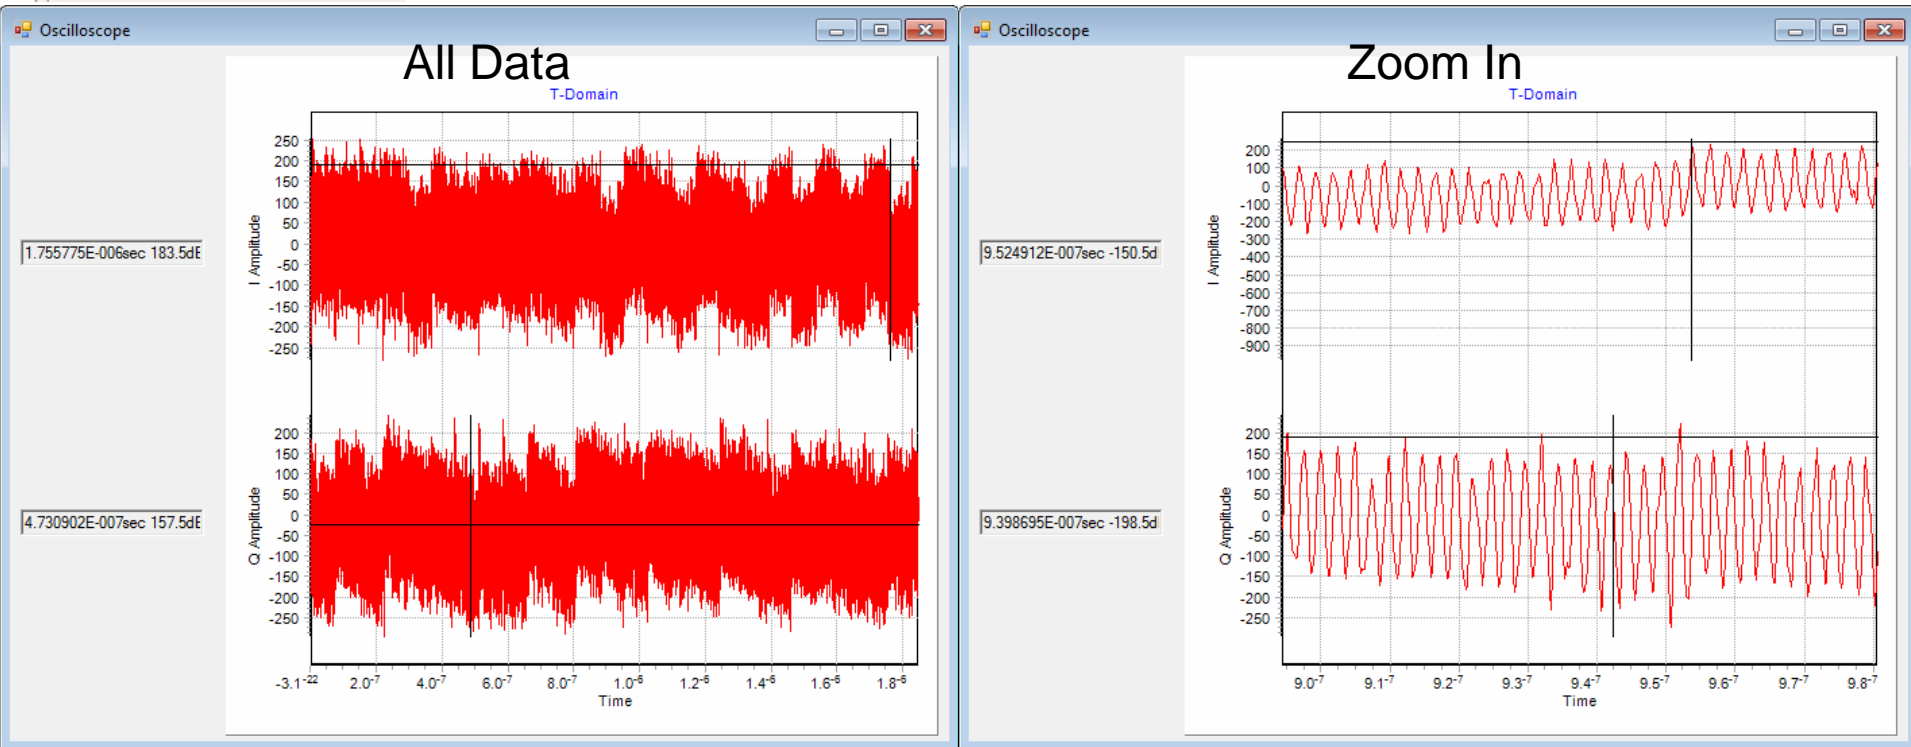
If you want to observe IQ waveform in time domain, pls select T-Domain under Graph IQ, then click “Graph IQ” button. Below is an example of -100dBm CW signal with 50kHz offset.

如果要看IQ的时域波形，可以在Graph IQ栏中选择T-Domain，然后点击Graph IQ按钮就可以看到IQ的时域波形。下面是一个天线口加了-100dBm偏移50kHz CW信号的例子。

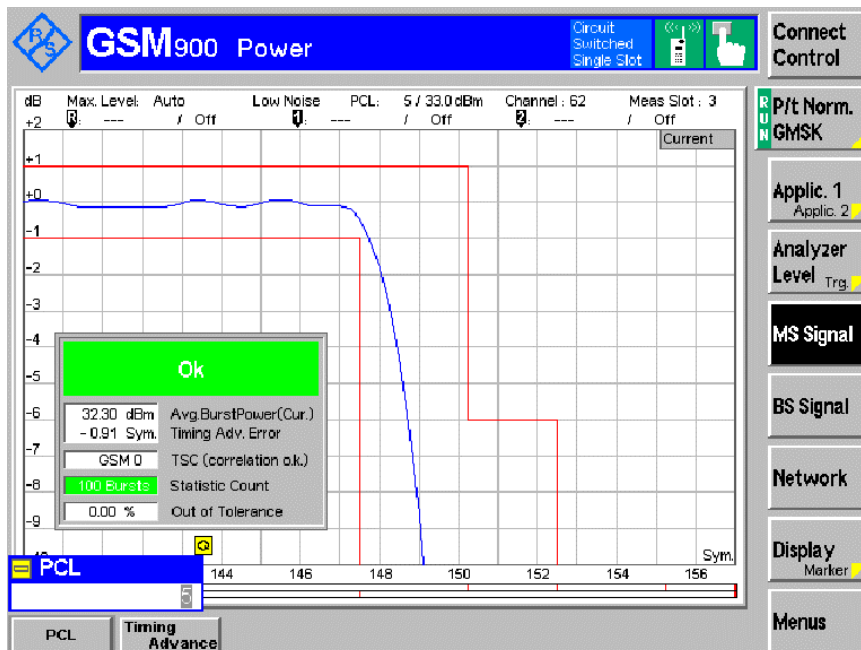
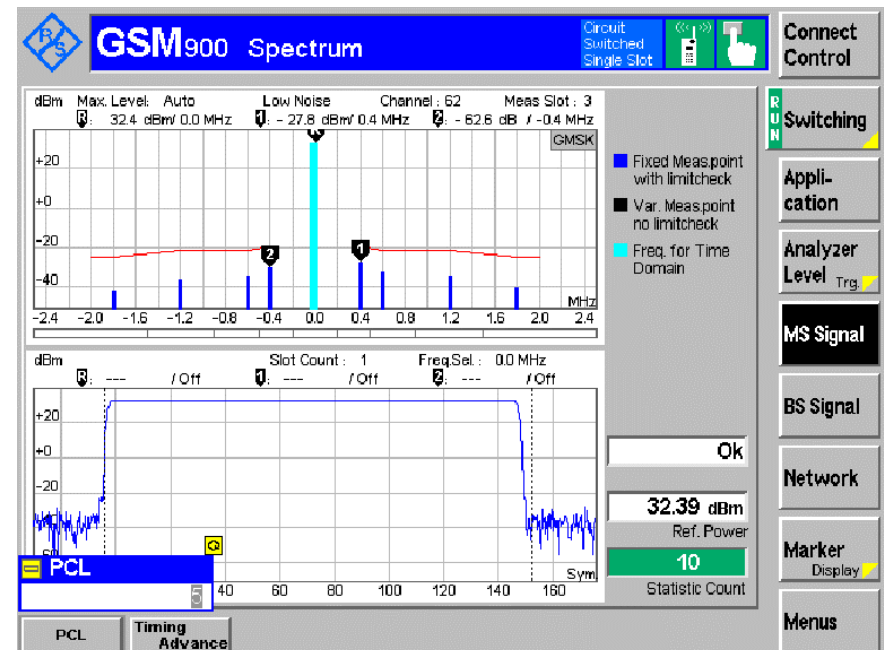
- **Platform:** MSM8909+WTR4905,MSM8952/76+WTR2955/65
- **适用平台：** MSM8909+WTR4905,MSM8952/76+WTR2955/65
- **Symptom:** GSM PvT right upper corner of falling edge is very close to left limit, it can be improved by tune timing, but GSM ORFS switching @PCL5 will be worse out of limits.
- **问题描述：** GSM PvT下降沿的右上拐角靠左侧)比较临界，调整Timing NV能改善，但GSM 开关谱会恶化(有可能超标)。如下图GSM900 @PCL5测量结果例子。

1. GSM RF has a trade-off between GSM PvT (right corner part of falling edge) and GSM ORFS switching @400kHz when testing higher power (like G900 PCL5).
2. OEM FE design limiting, GSM DA RFCAL higher power part saturated(e.g. below figure), which contributed to worse ORFS switching.

1. Base on current MPSS release default static NVs value, to fine tune “pa_stop_offset_adj” value of RFNV_GSM_Cx_GSM<band>_TX_TIMING_I. If it requires more marginal on ORFS switching, please try fine tune ramp down part of (e.g. add one more 9800 into 1st & 2nd Ramp_down values) RFNV_GSM_Cx_GSM<band>_POLAR_RAMP_PROFILE_I, according to actual design test result.

2. Tune HW matching to eliminate PA Tx saturation contributing non-linear to worse ORFS. Otherwise to accept more trade-off.

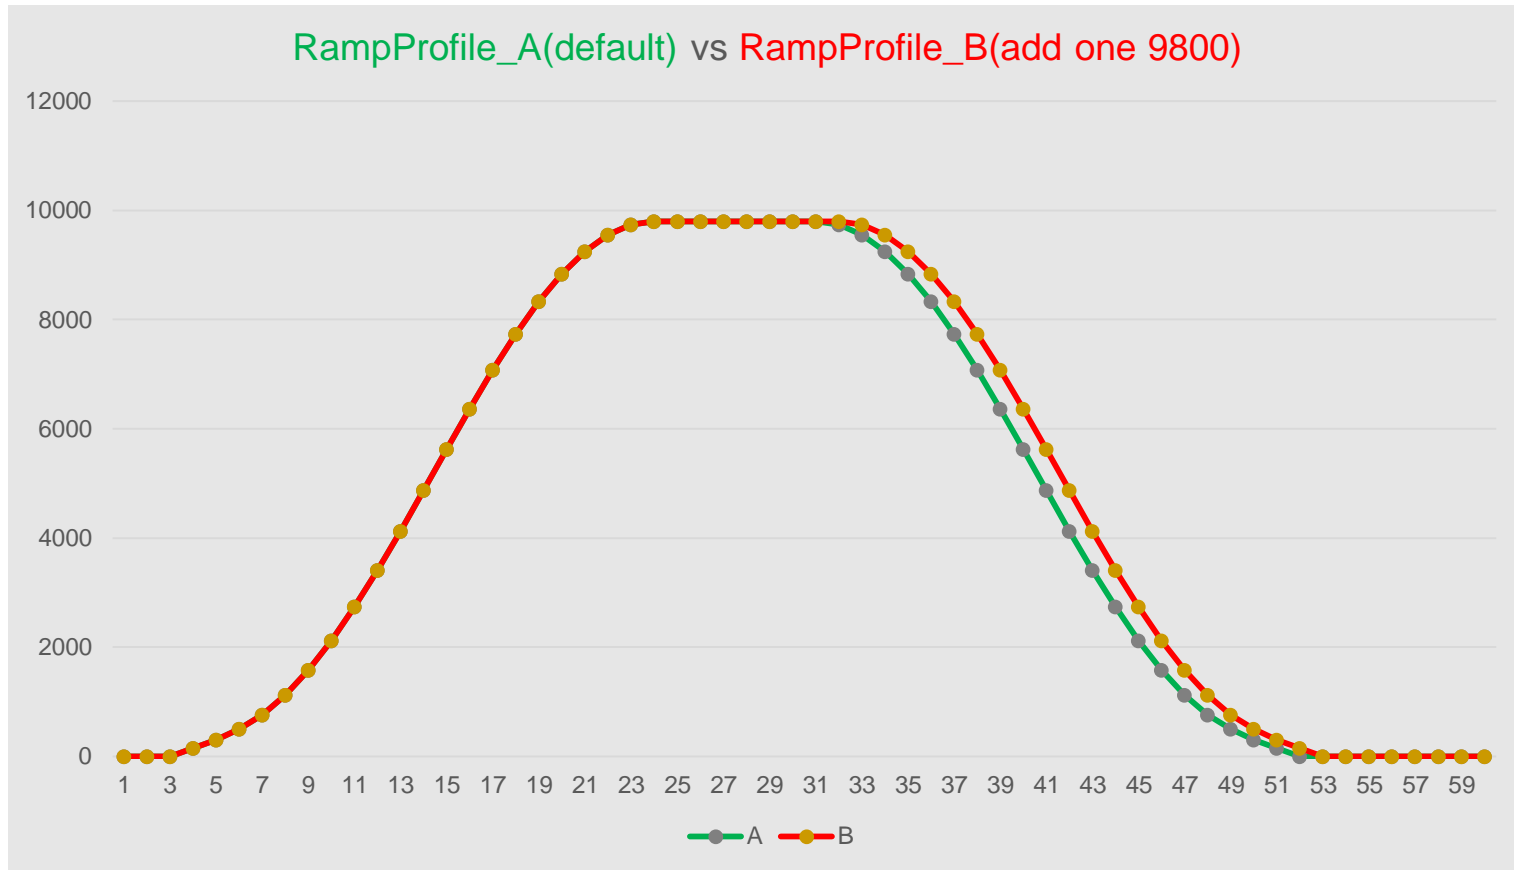
1. 基于当前MPSS软件默认静态NV设置条件下的实际测试结果, 可微调 RFNV_GSM_Cx_GSM<band>_TX_TIMING_I的”pa_stop_offset_adj”。如果微调timing后的需要更多的开关频谱, 可尝试微调RFNV_GSM_Cx_GSM<band>_POLAR_RAMP_PROFILE_I中的下降沿部分, 例如尝试在第1和第2个下降沿值中添加1个9800值是否有所帮助(如下图所示)。

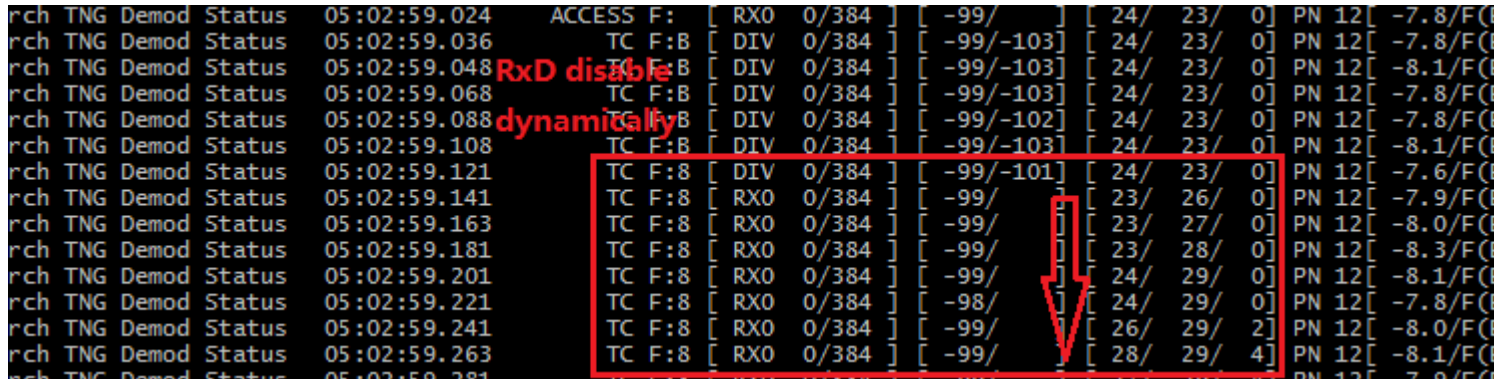
1. Customer accidentally duplicate a ANT_SEL (logic HIGH) signal from Tx0 signal configure table into in C2k RFC Rx1/Rx0 signal configure table, and the ANT_SEL is designed for a GRFC switcher control within FBRX_HDET circuit part.
2. Once 1x L1 dynamically switches RxD disable from enable and RFSW will set the ANT_SEL signal to be initial state LOW logic, afterwards affecting HDET reading, getting big Tx error and abnormal Tx max power (as below Figure. B).

1. 意外地在RFC中将控制FBRX_HDET通路中的GRFC开关信号，从Tx0信号配置中同时复制在CDMA Rx1和Rx0信号配置当中。
2. 在实际测试过程中，CDMA 接收分集会被L1动态打开和关闭，当分集关闭时RFSW将FBRX_HDET通路中的GRFC开关信号初始化为低，此时影响HDET读值从而最终反映到最大发射功率异常(如下图B所示)。

remove the duplicated the ANT_SEL signal from C2k RFC Rx1 & Rx0 signal configure.
