高通RF技术期刊2015-12-30

Qualcomm Technologies, Inc.

1. GSM ORFS modulation issue
2. LTE B13 spurious emission issue for VZW supplementary testing
3. Baseband modem power supply for CA/non-CA design

1. TA.2.0 ICI-CA RFC Customization
2. CDMA 1x RC1 TX gating failure due to wrong MIPI PA_ON register address setting
3. How to debug WCDMA RSCP variation issues via RF AGC logs
4. Common Issues About GSM Tx Timing

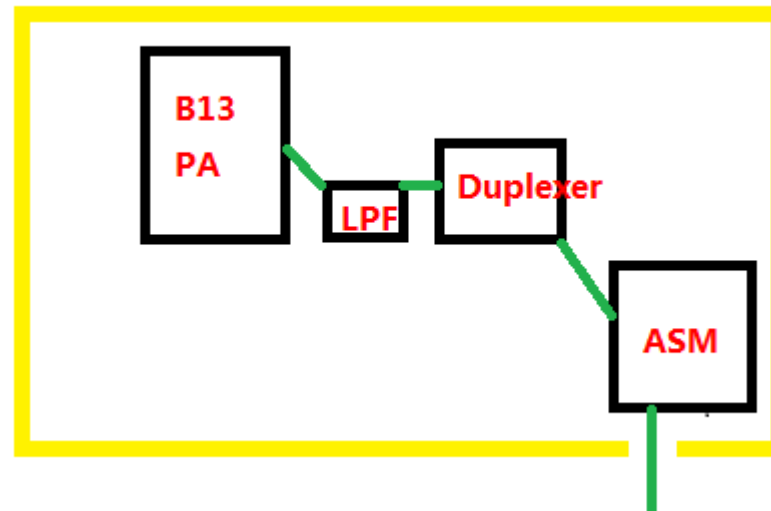
- **Analysis :** 1. For schematic, B13 LPF is required on post PA for 2nd harmonic suppression. On the other hand, the PN of B13 duplexer should meet QCT requirement. It's confirmed that there are no problem for sch and components PN. 2. For layout, PA/LP/Duplexer/ASM are located in same shielding can, B13 2nd harmonic can be improved by13dB after removing the shielding can. 3. cutting different shape holes can improve 2nd harmonic, different shape has different testing result. Larger size, better improvement. 4. The 2nd harmonic is coupled into front end circuits through cavity resonating. The cavity resonating and coupling will be much clear after covering the shielding can.

- **问题分析**：1. Schematic上，对于B13，需要在PA后面增加一个LPF，以抑制B13的二次谐波，另外duplexer也要符合高通的推荐规格型号。确认在硬件上原理图和器件选型完全符合高通要求。2. layout上，PA、LPF、Duplexer和ASM在同一个屏蔽罩里，当去掉此屏蔽罩，B13的二次谐波可以改善13dB。3. 在屏蔽罩上开尺寸、形状不同的孔，改善的幅度不同，孔越大，改善越明显。4. PA 的二次谐波通过屏蔽罩的腔体谐振，耦合到前端电路。当屏蔽罩盖上，谐振就越强，耦合就越明显。

- **Solution:** 1. cutting a dedicated hole on PA shielding can, but must make sure there is no radiation emission for other bands. 2. split into two separated shielding can for PA and front end circuit, that can cut off cavity coupling, and improve 2nd harmonic of B13.
- **解决方案：** 1. 在屏蔽罩上开孔，但可能带来其他频段的辐射杂散的问题。 2. layout的时候建议 B13 PA和前端电路分成两个独立屏蔽罩，这样可以有效切断腔体耦合，改善B13的二次谐波。

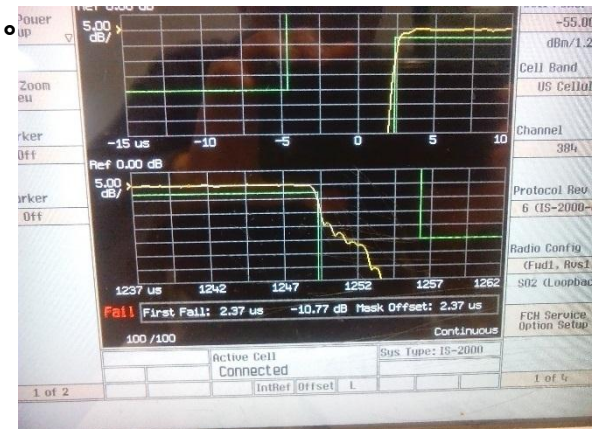
- **Platform:** MSM8916/39+WTR4905 (DPM 2.0), MSM8909 + WTR4905 (Jolokia 1.0)
- **适用平台：** MSM8916/39+WTR4905 (DPM 2.0), MSM8909 + WTR4905 (Jolokia 1.0)
- **Symptom:** CDMA 1x RC1 TX gating test fails due to mask is violated, **meanwhile**, tuning these timing macro definitions in `modem_proc\rftech_cdma\common\rf\inc\rf_cdma_constants.h` does NOT improve. Failure test screen shot on Agilent 8960 test box is shown as below.
- **问题描述：** CDMA 1x RC1门控发射测试因为测试到的功率曲线失败碰触了模板门限而失败。**并且**，调节`modem_proc\rftech_cdma\common\rf\inc\rf_cdma_constants.h`中以下几个CDMA时序参数宏定义的值，测试结果没有任何改善。失败现象如图。
 - RF_CDMA_TX_WARM_UP_US
 - RF_CDMA_PA_WARM_UP_US
 - RF_CDMA_TX_TURN_OFF_DELAY_US
 - RF_CDMA_PA_TURN_OFF_DELAY_US

- **Analysis:** This problem is due to the MIPI PA applied on CDMA bands' doesn't have an exclusive PA_ON register, but customer defines PA_ON register address in MIPI PA driver as 0x00, which is expected to be RFFE_INVALID_REG_ADDR. In this category of MIPI PA, generally PA_ON is a bit in PA_Range register, whose address is 0x00. Then while enabling TX, MIPI PA driver will write wrong value RF_REG_INVALID (0xff) to MIPI PA register 0x00.
- **问题分析：**这个问题是由于CDMA频段使用的MIPI PA没有单独的PA_ON寄存器，但却将PA驱动中的PA_ON寄存器地址设置成了0x00造成的（应该设置为RFFE_INVALID_REG_ADDR）。这类的MIPI PA，PA_ON往往是PA_Range寄存器中的一个位，而PA_Range寄存器的地址是0x00。打开TX时，如果PA_ON寄存器的地址也是0x00，那么会导致射频驱动往0x00对应的PA_RANGE寄存器里写入无效值RF_REG_INVALID（0xFF），导致测波形异常。

- **Solution:** replace PA_ON register address in MIPI PA driver from 0x00 to RFFE_INVALID_REG_ADDR if MIPI doesn't have exclusive PA_ON register.
- **解决方法：**如果MIPI PA没有单独的PA_ON寄存器，那么请在PA_ON寄存器的地址处使用RFFE_INVALID_REG_ADDR，而非0x00。

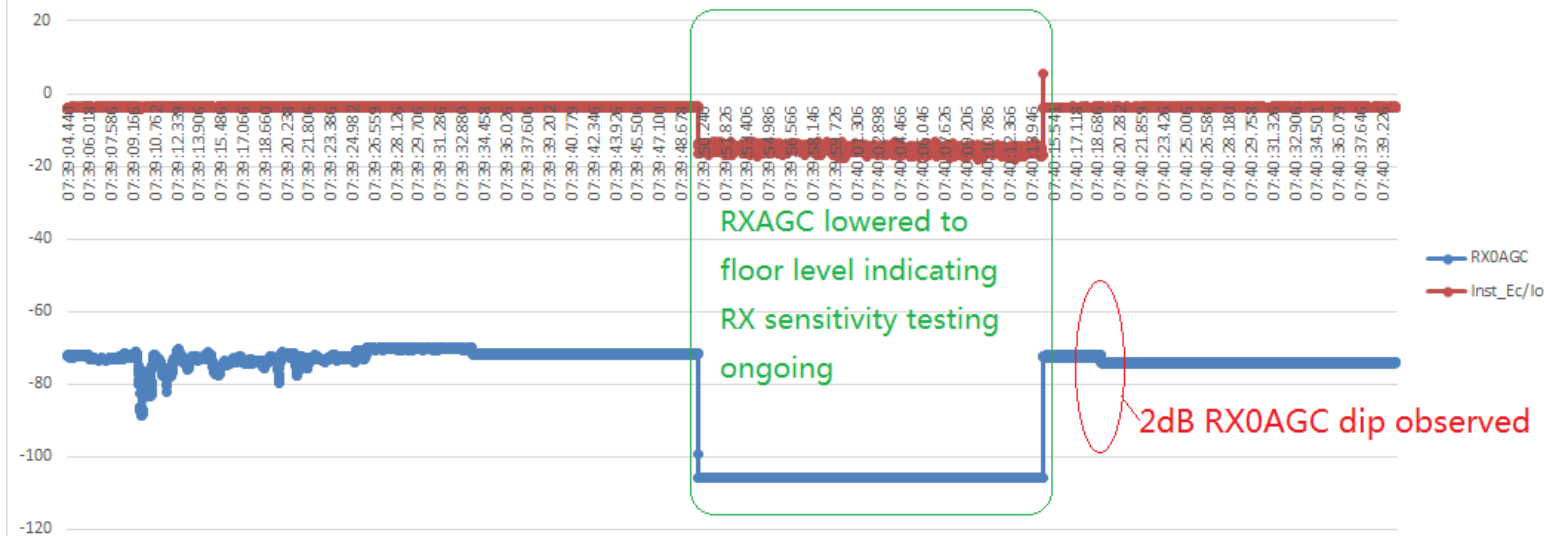
Figure 1 RX0AGC vs Inst_Ec/Io

1. To start analyzing RSCP variation issue, we need to find out if the variation comes out of Ec/Io or RXAGC or both. **Figure 1** is used to check where the variation coming out of.

- From the plotting, Ec/Io is maintained stable while there is 2dB dip in RX0AGC after RX sensitivity testing done which matches with the symptoms reported.

- The conclusion of Figure 1 is that the RSCP variation comes out of RXAGC while Ec/Io is ruled out.
2. To further narrow down RX0AGC dip, **Figure 2** WCDMA AGC plotting is generated which includes TXAGC, RX0AGC & RX1AGC(here RX0AGC represents Primary RXAGC, RX1AGC represents Diversity RXAGC).

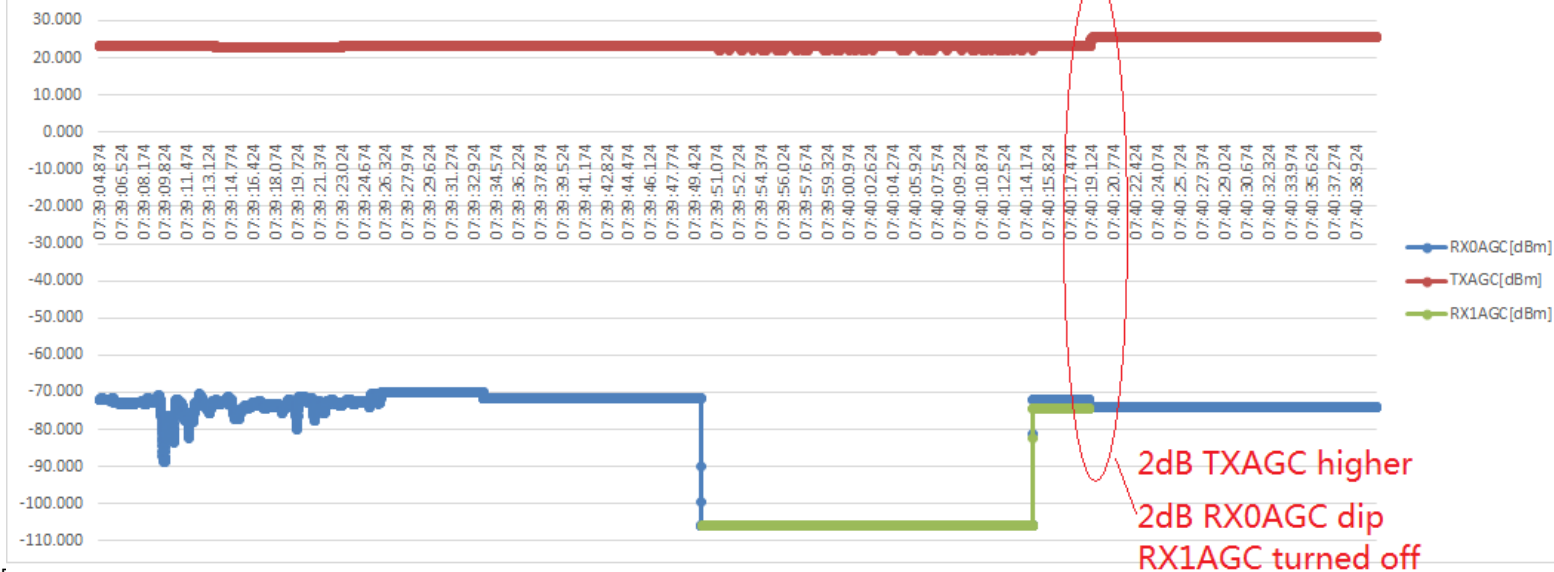
Figure 2 TXAGC vs RX0AGC

- Following the RX0AGC clue, it is found not only 2dB dip in RX0AGC but also 2dB higher in TXAGC at the same time.
 - While observing TXAGC & RX0AGC variation RX1AGC is turned off which is a very important clue.

- To summarize Figure 2, 2dB higher in TXAGC and 2dB dip in RX0AGC are both observed which looks to be additionally 2dB “insertion loss” suddenly added into the RTX chain, diversity chain is turned off right at the point which implies Div chain off might impact the primary RTX chain.

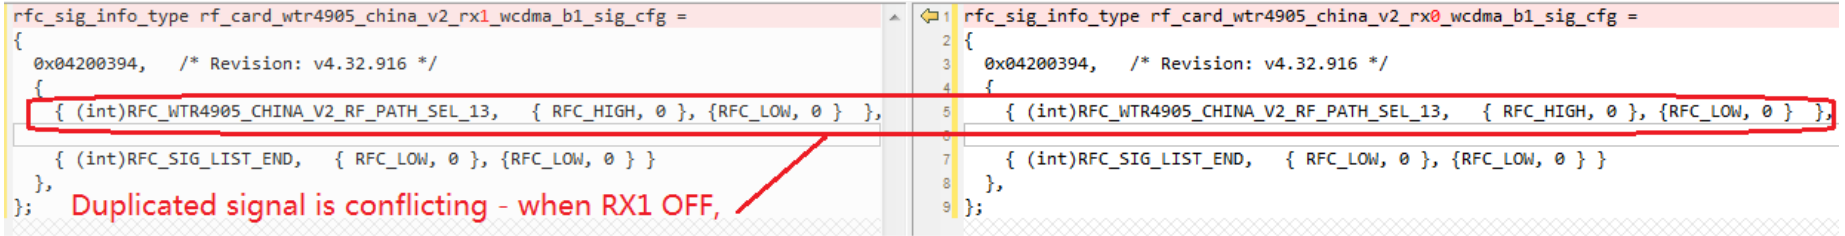
Figure 3

4. The left is to review the DRx chain configurations in which band the testing is ongoing.
 - It is not surprised to find that in RX1 sig_cfg there is a duplicated GRFC sig as in RX0 sig_cfg which is significant conflict because whatever it controls, it brings the signal into the unexpected state (pulled low in this case) for RX0_ON when RX1 turned off. See **Figure 3**.
 - In this case, the wrong signal state lead 2dB dip in RX0AGC and 2dB higher in TXAGC.

Duplicated signal is conflicting - when RX1 OFF, the signal is in the wrong state for RX0 ON

- In the solution section, let us summarize one thumb of rule on the rfc sig cfg for WCDMA(FDD) system: once you see the duplicated sig configuration across RX0 & RX1 & TX in the same band, you must be very careful and considering if it is the right signal configuration as expected.
- As seen in the analysis above, the wrong duplicated sig configuration in RX1 would impact WCDMA RX0 & TX AGC and further the other measurements like RSCP etc. the fix is removing the signal configuration in RX1, and leave it only in RX0 which would align with WCDMA RX0 & RX1 & TX AGC behavior in signaling mode.

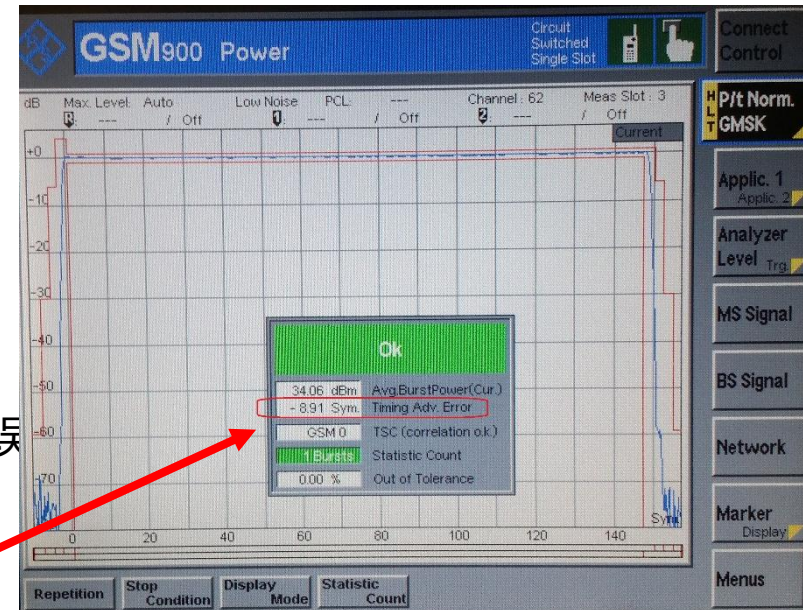
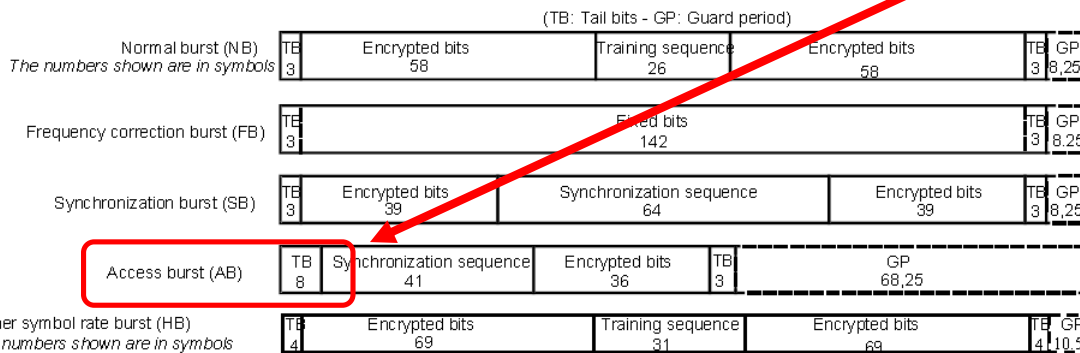
- **Symptom:** (AB)burst timing error is too large and failed to camp to callbox/NW
- **问题描述：** (AB)突发序列时序误差太大导致手机无法注册上仪器或实网
- **Analysis:** Check burst error of AB(Access Burst, RACH) or NB(Normal Burst) using callbox
 - Check burst error of AB using CMU200
 - There is 8 tail bits for AB, so if its burst error is larger than 8 symbol, decoding error of AB may happen to BTS side and failed to set up call per no IA from network
- **问题分析：** 用综测仪检查AB突发和正常突发的时序误差
 - 使用CMU200可以方便的观察AB突出的时序误差
 - AB突发有8字节的保护位，如果突发误差大于

- 8字节，有可能造成BTS测无法正确
- 解码RACH信道，而导致网络没有
 - 立即分配回应给申请接入的手机
