Remediation Guideline
Defect ID: ST4-473

Asset: 716 Rejects Bin
Location: West side compression beam

Purpose: This document outlines the governance framework, procedures, and compliance requirements for the Replace of the Steel Beam (Defect ID: ST4-473) on 716 Rejects Bin located at West side compression beam. The repair process addresses structural damage caused by continuous mining operations and degradation over time, ensuring compliance with Australian Standards.

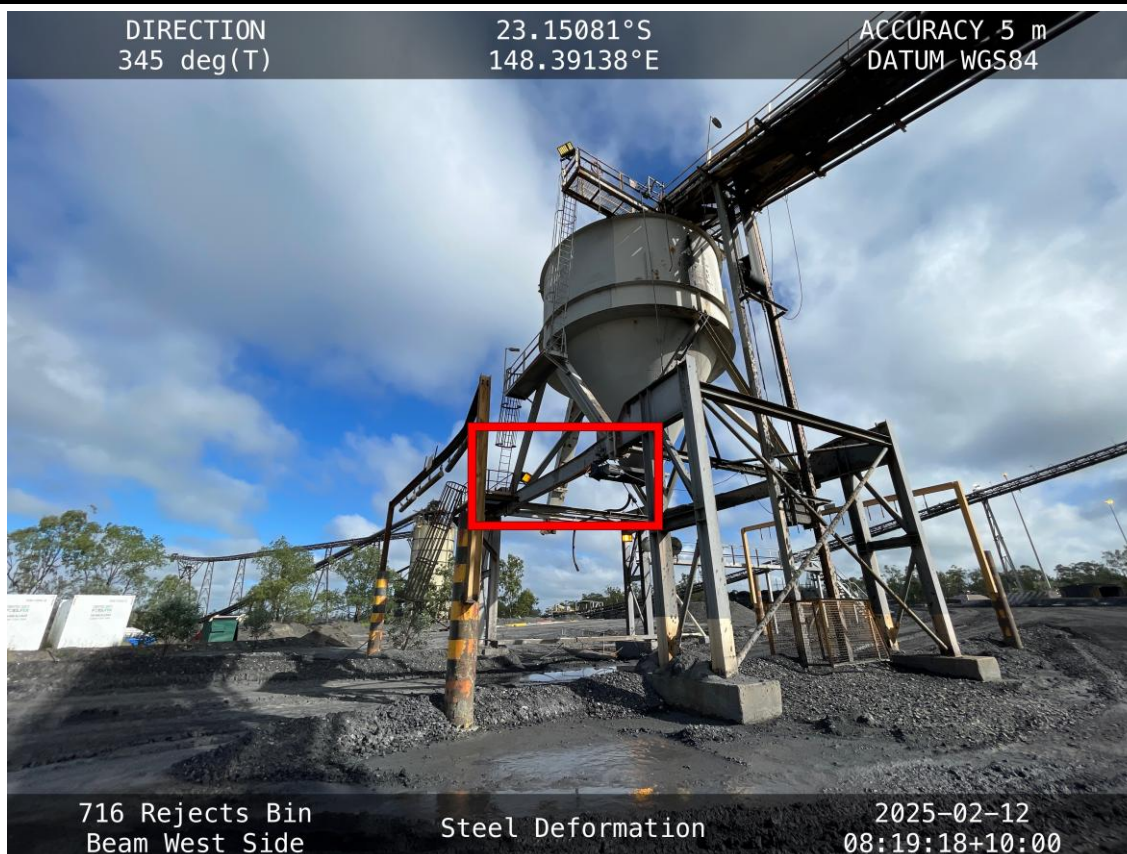
Permanent deformation was identified, likely caused by a mechanical impact or an excessive load. This deformation significantly reduces the structural element's stability, increasing its susceptibility to buckling.

Major [14]

Mark and cut the beam 1 m from each end connection, then lower the removed section safely

Position and align the new section between existing stubs.

Secure the beam temporarily with appropriate clamps and verify alignment using precision levels and laser measuring tools. Fit over-plates to flanges and webs at both ends.

Weld over-plates in accordance with AS/NZS 1554.1, following the approved welding sequence.
