DEFECT NUMBER		OC37.01		EQUIPMENT		KPBN01 - MP Reject Bin		FACILITY		Oak Creek Open Cut			
DEFECT CATEGORY		Structural		COMPONENT		Steel Plate		INSPECTED BY		Eduard Hernandez			
DEFECT TYPE		Steel Corrosion		LOCATION		Top ring northeast wall of the MP Reject Bin		DATE		08-11-2025			
Description of Structural Integrity Issue		Advanced corrosion with rupture was identified along the top ring of the northeast wall of the MP Reject Bin. The defect presents as through-thickness perforations concentrated at the joint between the wall and the upper ring, with surrounding surface delamination and coating failure. The ruptures compromise structural continuity of the bin wall.											
Structural Risk Assessment:		Potential Incident:		Structural Failure Mechanism:			Consequence:		Likelihood		Risk Rating		
		If not fixed, the MP Reject Bin could fail, leading to a loss of containment and potential hazards for personnel nearby. This failure may also disrupt operations and result in significant financial losses.		The corrosion causes through-thickness perforations that compromise the bin wall's structural integrity, leading to potential buckling and loss of load-bearing capacity.		Risk Assess

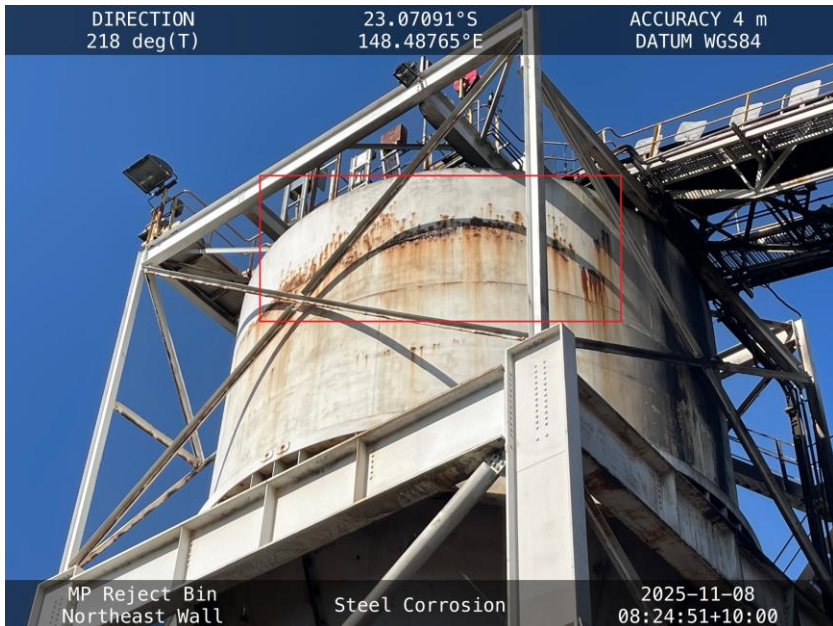
<div>MP Reject Bin Northeast WallSteel Corrosion2025-11-08 08:24:51+10:00</div></div></div></div>				<div><div><div><div>DIRECTION115 deg(T)23.07105°S148.48751°EACCURACY 12 mDATUM WGS84</div>

Required Action:							
Previous Audit Result for Defect:		No previous report available.								Severity Level:		Abnormal	
Corrective Action:		1. Remove all debris and built-up fines from the affected area. 2. Sandblast the corroded steel to remove rust and old coatings. 3. Weld a reinforcement plate over the perforated areas to restore structural integrity. 4. Apply a corrosion-resistant coating to protect the repair and surrounding steel. 5. Clean the area again to ensure no contaminants remain.								Estimated Corrective Action Cost:		30,000 - 50,000 AUD	
Photos:		<div><div><div><div>DIRECTION218 deg(T)23.07091°S148.48765°EACCURACY 4 mDATUM WGS84</div>
