| DEFECT NUMBER | OC47.15 | EQUIPMENT | KPCV10 - MP Reject Conveyor 10M | FACILITY | Oaky Creek Open Cut |
| DEFECT CATEGORY | Structural | COMPONENT | Steel Plate | INSPECTED BY | Eduard Hernandez |
| DEFECT TYPE | Steel Corrosion | LOCATION | Discharge from Reject Screen No.4 | DATE | 08-11-2025 |

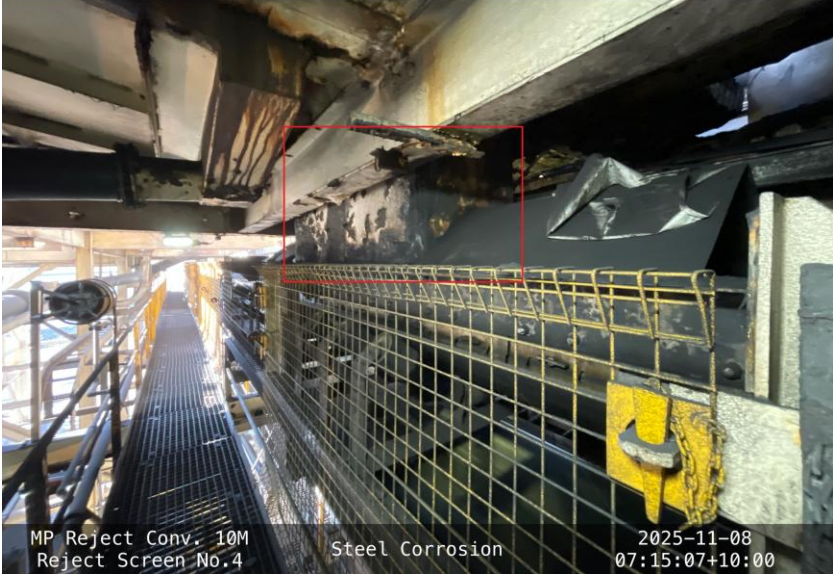
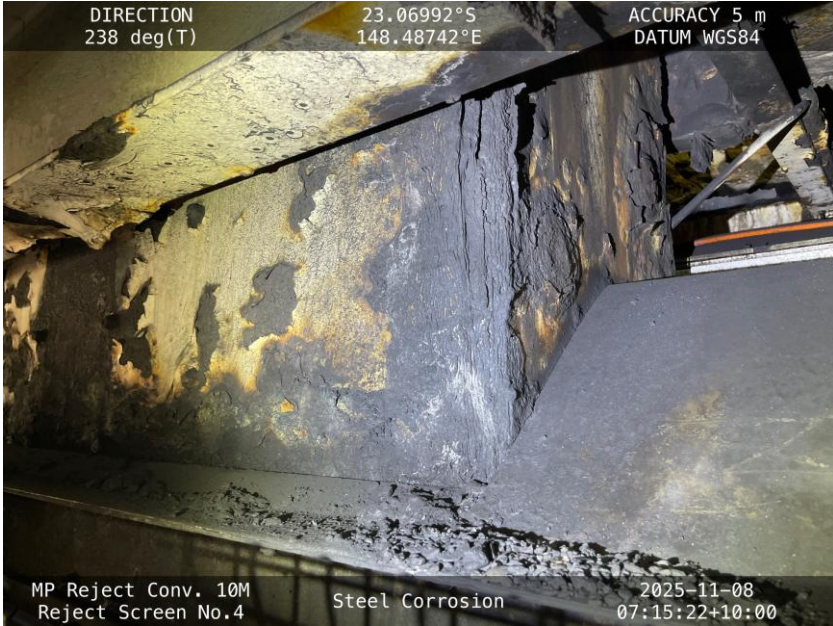
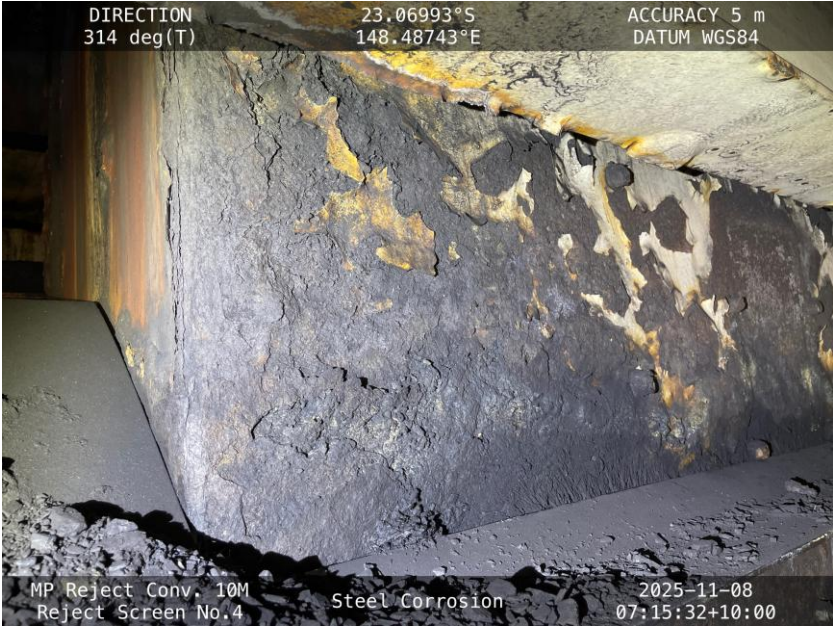
| Description of Structural Integrity Issue | Advanced corrosion is present on the surfaces of the discharge chute from Reject Screen No.4. The degradation is widespread, with material loss evident along the chute walls and at key structural transition points. | | | | |
| | If not fixed, the chute may failure, causing material spillage and operational downtime. This could also lead to injuries to personnel working nearby. | The chute is at risk of buckling and shear failure due to advanced corrosion weakening its structural integrity. | Risk Assessment: | 2-Minor. This rating is based on Financial impact: \$1M to \$5M operating profit \$300k to \$1M property damage \$1M to \$5M asset devaluation | C - Possible - Could occur more than once during a lifetime or life of plant. |
| Photos: | <div><div><div>DIRECTION 190 deg(T)</div><div>23.06993°S 148.48742°E</div><div>ACCURACY 7 m DATUM WGS84</div><div>MP Reject Conv. 10M Reject Screen No.4</div><div>Steel Corrosion</div><div>2025-11-08 07:15:07+10:00</div></div><div><div>DIRECTION 238 deg(T)</div><div>23.06992°S 148.48742°E</div><div>ACCURACY 5 m DATUM WGS84</div><div>MP Reject Conv. 10M Reject Screen No.4</div><div>Steel Corrosion</div><div>2025-11-08 07:15:22+10:00</div></div><div><div>DIRECTION 314 deg(T)</div><div>23.06993°S 148.48743°E</div><div>ACCURACY 5 m DATUM WGS84</div><div>MP Reject Conv. 10M Reject Screen No.4</div><div>Steel Corrosion</div><div>2025-11-08 07:15:32+10:00</div></div></div> | | | | |

| Corrective Action: | 1. Remove all debris and loose material from the chute. 2. Sandblast all corroded areas to bare metal. 3. Weld reinforcement plates to areas of significant corrosion. 4. Replace any severely damaged sections of the chute. 5. Apply a protective coating to all repaired surfaces. | | | | Estimated Corrective Action Cost: |
