DEFECT NUMBER		OC37.07		EQUIPMENT		KPBN01 - MP Reject Bin		FACILITY		Oak Creek Open Cut	
DEFECT CATEGORY		Structural		COMPONENT		Steel Beam		INSPECTED BY		Eduard Hernandez	
DEFECT TYPE		Steel Damage		LOCATION		Beam South Side Structure Bin		DATE		08-11-2025	
Description of Structural Integrity Issue		Permanent deformation was observed in the south beam of the MP Reject Bin structure, with the affected member displaying a noticeable lateral bend without signs of impact or collision. There is no visible tearing or section loss; however, the deflection may affect the structural alignment and induce secondary stresses in adjacent connections or support frames.									
Structural Risk Assessment:	Potential Incident:		Structural Failure Mechanism:			Consequence:		Likelihood		Risk Rating	
	If not fixed, the bent beam may lead to structural misalignment, risking failure of the bin. This could cause operational downtime and potential injuries to workers.		The beam is experiencing bending due to excessive load or residual stress, which may lead to buckling if not addressed.		Risk Assessment:	3-Moderate. This rating is based on Financial impact: \$5M to \$50M operating profit \$1M to \$5M pr

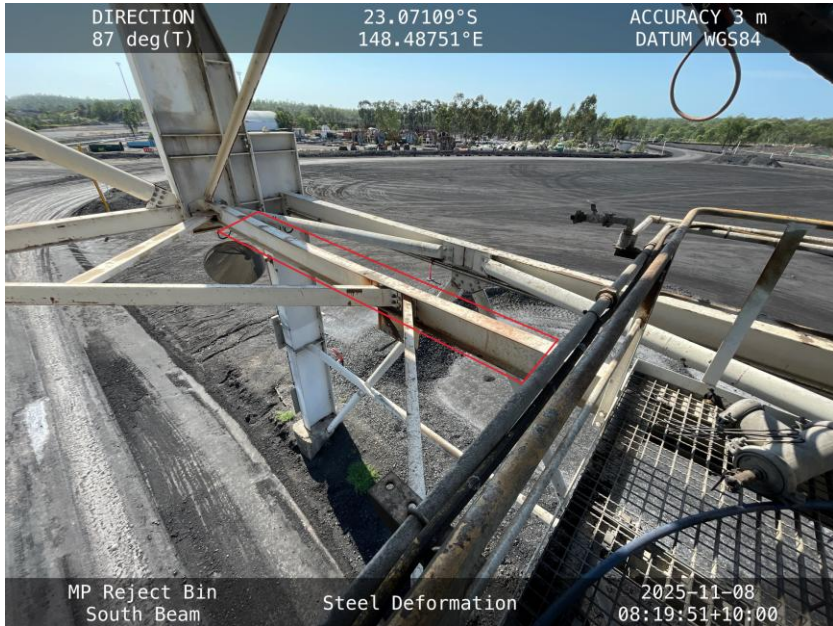
<div>MP Reject Bin South BeamSteel Deformation2025-11-08 08:19:51+10:00</div></div><div><div><div>DIRECTION 39 deg(T)</div><div>23.07110°S 148.48753°E</div><div>ACCURACY 5 m DATUM WGS84</div></div>

Required Action:					
Previous Audit Result for Defect:		No previous report available.							Severity Level:		Moderate
Corrective Action:		1. Install temporary supports for the affected beam and any connected elements. 2. Remove the deformed beam and replace it in accordance with the design characteristics. 3. Re-install all previously connected elements.							Estimated Corrective Action Cost:		10,000 - 20,000 AUD
Photos:		<div><div><div><div>DIRECTION 87 deg(T)</div><div>23.07109°S 148.48751°E</div><div>ACCURACY 3 m DATUM WGS84</div></div>

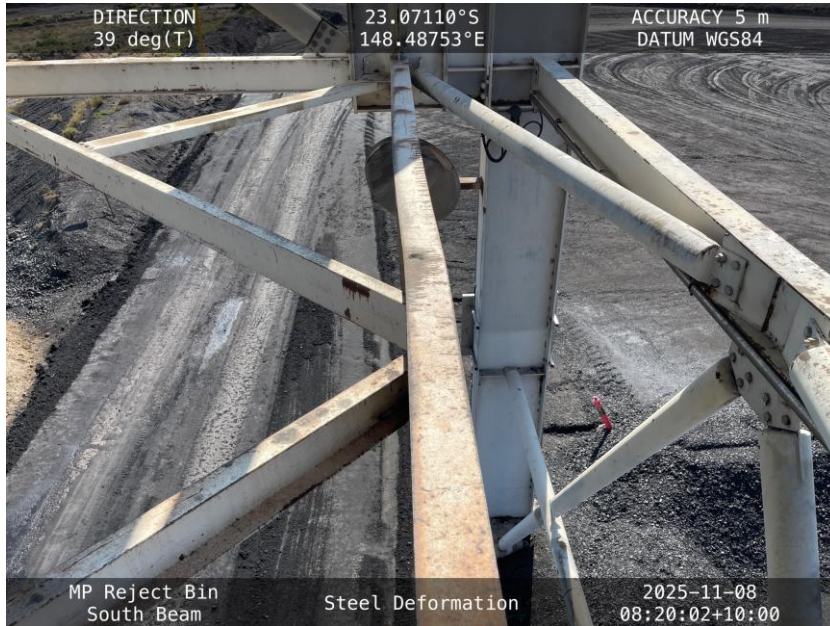
<div>MP Reject Bin South BeamSteel Deformation2025-11-08 08:20:02+10:00</div></div><div><div><div>DIRECTION 39 deg(T)</div><div>23.07110°S 148.48753°E</div><div>ACCURACY 5 m DATUM WGS84</div></div>

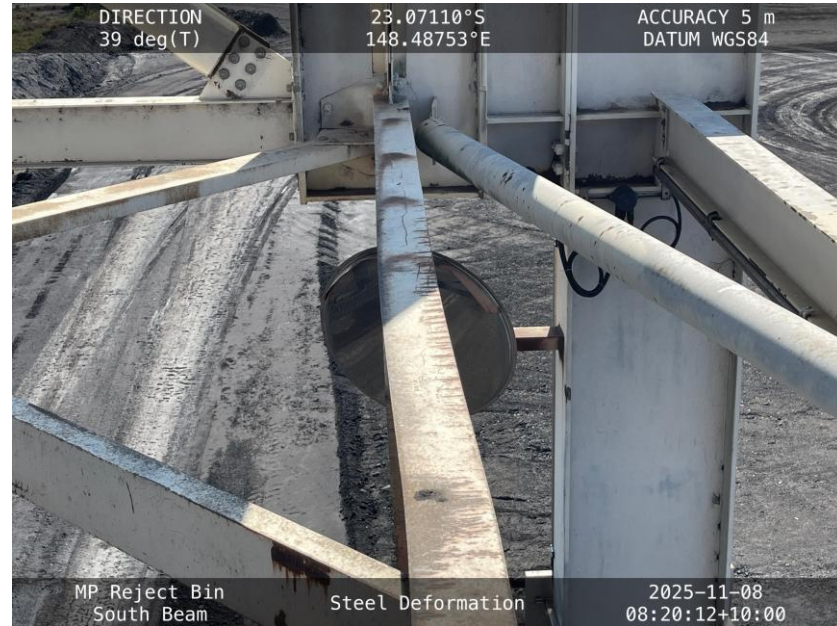
<div>MP Reject Bin South BeamSteel Deformation2025-11-08 08:20:12+10:00</div></div></div>
