DEFECT NUMBER	OC47.06 (Prev. 89)	EQUIPMENT	KPCV10 - MP Reject Conveyor 10M	FACILITY	Oaky Creek Open Cut
DEFECT CATEGORY	Structural	COMPONENT	Steel Beam	INSPECTED BY	Eduard Hernandez
DEFECT TYPE	Steel Corrosion	LOCATION	Crossbeam near Idler 161	DATE	08-11-2025
Description of Structural Integrity Issue	Severe through-section corrosion has occurred on the crossbeam near Idler 161 on MP Reject Conveyor 10M. The defect presents as advanced material loss with multiple perforations, compromising both the web and flange of the structural member.				
Structural Risk Assessment:	Potential Incident:	Structural Failure Mechanism:		Consequence:	Likelihood
	If not fixed, the crossbeam may fail, leading to a failure of the conveyor system. This could cause injuries to workers and disrupt operations significantly.	The corrosion weakens the beam, increasing the risk of bending and shear failure under load.	Risk Assessment:	3-Moderate. This rating is based on Financial impact: \$5M to \$50M operating profit \$1M to \$5M property damage \$5M to \$25M asset devaluation	B - Likely - May occur about once per year.

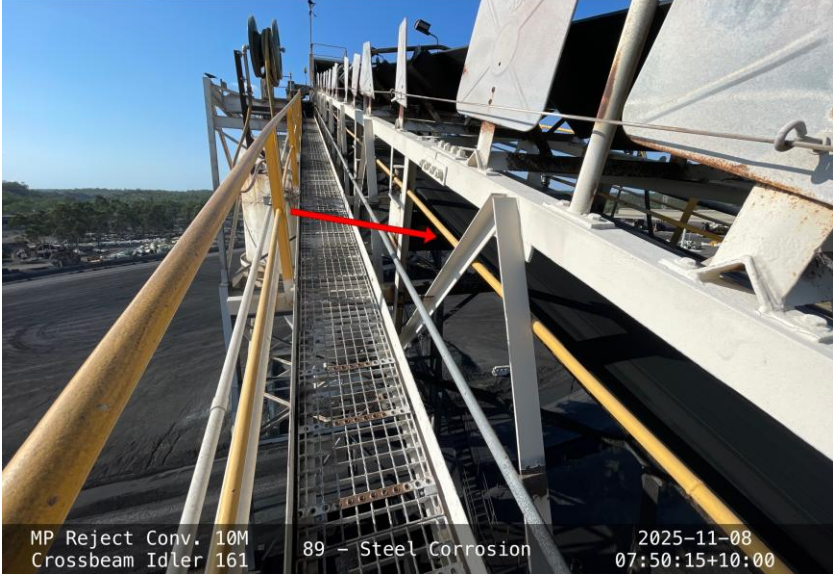
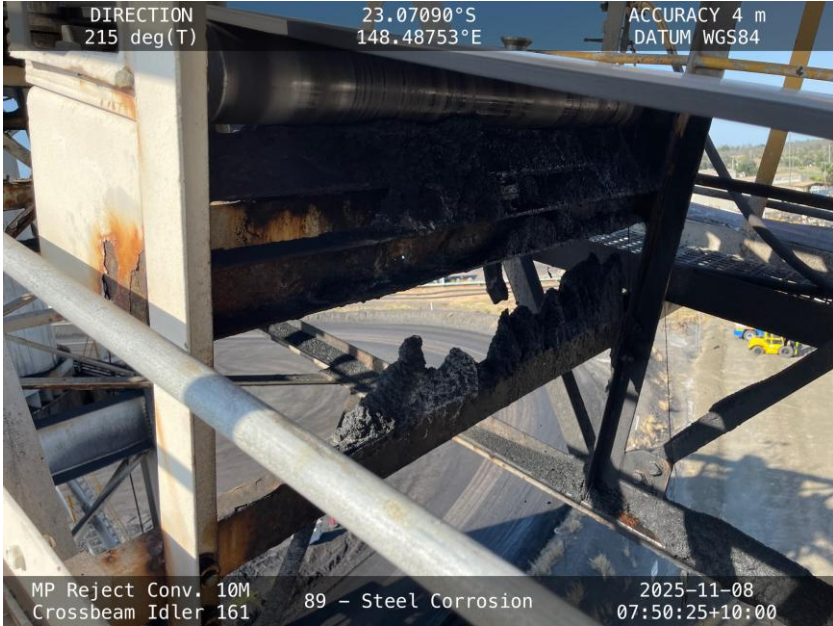
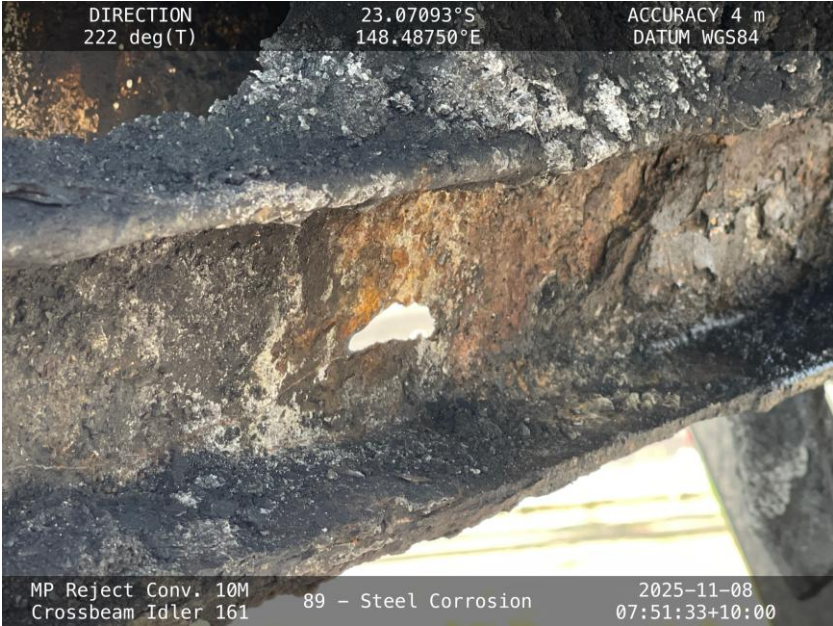
<div>MP Reject Conv. 10M Crossbeam Idler 161</div><div>89 - Steel Corrosion</div><div>2025-11-08 07:50:15+10:00</div></div><div><div><div>DIRECTION 215 deg(T)</div><div>23.07090°S 148.48753°E</div><div>ACCURACY 4 m DATUM WGS84</div></div>

<div>MP Reject Conv. 10M Crossbeam Idler 161</div><div>89 - Steel Corrosion</div><div>2025-11-08 07:50:25+10:00</div></div><div><div><div>DIRECTION 222 deg(T)</div><div>23.07093°S 148.48750°E</div><div>ACCURACY 4 m DATUM WGS84</div></div>

<div>MP Reject Conv. 10M Crossbeam Idler 161</div><div>89 - Steel Corrosion</div><div>2025-11-08 07:51:33+10:00</div></div></div>

Required Action:	Planned Corrective Action	
Previous Audit Result for Defect:	Significant material build up on beams and contacting return idler which may present a fire hazard. Minor corrosion on cross beam.				Severity Level:
Corrective Action:	1. Remove all debris and coal buildup from the crossbeam. 2. Sandblast the affected area to remove corrosion. 3. Weld a reinforcement plate over the damaged section. 4. Replace any severely damaged sections of the beam if necessary. 5. Apply a protective coating to the repaired area to prevent future corrosion.				Estimated Corrective Action Cost:
Photos:	<div><div><div><div>DIRECTION 182 deg(T)</div><div>23.07094°S 148.48753°E</div><div>ACCURACY 6 m DATUM WGS84</div></div>
