### STM32F072x8/xB device errata

This document applies to the part numbers of STM32F072x8/xB devices and the device variants as stated in this page.

It gives a summary and a description of the device errata, with respect to the device datasheet and reference manual RM0091.

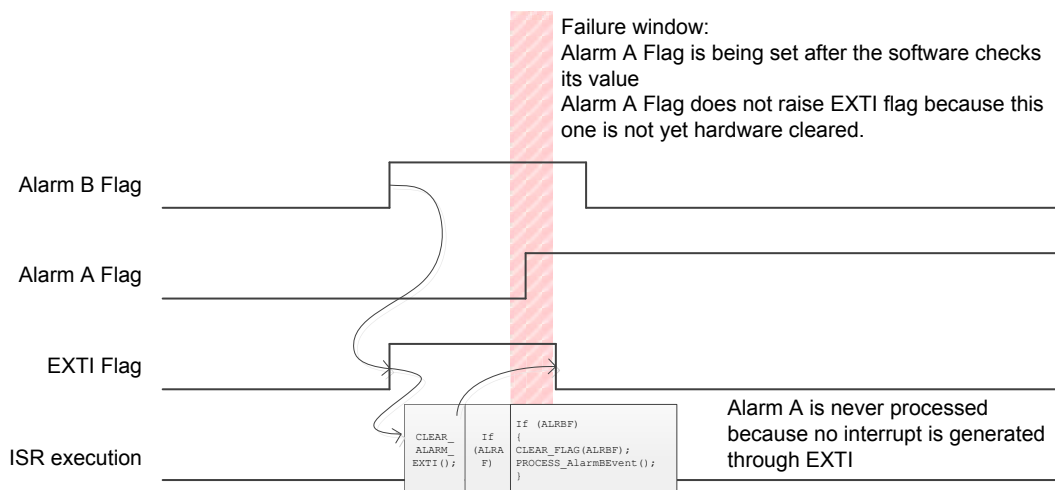
**Figure 1. Masked RTC interrupt**

The following code example and figure illustrate the failure mechanism: The Alarm A event is lost (fails to generate interrupt) as it occurs in the failure window, that is, after checking the Alarm A event flag but before the effective clear of the EXTI interrupt flag by hardware. The effective clear of the EXTI interrupt flag is delayed with respect to the software instruction to clear it.

In the interrupt service routine, apply three consecutive event flag checks - source one, source two, and source one again, as in the following code example:

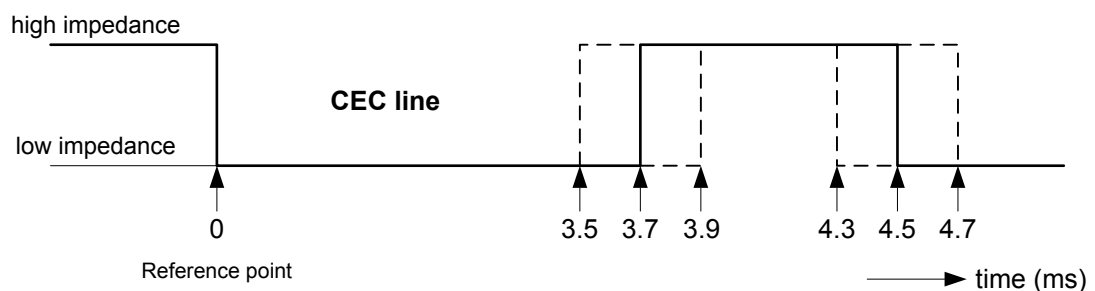
**Figure 2. HDMI-CEC start bit format with tolerances**

The start bit timing standard tolerances are shown in the following figure. The start bit is initiated by the device by driving the CEC line low (reference point). After 3.7 ms, the device releases the CEC line and starts checking its level. The following conditions must be met for the start bit to be valid:

If one of these conditions is not met, the transmission is aborted and never automatically retried. No error flag is set and the TXSOM (Tx start of message) bit is not cleared.

The only way to detect this error is for the application software to start a timeout when setting the TXSOM bit, restart it upon ARBLST or any RX event (as the transmission can be delayed by interleaved reception), and stop it upon TXBR (proof that the start bit was transmitted successfully) or TXEND event, or upon any TX error (which clears TXSOM). If the timeout expires (because none of those events occurred), the application software must restart the HDMI-CEC peripheral and retransmit the message.
