### STM32L451xx device errata

It gives a summary and a description of the device errata, with respect to the device datasheet and reference manual RM0394.

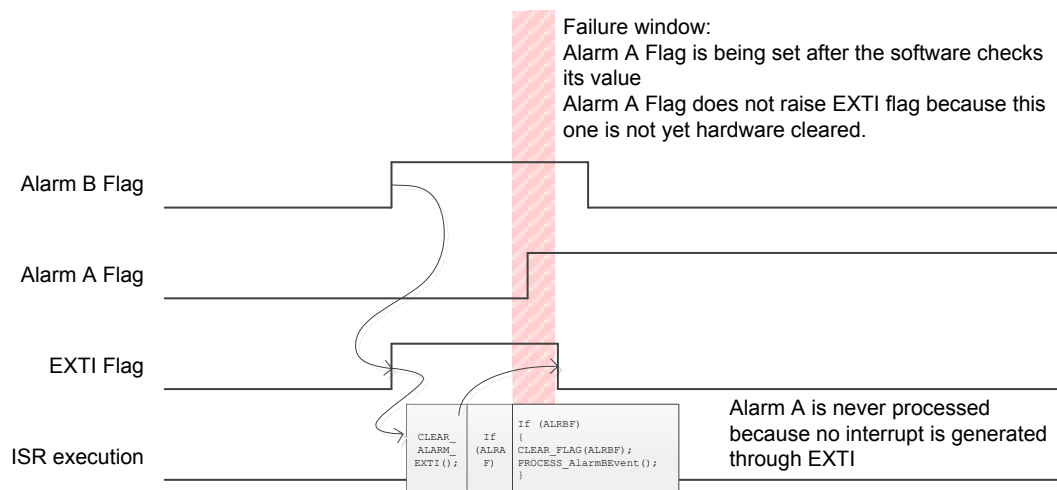
Figure 1. Masked RTC interrupt

The following code example and figure illustrate the failure mechanism: The Alarm A event is lost (fails to generate interrupt) as it occurs in the failure window, that is, after checking the Alarm A event flag but before the effective clear of the EXTI interrupt flag by hardware. The effective clear of the EXTI interrupt flag is delayed with respect to the software instruction to clear it.

In the interrupt service routine, apply three consecutive event flag checks - source one, source two, and source one again, as in the following code example:
