STM32L433xx/443xx device errata

Applicability

This document applies to the part numbers of STM32L433xx/443xx devices and the device variants as stated in this page.

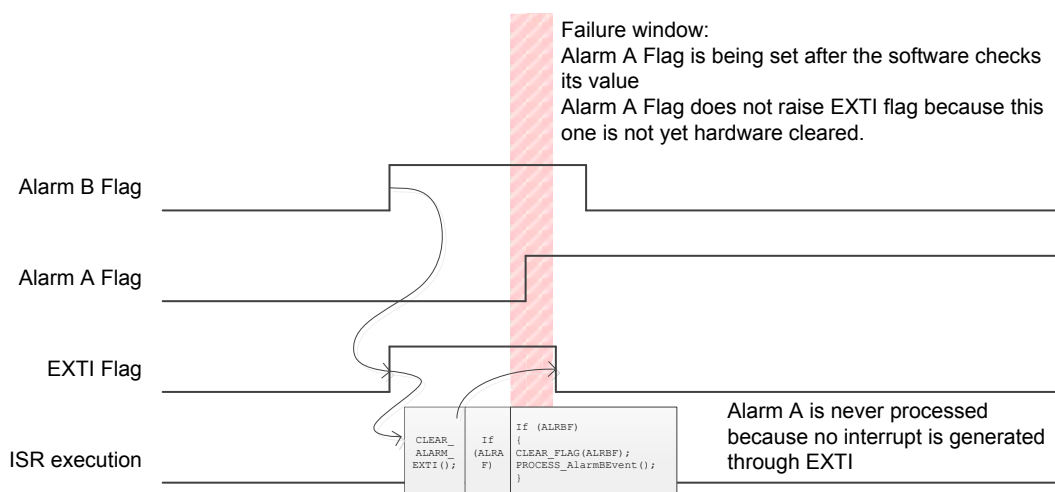
Figure 1. Masked RTC interrupt

The following code example and figure illustrate the failure mechanism: The Alarm A event is lost (fails to generate interrupt) as it occurs in the failure window, that is, after checking the Alarm A event flag but before the effective clear of the EXTI interrupt flag by hardware. The effective clear of the EXTI interrupt flag is delayed with respect to the software instruction to clear it.

```
void RTC_Alarm_IRQHandler(void)
{
    CLEAR_ALARM_EXTI(); /* Clear the EXTI line flag for RTC alarms*/
    If(ALRAF) /* Check if Alarm A triggered ISR */
    {
        CLEAR_FLAG(ALRAF); /* Clear the Alarm A interrupt pending bit */
        PROCESS_AlarmAEvent(); /* Process Alarm A event */
    }
    If(ALRBF) /* Check if Alarm B triggered ISR */
    {
        CLEAR_FLAG(ALRBF); /* Clear the Alarm B interrupt pending bit */
        PROCESS_AlarmBEvent(); /* Process Alarm B event */
    }
}
```

Workaround

In the interrupt service routine, apply three consecutive event flag checks - source one, source two, and source one again, as in the following code example:
