STM32L496xx/4A6xx device errata

Applicability

This document applies to the part numbers of STM32L496xx/4A6xx devices and the device variants as stated in this page.

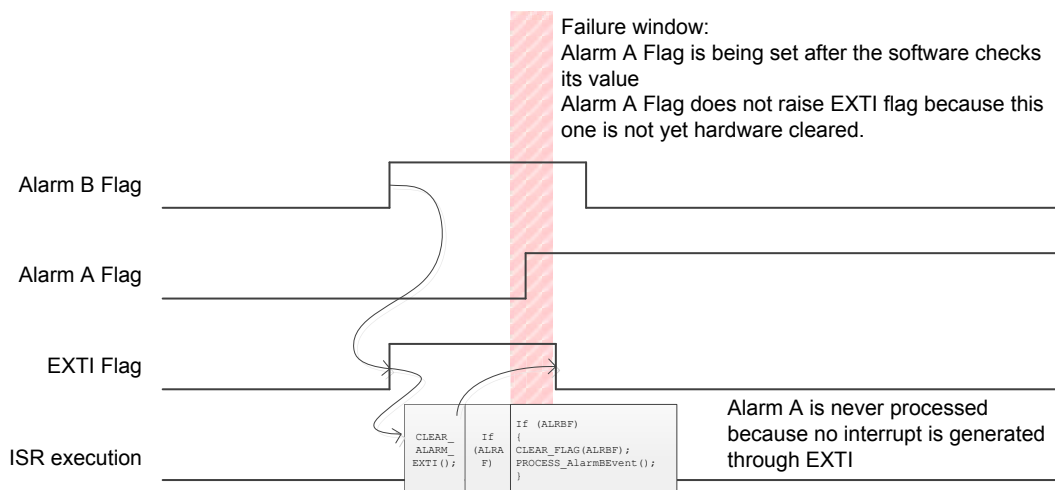
Figure 1. Masked RTC interrupt

The following code example and figure illustrate the failure mechanism: The Alarm A event is lost (fails to generate interrupt) as it occurs in the failure window, that is, after checking the Alarm A event flag but before the effective clear of the EXTI interrupt flag by hardware. The effective clear of the EXTI interrupt flag is delayed with respect to the software instruction to clear it.

Workaround

In the interrupt service routine, apply three consecutive event flag checks - source one, source two, and source one again, as in the following code example:
