Silicon identification

This errata sheet applies to the revision A of the STMicroelectronics low-density STM32F101xx access line, STM32F102xx USB access line and STM32F103xx performance line products. These families feature an Arm® 32-bit Cortex®-M3 core, for which an errata notice is also available (see [Section 1](#) for details).

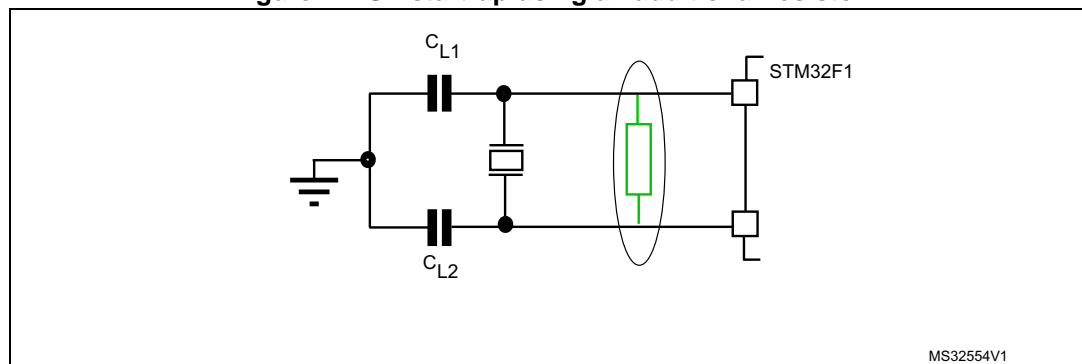
Figure 1. LSE start-up using an additional resistor

The LSE (Low Speed External) oscillator system has been designed to minimize the overall power consumption of the STM32F1 microcontroller. It is extremely important to take specific care in the design of the PCB to ensure this low power oscillator starts in harsh conditions. In some PCB designs without coating, an induced low leakage may prevent the LSE to start-up, regardless of the 32.768 KHz crystal used. This phenomenon is amplified in humid environments that create frost on the OSC32_IN/OSC32_OUT tracks. This unwanted behavior may happen only at the first back-up domain power-on of the device.

It is recommended to mount an additional parallel feedback resistor (from 16 MΩ to 22 MΩ) on board to help the oscillation start-up in all cases (see [Figure 1](#)). For more details on compatible crystals and hardware techniques on PCB, refer to AN2867 “Oscillator design guide for STM8AF/AL/S, STM32 MCUs and MPUs” available on www.st.com.
