Silicon identification

This errata sheet applies to the revision A or 1 of the STMicroelectronics STM32F101xF/G access line and STM32F103xF/G performance line XL-density products. These families feature an Arm® 32-bit Cortex®-M3 core, for which an errata notice is also available (see [Section 1](#) for details).

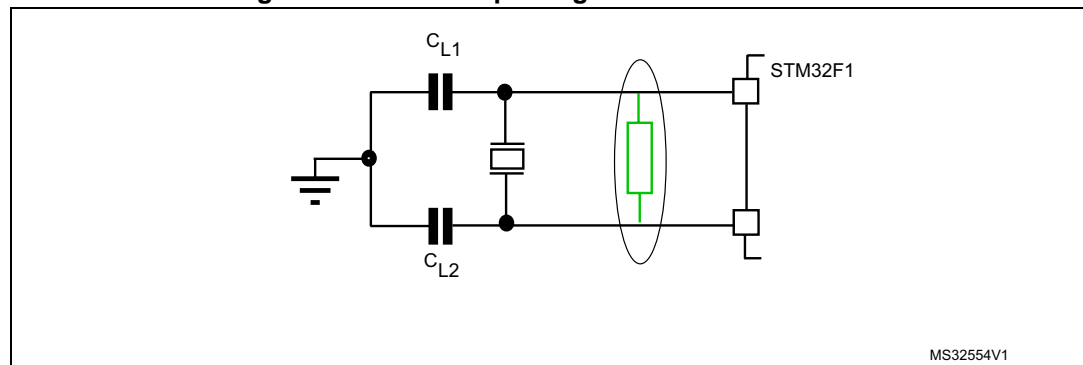
Figure 1. LSE start-up using an additional resistor

The LSE (Low Speed External) oscillator system has been designed to minimize the overall power consumption of the STM32F1 microcontroller. It is extremely important to take specific care in the design of the PCB to ensure this low power oscillator starts in harsh conditions. In some PCB designs without coating, an induced low leakage may prevent the LSE to start-up, regardless of the 32.768 KHz crystal used. This phenomenon is amplified in humid environments that create frost on the OSC32_IN/OSC32_OUT tracks. This unwanted behavior may happen only at the first back-up domain power-on of the device.

It is recommended to mount an additional parallel feedback resistor (from 16 M Ω to 22 M Ω) on board to help the oscillation start-up in all cases (see [Figure 1](#)). For more details on compatible crystals and hardware techniques on PCB, refer to AN2867 "Oscillator design guide for STM8AF/AL/S, STM32 MCUs and MPUs" available on www.st.com.
