STM32F101x8/B, STM32F102x8/B and STM32F103x8/B medium-density device limitations

Silicon identification

This errata sheet applies to the revisions B, Z, Y, 1, 2, 3 and X of the STMicroelectronics medium-density STM32F101xx access line and STM32F103xx performance line products, and to revision Y, 1, 2 and X of the STM32F102xx USB access line devices. These families feature an Arm® 32-bit Cortex®-M3 core, for which an errata notice is also available (see [Section 1](#) for details).

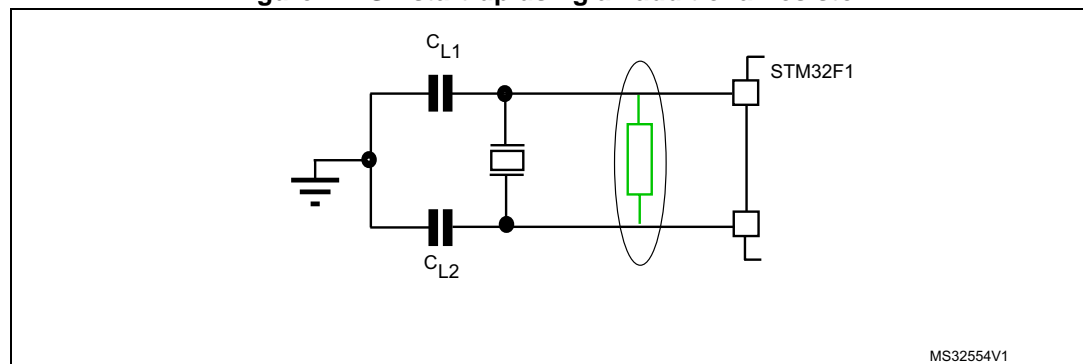
Figure 1. LSE start-up using an additional resistor

The LSE (Low Speed External) oscillator system has been designed to minimize the overall power consumption of the STM32F1 microcontroller. It is extremely important to take specific care in the design of the PCB to ensure this low power oscillator starts in harsh conditions. In some PCB designs without coating, an induced low leakage may prevent the LSE to start-up, regardless of the 32.768 KHz crystal used. This phenomenon is amplified in humid environments that create frost on the OSC32_IN/OSC32_OUT tracks. This unwanted behavior may happen only at the first back-up domain power-on of the device.

It is recommended to mount an additional parallel feedback resistor (from 16 M Ω to 22 M Ω) on board to help the oscillation start-up in all cases (see [Figure 1](#)). For more details on compatible crystals and hardware techniques on PCB, refer to AN2867 application note.
