STM32L422xB device errata

This document applies to the part numbers of STM32L422xB devices and the device variants as stated in this page.

It gives a summary and a description of the device errata, with respect to the device datasheet and reference manual RM394.

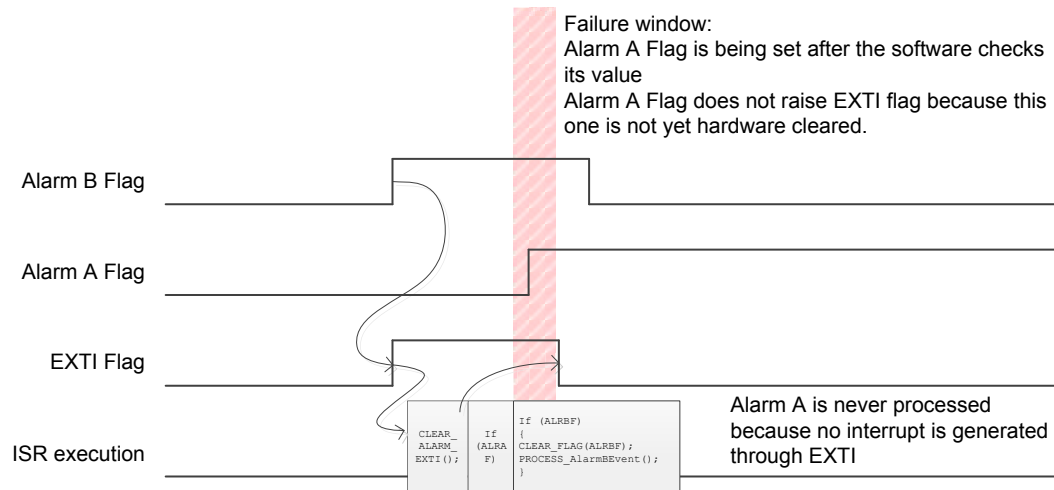
Figure 1. Masked RTC interrupt

The following code example and figure illustrate the failure mechanism: The Alarm A event is lost (fails to generate interrupt) as it occurs in the failure window, that is, after checking the Alarm A event flag but before the effective clear of the EXTI interrupt flag by hardware. The effective clear of the EXTI interrupt flag is delayed with respect to the software instruction to clear it.

In the interrupt service routine, apply three consecutive event flag checks - source one, source two, and source one again, as in the following code example:
