### STM32L452xx device errata

This document applies to the part numbers of STM32L452xx devices and the device variants as stated in this page.

It gives a summary and a description of the device errata, with respect to the device datasheet and reference manual RM0394.

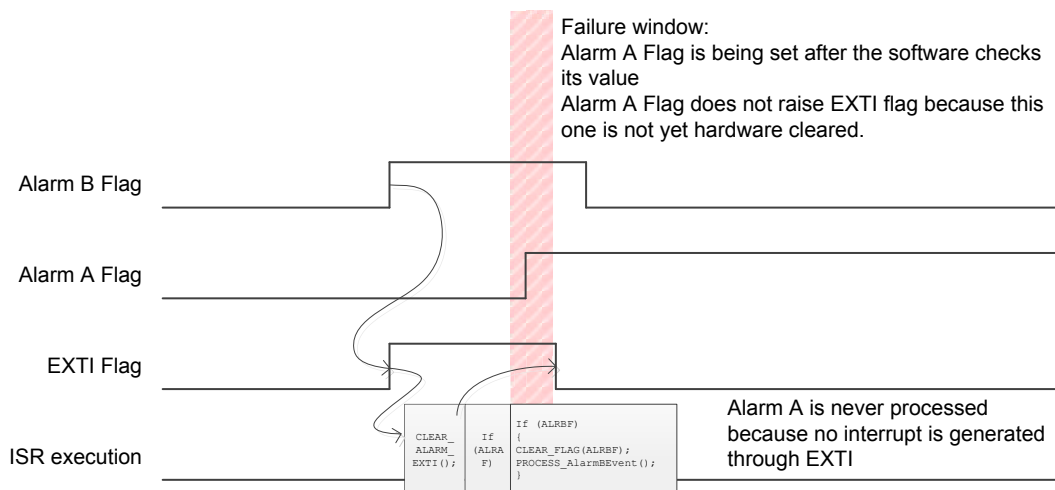
Figure 1. Masked RTC interrupt

The following code example and figure illustrate the failure mechanism: The Alarm A event is lost (fails to generate interrupt) as it occurs in the failure window, that is, after checking the Alarm A event flag but before the effective clear of the EXTI interrupt flag by hardware. The effective clear of the EXTI interrupt flag is delayed with respect to the software instruction to clear it.

In the interrupt service routine, apply three consecutive event flag checks - source one, source two, and source one again, as in the following code example:
