Applicability

This document applies to the part numbers of STM32F091xB/xC devices listed in [Table 1](#) and their variants shown in [Table 2](#).

[Section 1](#) gives a summary and [Section 2](#) a description of device limitations and documentation errata, with respect to the device datasheet and reference manual RM0091.

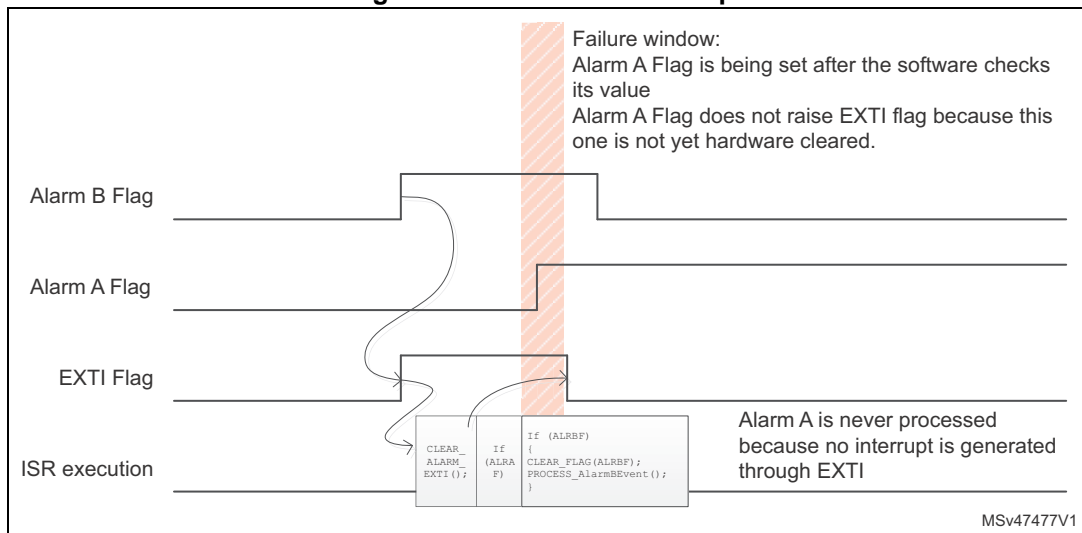
Figure 1. Masked RTC interrupt

One RTC interrupt can mask another RTC interrupt if both share the same EXTI configurable line, such as the RTC Alarm A and Alarm B, of which the event flags are OR-ed to the same EXTI line (refer to the **EXTI line connections** table in the **Extended interrupt and event controller (EXTI)** section of the reference manual).

The following code example and figure illustrate the failure mechanism: The Alarm A event is lost (fails to generate interrupt) as it occurs in the failure window, that is, after checking the Alarm A event flag but before the effective clear of the EXTI interrupt flag by hardware. The effective clear of the EXTI interrupt flag is delayed with respect to the software instruction to clear it.

In the interrupt service routine, apply three consecutive event flag checks - source one, source two, and source one again, as in the following code example:

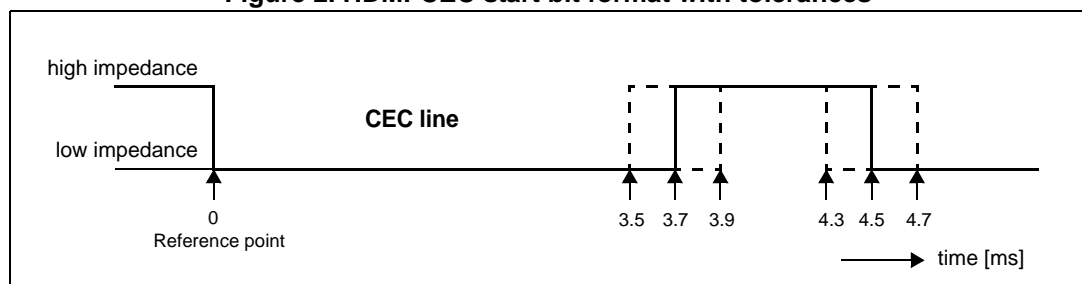
Figure 2. HDMI-CEC start bit format with tolerances

The start bit timing standard tolerances are shown in [Figure 2](#). The start bit is initiated by the device by driving the CEC line low (reference point). After 3.7 ms, the device releases the CEC line and starts checking its level. The following conditions must be met for the start bit to be valid:

If one of these conditions is not met, the transmission is aborted and never automatically retried. No error flag is set and the TXSOM (Tx Start Of Message) bit is not cleared.

The only way to detect this error is for the application software to start a timeout when setting the TXSOM bit, restart it upon ARBLST or any RX event (as the transmission can be
