## STM32L462CE/RE/VE device errata

This document applies to the part numbers of STM32L462CE/RE/VE devices and the device variants as stated in this page.

It gives a summary and a description of the device errata, with respect to the device datasheet and reference manual RM0394.

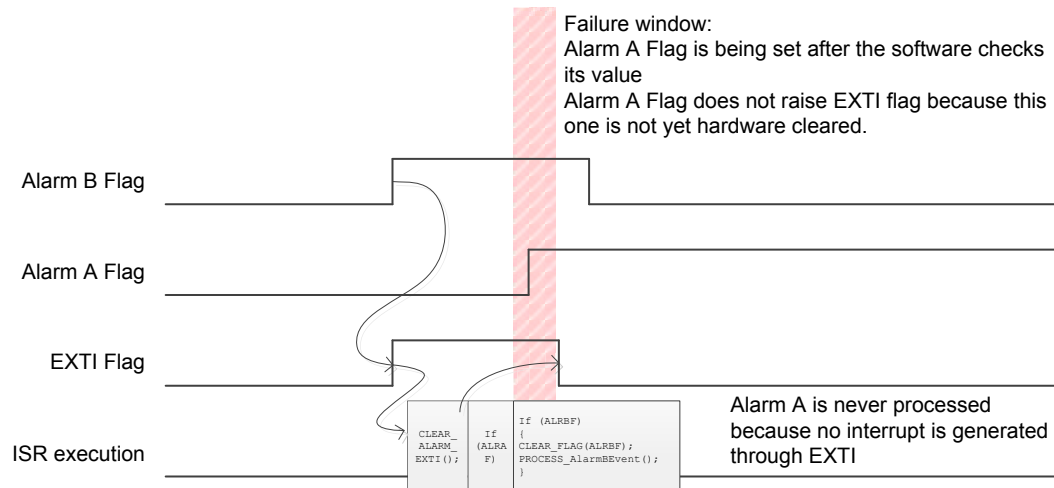
Figure 1. Masked RTC interrupt

The following code example and figure illustrate the failure mechanism: The Alarm A event is lost (fails to generate interrupt) as it occurs in the failure window, that is, after checking the Alarm A event flag but before the effective clear of the EXTI interrupt flag by hardware. The effective clear of the EXTI interrupt flag is delayed with respect to the software instruction to clear it.

In the interrupt service routine, apply three consecutive event flag checks - source one, source two, and source one again, as in the following code example:
