## Applicability

This document applies to the part numbers of STM32F051x4/x6/x8 devices listed in [Table 1](#) and their variants shown in [Table 2](#).

# 1 Summary of device errata

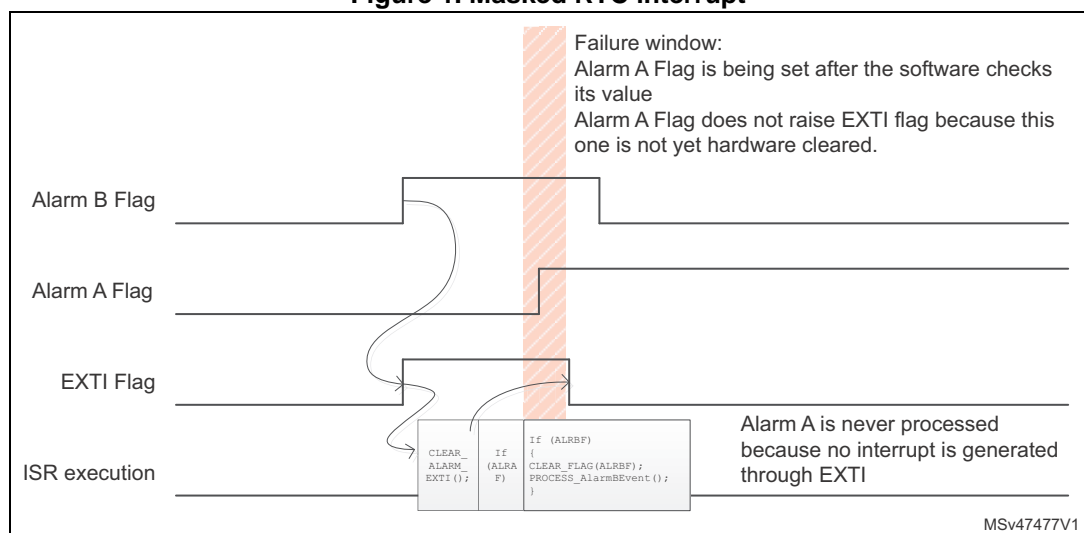
**Figure 1. Masked RTC interrupt**

The following code example and figure illustrate the failure mechanism: The Alarm A event is lost (fails to generate interrupt) as it occurs in the failure window, that is, after checking the Alarm A event flag but before the effective clear of the EXTI interrupt flag by hardware. The effective clear of the EXTI interrupt flag is delayed with respect to the software instruction to clear it.

## Workaround

In the interrupt service routine, apply three consecutive event flag checks - source one, source two, and source one again, as in the following code example:

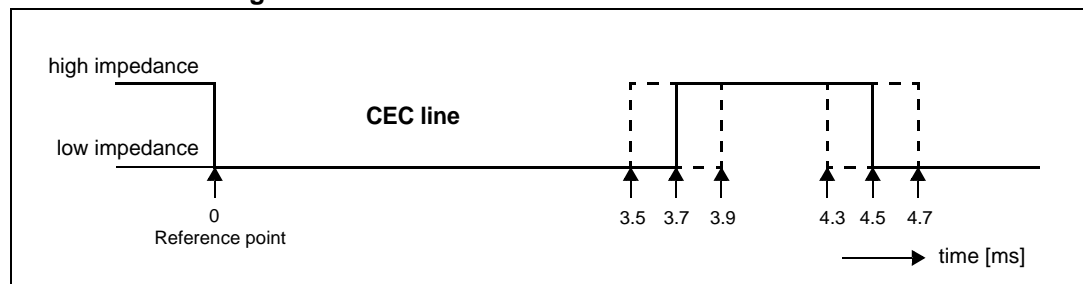
**Figure 2. HDMI-CEC start bit format with tolerances**

The start bit timing standard tolerances are shown in [Figure 2](#). The start bit is initiated by the device by driving the CEC line low (reference point). After 3.7 ms, the device releases the CEC line and starts checking its level. The following conditions must be met for the start bit to be valid:

If one of these conditions is not met, the transmission is aborted and never automatically retried. No error flag is set and the TXSOM (Tx Start Of Message) bit is not cleared.

#### Workaround

The only way to detect this error is for the application software to start a timeout when setting the TXSOM bit, restart it upon ARBLST or any RX event (as the transmission can be delayed by interleaved reception), and stop it upon TXBR (proof that the start bit was transmitted successfully) or TXEND event, or upon any TX error (which clears TXSOM). If the timeout expires (because none of those events occurred), the application software must restart the HDMI-CEC peripheral and retransmit the message.
