STM32F100xC, STM32F100xD and STM32F100xE high-density value line device limitations

This errata sheet applies to the revision A of the STMicroelectronics high-density value line products.

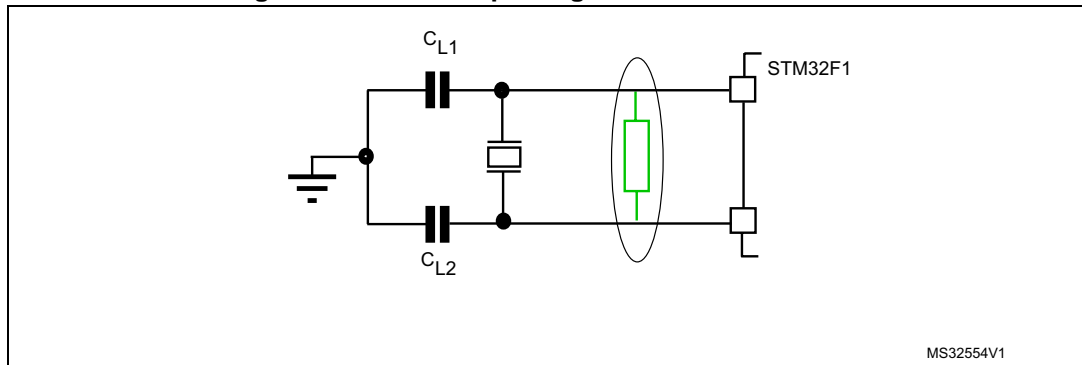
Figure 1. LSE start-up using an additional resistor

The LSE (low speed external) oscillator system is designed to minimize the overall power consumption of the STM32F1 microcontroller. It is extremely important to take specific care in the design of the PCB to ensure this low power oscillator starts in harsh conditions. In some PCB designs without coating, an induced low leakage may prevent the LSE to start-up, regardless of the 32.768 KHz crystal used. This phenomenon is amplified in humid environments that create frost on the OSC32_IN/OSC32_OUT tracks. This unwanted behavior may happen only at the first back-up domain power-on of the device.

It is recommended to mount an additional parallel feedback resistor (from 16 MΩ to 22 MΩ) on board to help the oscillation start-up in all cases (see [Figure 1](#)). For more details on compatible crystals and hardware techniques on PCB, refer to AN2867 “Oscillator design guide for STM8AF/AL/S, STM32 MCUs and MPUs”, available on www.st.com.
