STM32F301x6/x8 device errata

This document applies to the part numbers of STM32F301x6/x8 devices and the device variants as stated in this page.

It gives a summary and a description of the device errata, with respect to the device datasheet and reference manual RM0365.

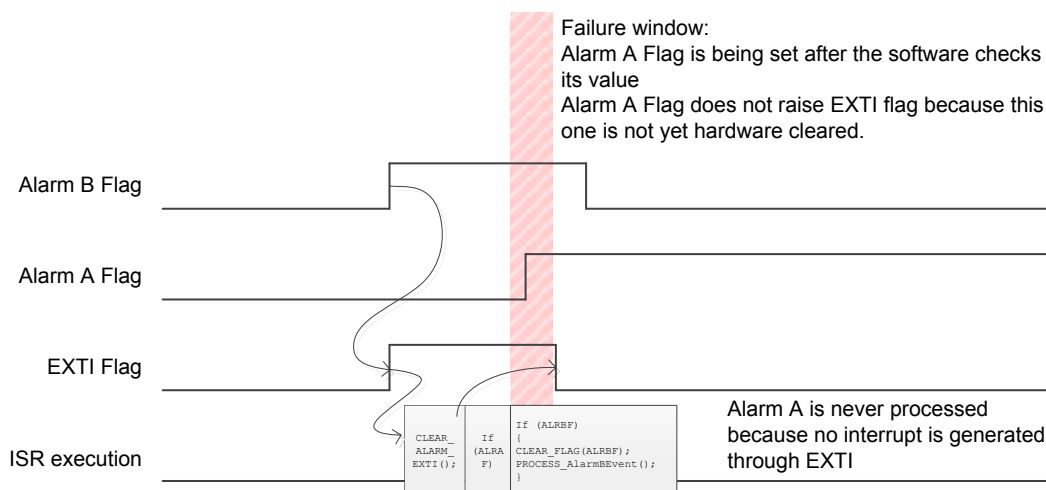
Figure 1. Masked RTC interrupt

The following code example and figure illustrate the failure mechanism: The Alarm A event is lost (fails to generate interrupt) as it occurs in the failure window, that is, after checking the Alarm A event flag but before the effective clear of the EXTI interrupt flag by hardware. The effective clear of the EXTI interrupt flag is delayed with respect to the software instruction to clear it.

Workaround

In the interrupt service routine, apply three consecutive event flag checks - source one, source two, and source one again, as in the following code example:
