STM32F048C6/G6/T6 device errata

This document applies to STM32F048C6/G6/T6 devices and the device variants as stated in this page.

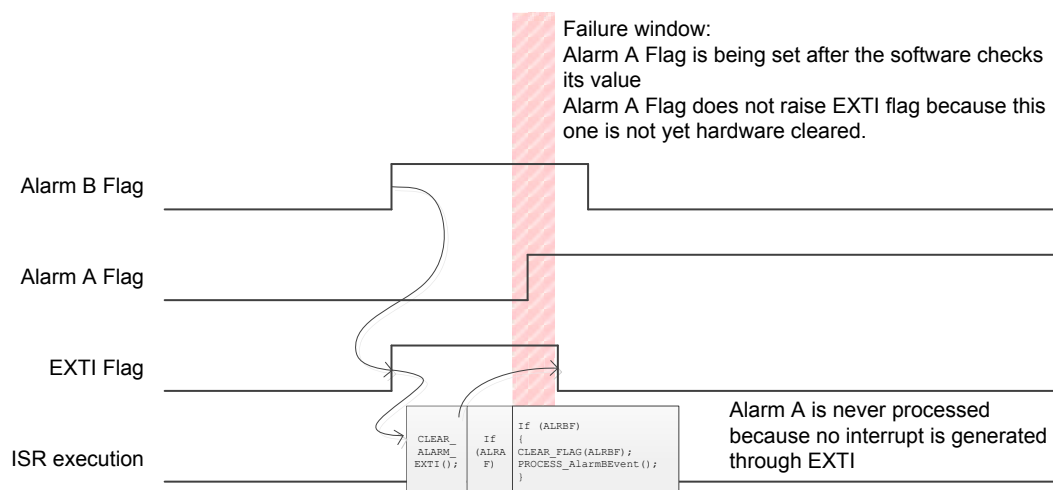
Figure 1. Masked RTC interrupt

The following code example and figure illustrate the failure mechanism: The Alarm A event is lost (fails to generate interrupt) as it occurs in the failure window, that is, after checking the Alarm A event flag but before the effective clear of the EXTI interrupt flag by hardware. The effective clear of the EXTI interrupt flag is delayed with respect to the software instruction to clear it.

In the interrupt service routine, apply three consecutive event flag checks - source one, source two, and source one again, as in the following code example:

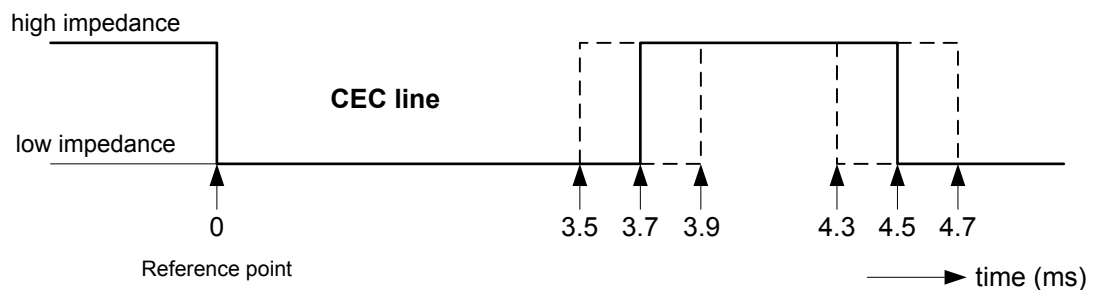
Figure 2. HDMI-CEC start bit format with tolerances

The start bit timing standard tolerances are shown in the following figure. The start bit is initiated by the device by driving the CEC line low (reference point). After 3.7 ms, the device releases the CEC line and starts checking its level. The following conditions must be met for the start bit to be valid:

If one of these conditions is not met, the transmission is aborted and never automatically retried. No error flag is set and the TXSOM (Tx start of message) bit is not cleared.

The only way to detect this error is for the application software to start a timeout when setting the TXSOM bit, restart it upon ARBLST or any RX event (as the transmission can be delayed by interleaved reception), and stop it upon TXBR (proof that the start bit was transmitted successfully) or TXEND event, or upon any TX error (which clears TXSOM). If the timeout expires (because none of those events occurred), the application software must restart the HDMI-CEC peripheral and retransmit the message.
