## STM32F098CC/RC/VC device errata

This document applies to STM32F098CC/RC/VC devices and the device variants as stated in this page.

It gives a summary and a description of the device errata, with respect to the device datasheet and reference manual RM0091.

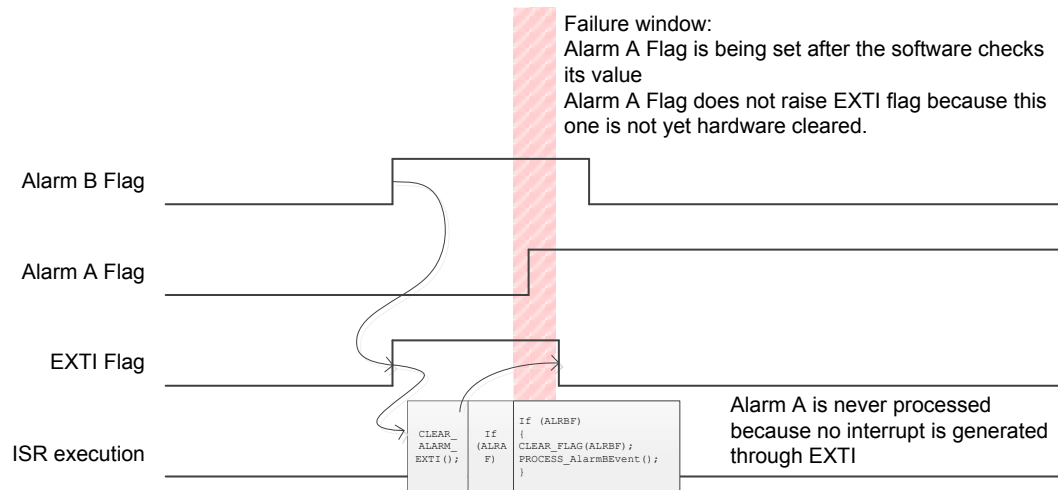
**Figure 1. Masked RTC interrupt**

The following code example and figure illustrate the failure mechanism: The Alarm A event is lost (fails to generate interrupt) as it occurs in the failure window, that is, after checking the Alarm A event flag but before the effective clear of the EXTI interrupt flag by hardware. The effective clear of the EXTI interrupt flag is delayed with respect to the software instruction to clear it.

In the interrupt service routine, apply three consecutive event flag checks - source one, source two, and source one again, as in the following code example:

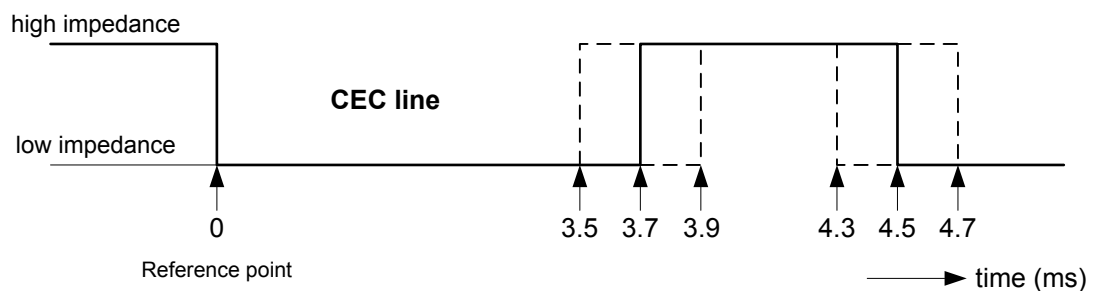
Figure 2. HDMI-CEC start bit format with tolerances

The start bit timing standard tolerances are shown in the following figure. The start bit is initiated by the device by driving the CEC line low (reference point). After 3.7 ms, the device releases the CEC line and starts checking its level. The following conditions must be met for the start bit to be valid:

If one of these conditions is not met, the transmission is aborted and never automatically retried. No error flag is set and the TXSOM (Tx start of message) bit is not cleared.

The only way to detect this error is for the application software to start a timeout when setting the TXSOM bit, restart it upon ARBLST or any RX event (as the transmission can be delayed by interleaved reception), and stop it upon TXBR (proof that the start bit was transmitted successfully) or TXEND event, or upon any TX error (which clears TXSOM). If the timeout expires (because none of those events occurred), the application software must restart the HDMI-CEC peripheral and retransmit the message.
