Applicability

This document applies to the part numbers of STM32F042x4/x6 devices listed in [Table 1](#) and their variants shown in [Table 2](#).

[Section 1](#) gives a summary and [Section 2](#) a description of device limitations and documentation errata, with respect to the device datasheet and reference manual RM0091.

Table 1. Device summary

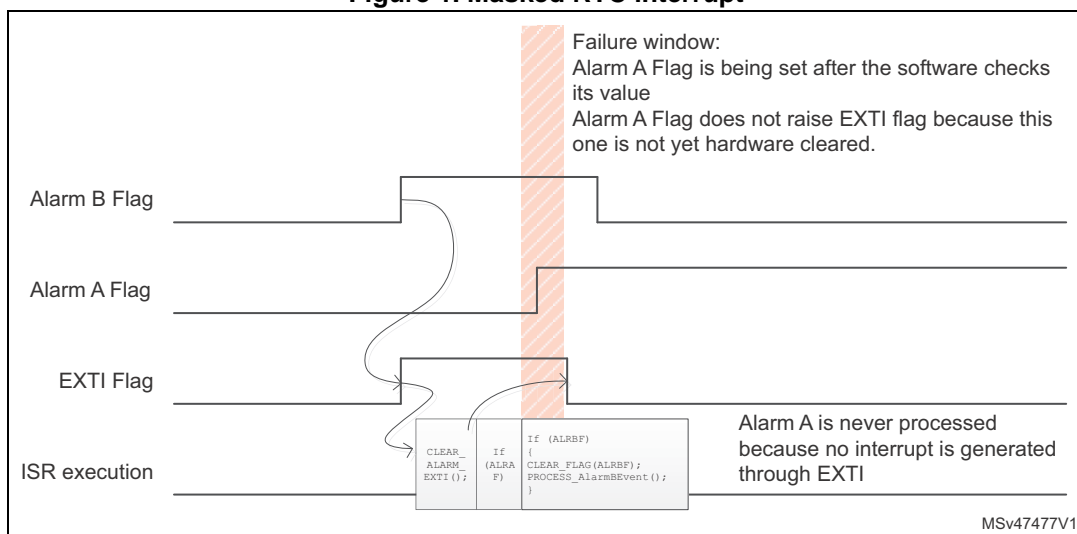
Figure 1. Masked RTC interrupt

2.7.4 RTC interrupt can be masked by another RTC interrupt

One RTC interrupt can mask another RTC interrupt if both share the same EXTI configurable line, such as the RTC Alarm A and Alarm B, of which the event flags are OR-ed to the same EXTI line (refer to the **EXTI line connections** table in the **Extended interrupt and event controller (EXTI)** section of the reference manual).

The following code example and figure illustrate the failure mechanism: The Alarm A event is lost (fails to generate interrupt) as it occurs in the failure window, that is, after checking the Alarm A event flag but before the effective clear of the EXTI interrupt flag by hardware. The effective clear of the EXTI interrupt flag is delayed with respect to the software instruction to clear it.

**Workaround**

In the interrupt service routine, apply three consecutive event flag checks - source one, source two, and source one again, as in the following code example:

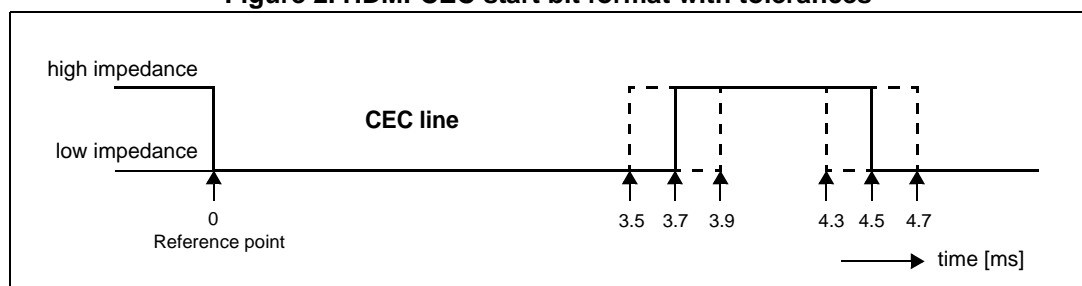
Figure 2. HDMI-CEC start bit format with tolerances

This failure is unlikely to happen as the CEC start bit corruption by another device can only occur if that device does not respect the CEC communication protocol.

The start bit timing standard tolerances are shown in [Figure 2](#). The start bit is initiated by the device by driving the CEC line low (reference point). After 3.7 ms, the device releases the CEC line and starts checking its level. The following conditions must be met for the start bit to be valid:

If one of these conditions is not met, the transmission is aborted and never automatically retried. No error flag is set and the TXSOM (Tx Start Of Message) bit is not cleared.

The only way to detect this error is for the application software to start a timeout when setting the TXSOM bit, restart it upon ARBLST or any RX event (as the transmission can be delayed by interleaved reception), and stop it upon TXBR (proof that the start bit was transmitted successfully) or TXEND event, or upon any TX error (which clears TXSOM). If the timeout expires (because none of those events occurred), the application software must restart the HDMI-CEC peripheral and retransmit the message.
