STM32F105xx and STM32F107xx revision Z connectivity line device limitations

This errata sheet applies to the revision Z of the STMicroelectronics STM32F105xx and STM32F107xx connectivity line products. This family features an Arm® 32-bit Cortex®-M3 core, for which an errata notice is also available (see [Section 1](#) for details).

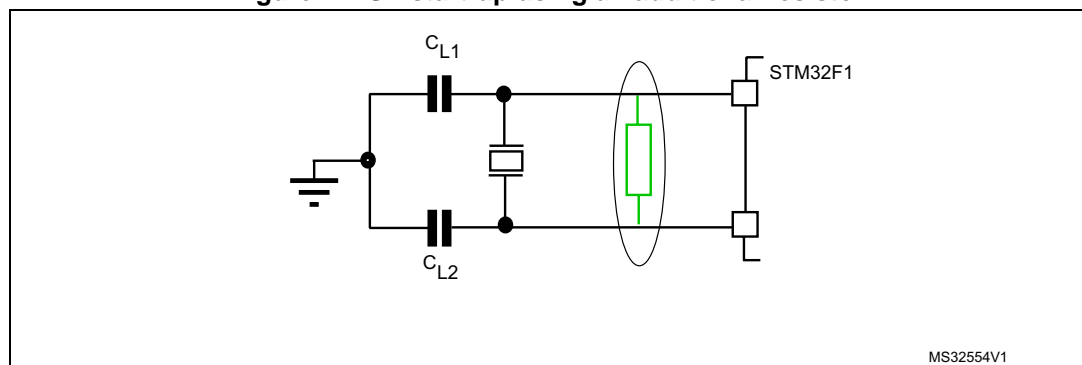
Figure 1. LSE start-up using an additional resistor

The LSE (Low Speed External) oscillator system has been designed to minimize the overall power consumption of the STM32F1 microcontroller. It is extremely important to take specific care in the design of the PCB to ensure this low power oscillator starts in harsh conditions. In some PCB designs without coating, an induced low leakage may prevent the LSE to start-up, regardless of the 32.768 KHz crystal used. This phenomenon is amplified in humid environments that create frost on the OSC32_IN/OSC32_OUT tracks. This unwanted behavior may happen only at the first back-up domain power-on of the device.

It is recommended to mount an additional parallel feedback resistor (from 16 M Ω to 22 M Ω) on board to help the oscillation start-up in all cases (see [Figure 1](#)). For more details on compatible crystals and hardware techniques on PCB, refer to AN2867 application note.
