## Applicability

This document applies to the part numbers of STM32F070x6/xB devices listed in [Table 1](#) and their variants shown in [Table 2](#).

[Section 1](#) gives a summary and [Section 2](#) a description of device limitations and documentation errata, with respect to the device datasheet and reference manual RM0360.

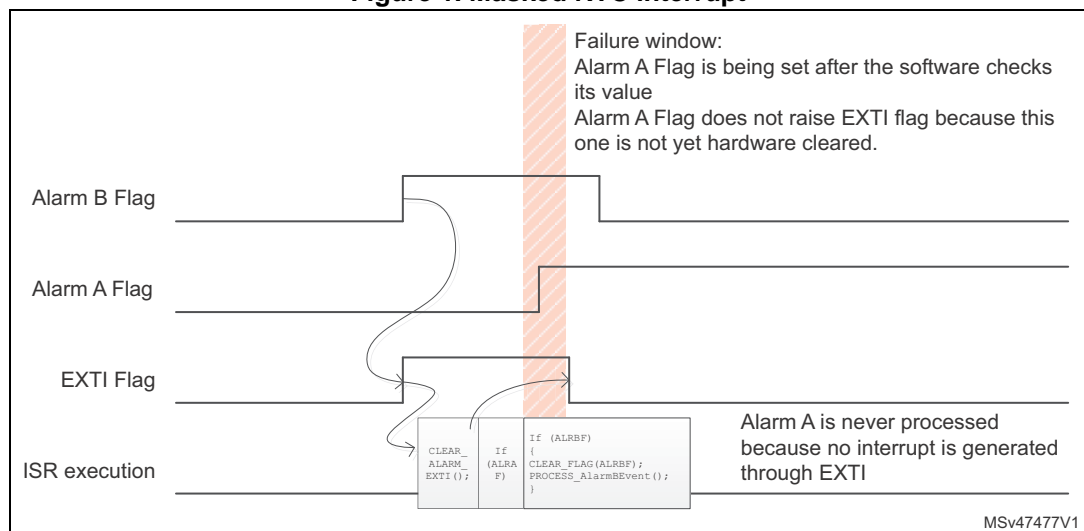
**Figure 1. Masked RTC interrupt**

One RTC interrupt can mask another RTC interrupt if both share the same EXTI configurable line, such as the RTC Alarm A and Alarm B, of which the event flags are OR-ed to the same EXTI line (refer to the **EXTI line connections** table in the **Extended interrupt and event controller (EXTI)** section of the reference manual).

The following code example and figure illustrate the failure mechanism: The Alarm A event is lost (fails to generate interrupt) as it occurs in the failure window, that is, after checking the Alarm A event flag but before the effective clear of the EXTI interrupt flag by hardware. The effective clear of the EXTI interrupt flag is delayed with respect to the software instruction to clear it.

In the interrupt service routine, apply three consecutive event flag checks - source one, source two, and source one again, as in the following code example:
