Applicability

This document applies to the part numbers of STM32F071x8/xB devices listed in [Table 1](#) and their variants shown in [Table 2](#).

Table 1. Device summary

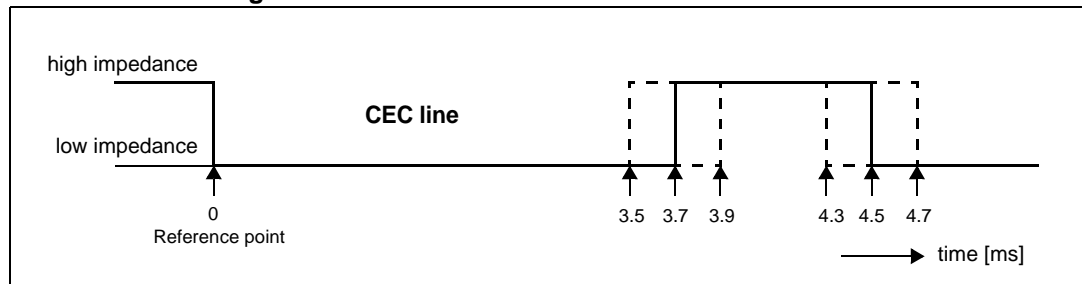
Figure 1. HDMI-CEC start bit format with tolerances

This failure is unlikely to happen as the CEC start bit corruption by another device can only occur if that device does not respect the CEC communication protocol.

CEC line and starts checking its level. The following conditions must be met for the start bit to be valid:

If one of these conditions is not met, the transmission is aborted and never automatically retried. No error flag is set and the TXSOM (Tx Start Of Message) bit is not cleared.

The only way to detect this error is for the application software to start a timeout when setting the TXSOM bit, restart it upon ARBLST or any RX event (as the transmission can be delayed by interleaved reception), and stop it upon TXBR (proof that the start bit was transmitted successfully) or TXEND event, or upon any TX error (which clears TXSOM). If the timeout expires (because none of those events occurred), the application software must restart the HDMI-CEC peripheral and retransmit the message.
