STM32L412xx device errata

This document applies to the part numbers of STM32L412xx devices and the device variants as stated in this page.

It gives a summary and a description of the device errata, with respect to the device datasheet and reference manual RM394.

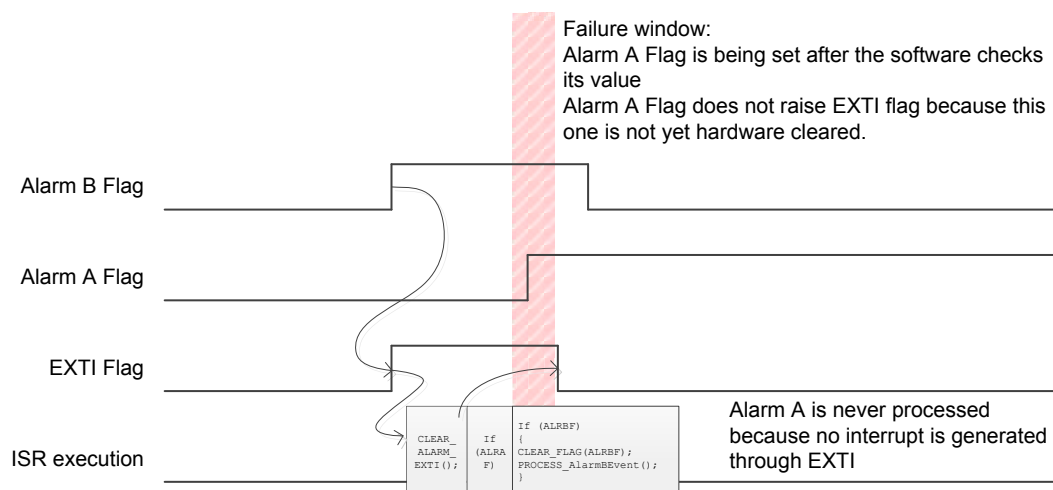
Figure 1. Masked RTC interrupt

The following code example and figure illustrate the failure mechanism: The Alarm A event is lost (fails to generate interrupt) as it occurs in the failure window, that is, after checking the Alarm A event flag but before the effective clear of the EXTI interrupt flag by hardware. The effective clear of the EXTI interrupt flag is delayed with respect to the software instruction to clear it.

Workaround

In the interrupt service routine, apply three consecutive event flag checks - source one, source two, and source one again, as in the following code example:
