STM32L431xx device errata

This document applies to the part numbers of STM32L431xx devices and the device variants as stated in this page.

It gives a summary and a description of the device errata, with respect to the device datasheet and reference manual RM394.

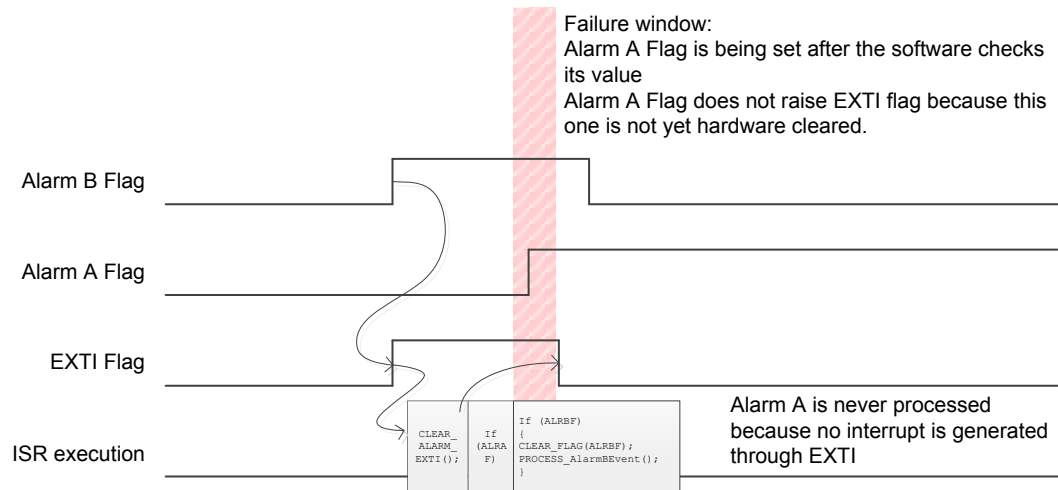
Figure 1. Masked RTC interrupt

The following code example and figure illustrate the failure mechanism: The Alarm A event is lost (fails to generate interrupt) as it occurs in the failure window, that is, after checking the Alarm A event flag but before the effective clear of the EXTI interrupt flag by hardware. The effective clear of the EXTI interrupt flag is delayed with respect to the software instruction to clear it.

```
void RTC_Alarm_IRQHandler(void)
{
    CLEAR_ALARM_EXTI(); /* Clear the EXTI line flag for RTC alarms*/
    If(ALRAF) /* Check if Alarm A triggered ISR */
    {
        CLEAR_FLAG(ALRAF); /* Clear the Alarm A interrupt pending bit */
        PROCESS_AlarmAEvent(); /* Process Alarm A event */
    }
    If(ALRBF) /* Check if Alarm B triggered ISR */
    {
        CLEAR_FLAG(ALRBF); /* Clear the Alarm B interrupt pending bit */
        PROCESS_AlarmBEvent(); /* Process Alarm B event */
    }
}
```

In the interrupt service routine, apply three consecutive event flag checks - source one, source two, and source one again, as in the following code example:
