STM32F078CB/RB/VB device errata

This document applies to STM32F078CB/RB/VB devices and the device variants as stated in this page.

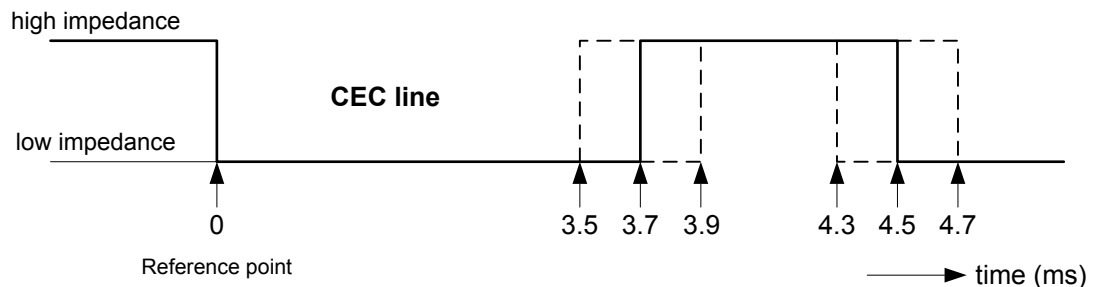
Figure 2. HDMI-CEC start bit format with tolerances

The start bit timing standard tolerances are shown in the following figure. The start bit is initiated by the device by driving the CEC line low (reference point). After 3.7 ms, the device releases the CEC line and starts checking its level. The following conditions must be met for the start bit to be valid:

If one of these conditions is not met, the transmission is aborted and never automatically retried. No error flag is set and the TXSOM (Tx start of message) bit is not cleared.

The only way to detect this error is for the application software to start a timeout when setting the TXSOM bit, restart it upon ARBLST or any RX event (as the transmission can be delayed by interleaved reception), and stop it upon TXBR (proof that the start bit was transmitted successfully) or TXEND event, or upon any TX error (which clears TXSOM). If the timeout expires (because none of those events occurred), the application software must restart the HDMI-CEC peripheral and retransmit the message.
