## Applicability

This document applies to the part numbers of STM32L475xx devices listed in [Table 1](#) and their variants shown in [Table 2](#).

**Table 1. Device summary**

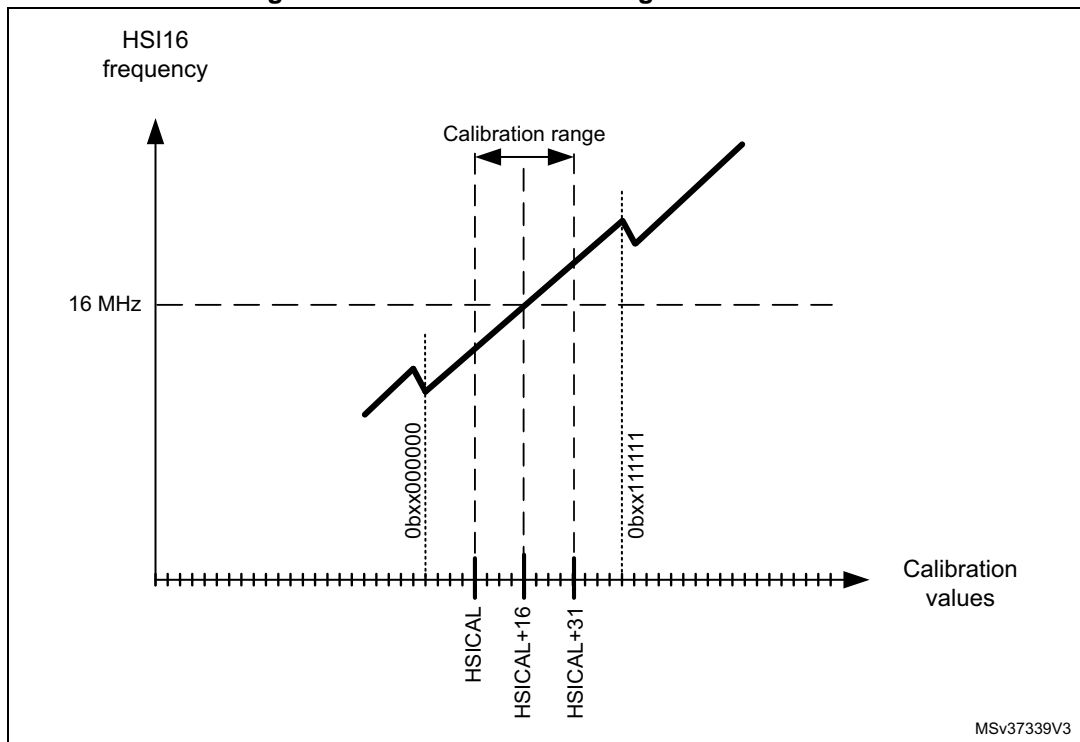
Figure 1. HSI oscillator trimming characteristics

Consequently, the user trim correction must not jump over the codes multiple of 64, which can limit the user correction either in positive or in negative direction.

None.

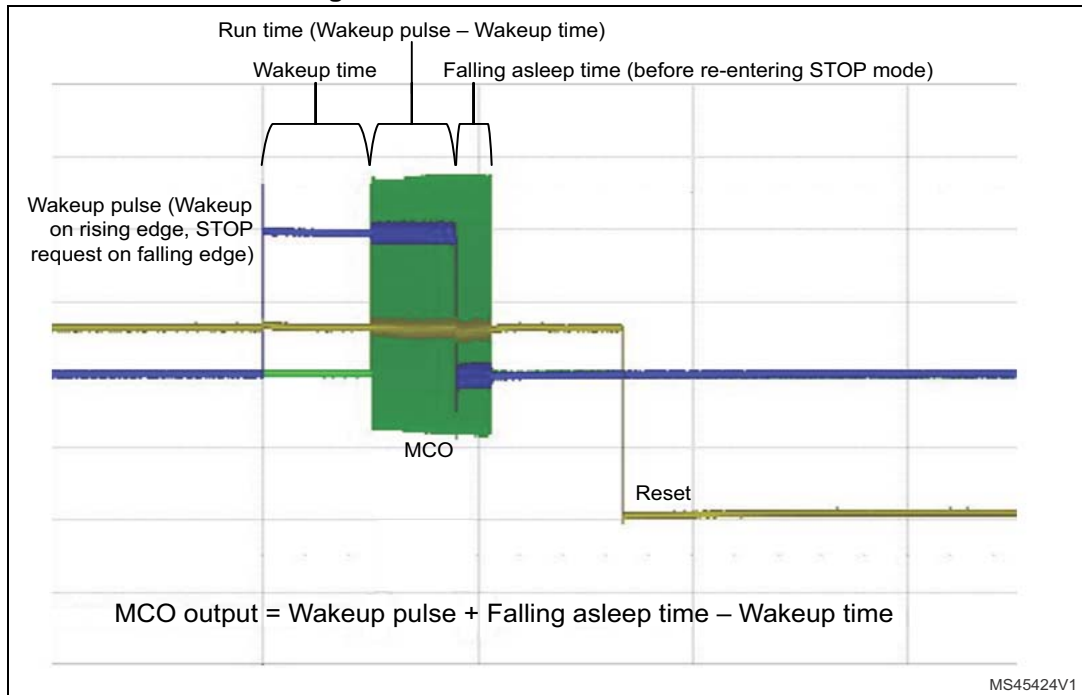
**Figure 2. Minimum Run time definition**

The minimum Run time defined in [Table 4](#) corresponds to the firmware execution time on the core. Note also that, as shown in [Figure 2](#), the length of the MCO output (green trace) is longer than the firmware execution time.

Ensure that the Run time between two Stop sequences is long enough to avoid the generation of a Brown Out Reset.

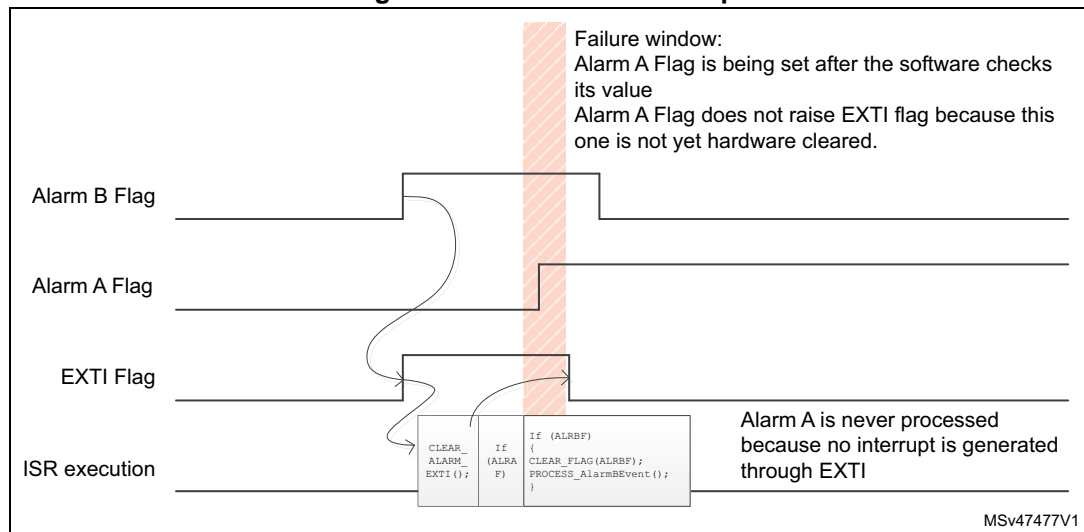
Figure 3. Masked RTC interrupt

The following code example and figure illustrate the failure mechanism: The Alarm A event is lost (fails to generate interrupt) as it occurs in the failure window, that is, after checking the Alarm A event flag but before the effective clear of the EXTI interrupt flag by hardware. The effective clear of the EXTI interrupt flag is delayed with respect to the software instruction to clear it.

In the interrupt service routine, apply three consecutive event flag checks - source one, source two, and source one again, as in the following code example:
