This document applies to the part numbers of STM32F031x4/x6 devices listed in [Table 1](#) and their variants shown in [Table 2](#).

[Section 1](#) gives a summary and [Section 2](#) a description of device limitations and documentation errata, with respect to the device datasheet and reference manual RM0091.

Table 1. Device summary

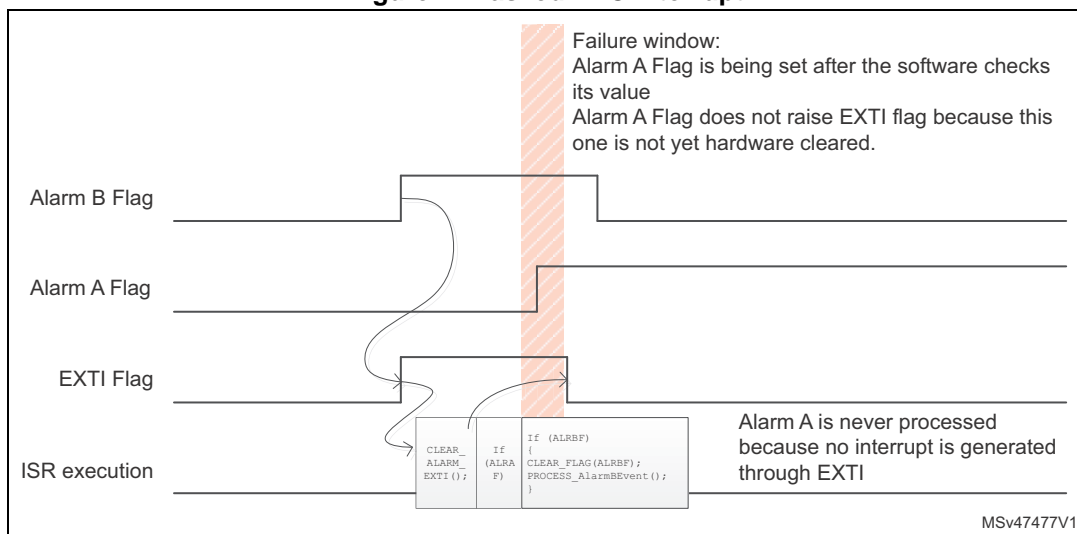
Figure 1. Masked RTC interrupt

The following code example and figure illustrate the failure mechanism: The Alarm A event is lost (fails to generate interrupt) as it occurs in the failure window, that is, after checking the Alarm A event flag but before the effective clear of the EXTI interrupt flag by hardware. The effective clear of the EXTI interrupt flag is delayed with respect to the software instruction to clear it.

In the interrupt service routine, apply three consecutive event flag checks - source one, source two, and source one again, as in the following code example:

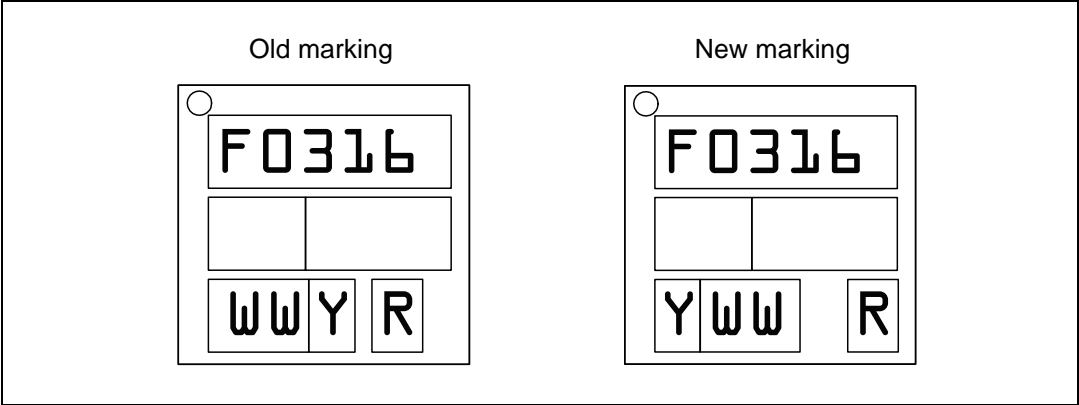
Figure 2. WLCSP25 package marking

From week 9, 2017 on, the marking on the WLCSP25 package is modified to show the date in the format YWW. [Figure 2](#) illustrates the difference between the old and the new product marking. The figure in the product datasheet was also updated to better reflect the dimensions and layout of the marking on the package.
