## STM32L432KB/KC and STM32L442KC device errata

This document applies to the part numbers of STM32L432KB/KC and STM32L442KC devices and the device variants as stated in this page.

It gives a summary and a description of the device errata, with respect to the device datasheet and reference manual RM394.

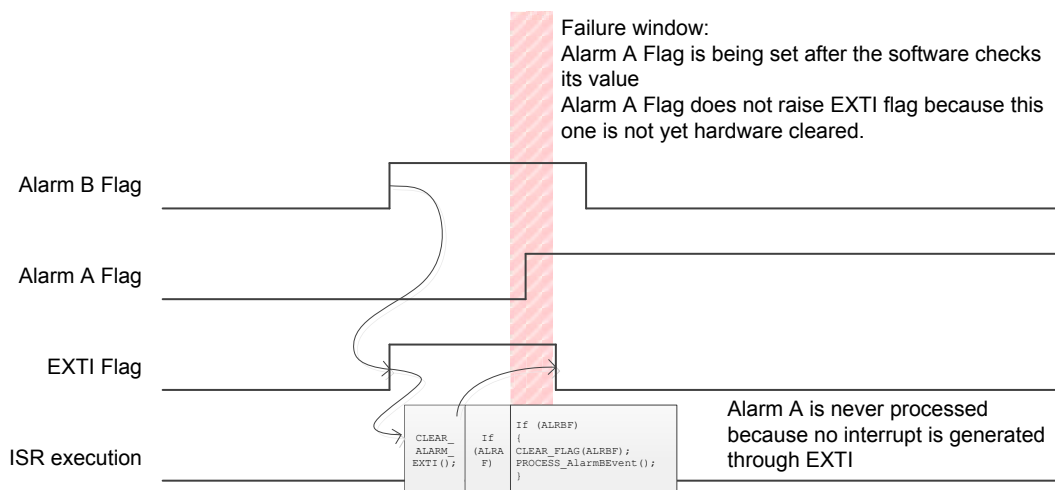
**Figure 1. Masked RTC interrupt**

The following code example and figure illustrate the failure mechanism: The Alarm A event is lost (fails to generate interrupt) as it occurs in the failure window, that is, after checking the Alarm A event flag but before the effective clear of the EXTI interrupt flag by hardware. The effective clear of the EXTI interrupt flag is delayed with respect to the software instruction to clear it.

#### Workaround

In the interrupt service routine, apply three consecutive event flag checks - source one, source two, and source one again, as in the following code example:
