STM32F101xC/D/E and STM32F103xC/D/E high-density device limitations

Silicon identification

This errata sheet applies to the revisions Z, Y, 1, 2, 3 and X of the STMicroelectronics STM32F101xC/D/E access line and STM32F103xC/D/E performance line high-density products. These families feature an Arm® 32-bit Cortex®-M3 core, for which an errata notice is also available (see [Section 1](#) for details).

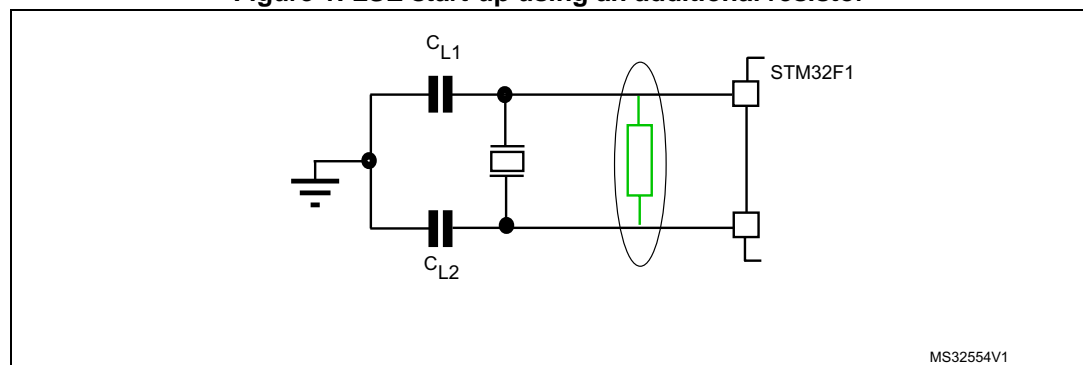
Figure 1. LSE start-up using an additional resistor

The LSE (Low Speed External) oscillator system has been designed to minimize the overall power consumption of the STM32F1 microcontroller. It is extremely important to take specific care in the design of the PCB to ensure this low power oscillator starts in harsh conditions. In some PCB designs without coating, an induced low leakage may prevent the LSE to start-up, regardless of the 32.768 KHz crystal used. This phenomenon is amplified in humid environments that create frost on the OSC32_IN/OSC32_OUT tracks. This unwanted behavior may happen only at the first back-up domain power-on of the device.

It is recommended to mount an additional parallel feedback resistor (from 16 MΩ to 22 MΩ) on board to help the oscillation start-up in all cases (see [Figure 1](#)). For more details on compatible crystals and hardware techniques on PCB refer to AN2867 “Oscillator design guide for STM8AF/AL/S, STM32 MCUs and MPUs” available on www.st.com.
