Applicability

This document applies to the part numbers of STM32L471xx devices listed in [Table 1](#) and their variants shown in [Table 2](#).

[Section 1](#) gives a summary and [Section 2](#) a description of workarounds for device limitations, with respect to the device datasheet and reference manual RM0351.

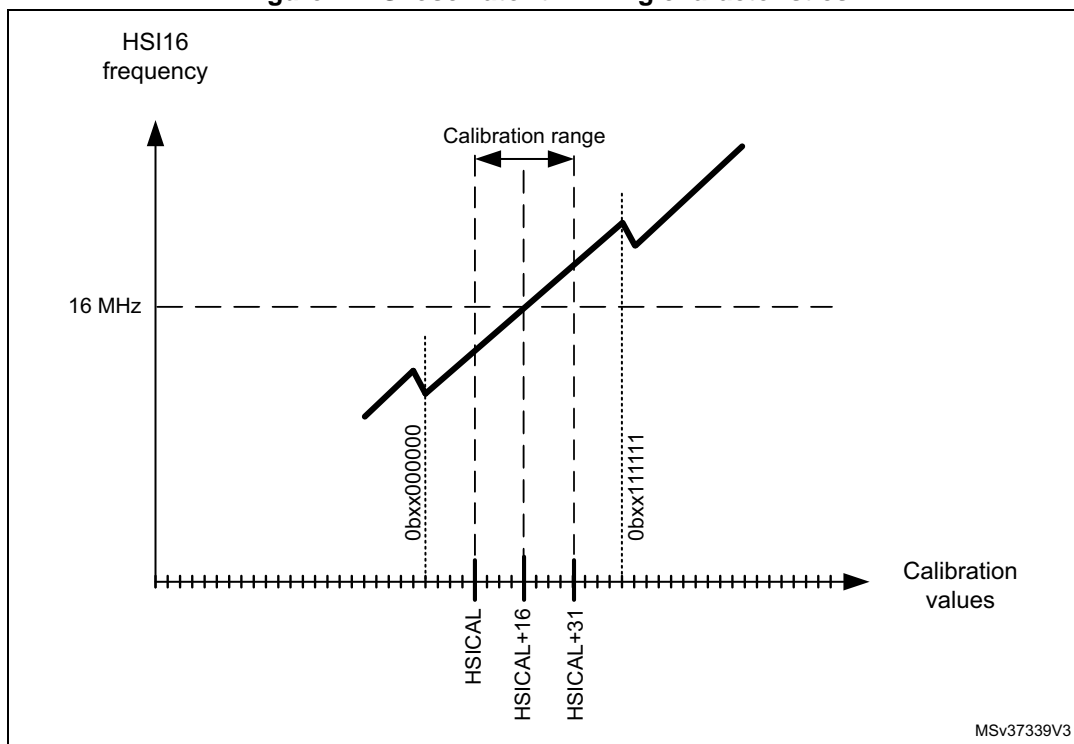
Figure 1. HSI oscillator trimming characteristics

Consequently, the user trim correction must not jump over the codes multiple of 64, which can limit the user correction either in positive or in negative direction.

Workaround

None.

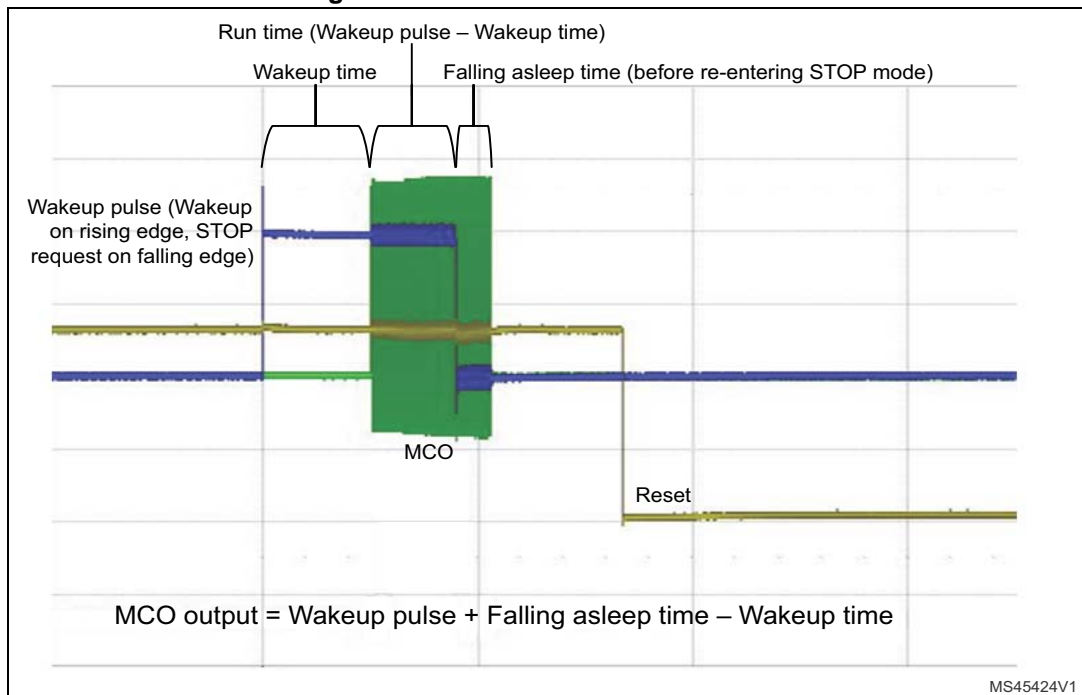
Figure 2. Minimum Run time definition

The minimum Run time defined in [Table 4](#) corresponds to the firmware execution time on the core. Note also that, as shown in [Figure 2](#), the length of the MCO output (green trace) is longer than the firmware execution time.

**Workaround**

Ensure that the Run time between two Stop sequences is long enough to avoid the generation of a Brown Out Reset.
