STM32F058C8/R8 device errata

This document applies to STM32F058C8/R8 devices and the device variants as stated in this page.

It gives a summary and a description of the device errata, with respect to the device datasheet and reference manual RM0091.

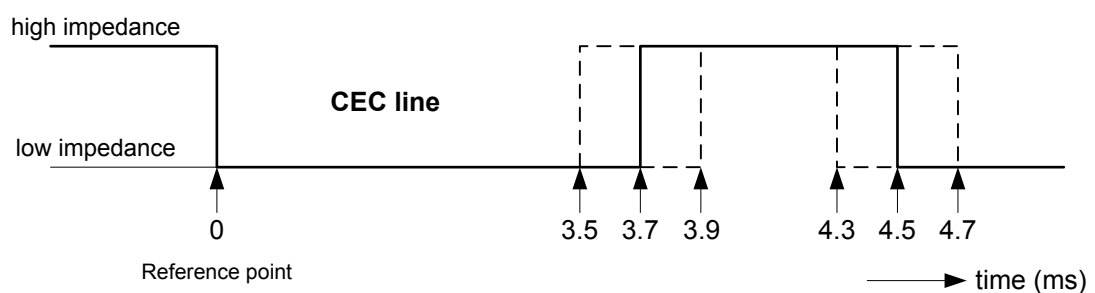
Figure 2. HDMI-CEC start bit format with tolerances

The start bit timing standard tolerances are shown in the following figure. The start bit is initiated by the device by driving the CEC line low (reference point). After 3.7 ms, the device releases the CEC line and starts checking its level. The following conditions must be met for the start bit to be valid:

If one of these conditions is not met, the transmission is aborted and never automatically retried. No error flag is set and the TXSOM (Tx start of message) bit is not cleared.

The only way to detect this error is for the application software to start a timeout when setting the TXSOM bit, restart it upon ARBLST or any RX event (as the transmission can be delayed by interleaved reception), and stop it upon TXBR (proof that the start bit was transmitted successfully) or TXEND event, or upon any TX error (which clears TXSOM). If the timeout expires (because none of those events occurred), the application software must restart the HDMI-CEC peripheral and retransmit the message.
