GSM Tx power jumping issue

- **KBA number** : KBA-170428013933
- **Platform**: ALL
- **适用平台** : ALL
- **Symptom**: Customer use MSM8937+WTR2965 to design a project. The GSM RF cal is OK. But during signaling call, GSM call is not easy to be established. When GSM call is connected, the Tx power will jump occasionally no matter what PCL it is set for Tx.
- **问题现象**：客户使用MSM8937+WTR2965设计了一个项目。GSM RF校准是通过的。但是GSM信令call与仪表很难建立起来，在与仪表建立GSM call之后，实际测得的GSM Tx power在上下抖动，表现为PVT曲线中间那条直线上下抖动。

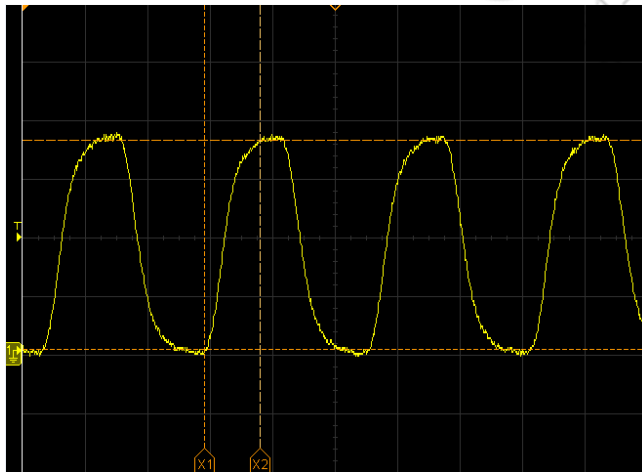
- **Root cause:** After checking the schematic, we found that customer add a 100 ohm + 22 pF RC filters for Phase II PAM's RFFE1_CLK. And the waveform of RFFE1_CLK between with this RC filters and without this RC filters disclose the root cause.
- **问题根源:** 检查原理图,发现客户在前端Phase II PAM的RFFE1_CLK上面串了100 欧姆 和 22pF的RC滤波电路。拿示波器测量带这个RC滤波和不带RC滤波的RFFE1_CLK波形。波形的差异揭示了问题根源.

带RC滤波的RFFE1_CLK波形

- **Solution:** .
 - RC filter distort RFFE1_CLK waveform and integrity. It will lead to MIPI command decode error sometimes and lead to such kind of issue.
 - Replace serial 100 ohm with 0 ohm and issue is resolved.
- **解决方案：**
 - RC滤波器使得RFFE1_CLK波形失真，破坏了信号完整性，导致MIPI指令解码错误带来这种问题。
 - 把串接在RFFE1_CLK上的100欧姆 用 0欧姆替换掉，问题解决。

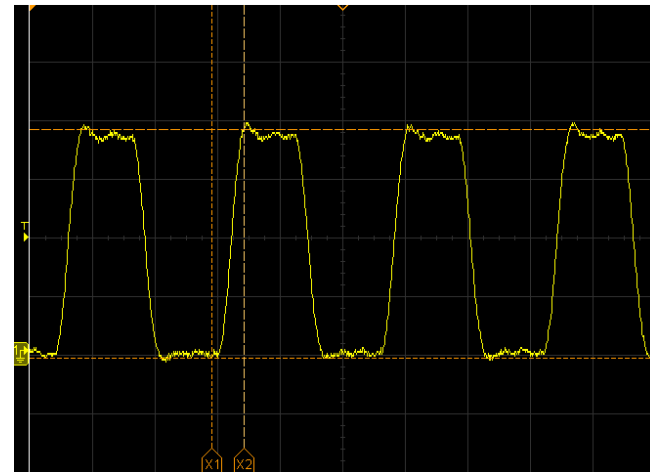
不带RC滤波的RFFE1_CLK波形
