Qualcomm Technologies, Inc.

PM660

Device Revision Guide

80-P7905-4 Rev. F

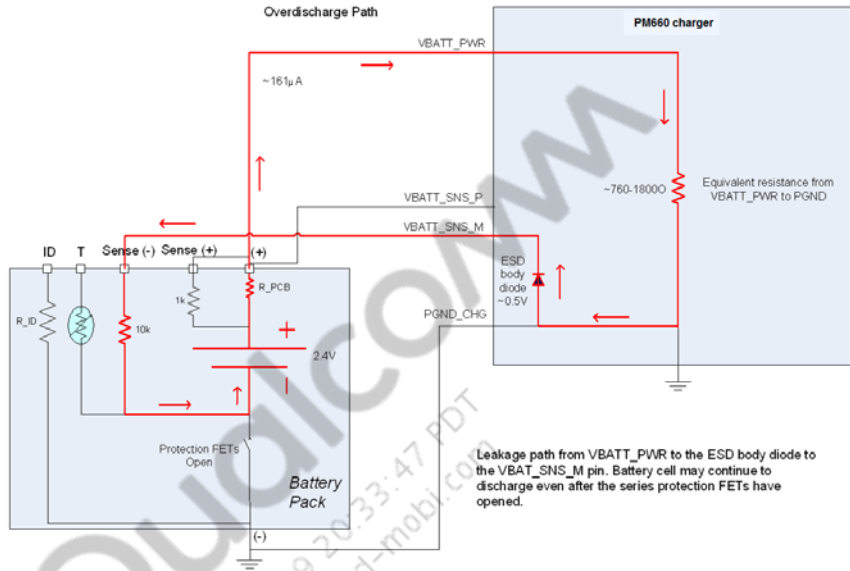
Description (cont.)	<p>When using the “in battery pack” differential sensing feature, a leakage path on the negative sense line causes the battery to continuously discharge even with battery protection FETs open. For example, a 2.4 V battery has a leakage of $\sim 161 \mu\text{A}$ with 10 k series resistor on VBATT_SNS_M. The leakage is higher for a lower series resistance. As such, the “in battery pack” differential sensing feature cannot be used at this time.</p>

<p>Overdischarge Path</p> <p>VBATT_PWR</p> <p>$\sim 161 \mu\text{A}$</p> <p>VBATT_SNS_P</p> <p>VBATT_SNS_M</p> <p>ESD body diode $\sim 0.5\text{V}$</p> <p>PGND_CHG</p> <p>Equivalent resistance from VBATT_PWR to PGND</p> <p>$\sim 760-18000$</p> <p>Leakage path from VBATT_PWR to the ESD body diode to the VBATT_SNS_M pin. Battery cell may continue to discharge even after the series protection FETs have opened.</p> <p>Protection FETs Open</p> <p>Battery Pack</p> <p>2.4V</p> <p>Sense (-)</p> <p>Sense (+)</p> <p>1k</p> <p>10k</p> <p>R_ID</p> <p>R_PCB</p>

Impact	<p>The battery cell continues to discharge even when protection FETs open. This could result in an overdischarged battery from becoming further discharged.</p>

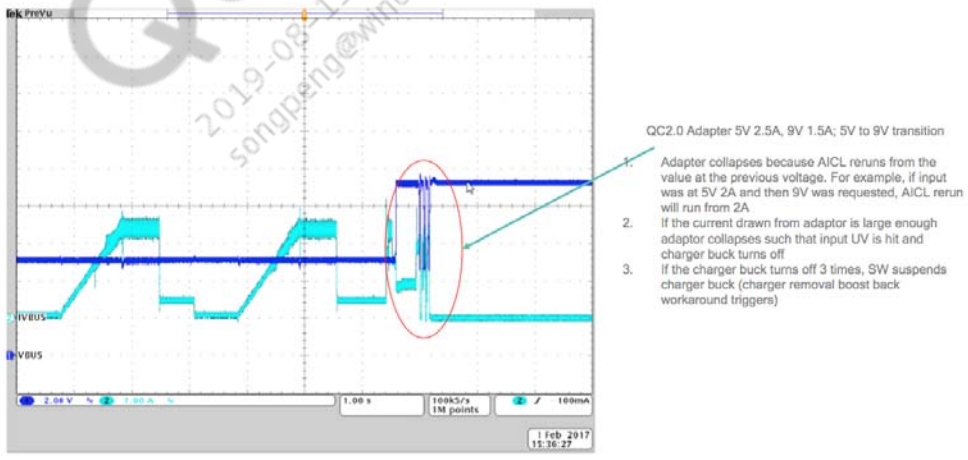
Description	<p>It is observed that certain low power rated QC3/QC2 adapters collapse when a voltage increment is requested due to large system load. If the adapter collapses below the input UVLO threshold for 20 msec, then the charger buck is turned off. If the charger buck is turned off three times in 1 second, then the software suspends the charger buck.</p>

Impact	<p>The root cause of the adapter collapse is a bug in the way HW AICL runs. When a voltage increment is requested from a QC adapter, AICL is re-run at the new voltage from the value at the previous voltage. For example, in case of QC2 adapter, if input was at 5 V 2 A and then 9 V was requested, AICL is re-run from 2 A. This may result in collapsing a low power rated adapter such as one shown in plot above. The charger buck gets suspended because the charger removal boost back workaround kicks in. This software workaround looks at how many times the charge buck shutdown in 1 second. If it shuts down 3 times in 1 second, then it is deemed that charger is accidentally reverse boosting and charger buck is suspended. The reason this software workaround is needed is because of a hardware bug, which prevents the PM660 device from running input missing poller to prevent accidental reverse boost upon charger removal.</p>

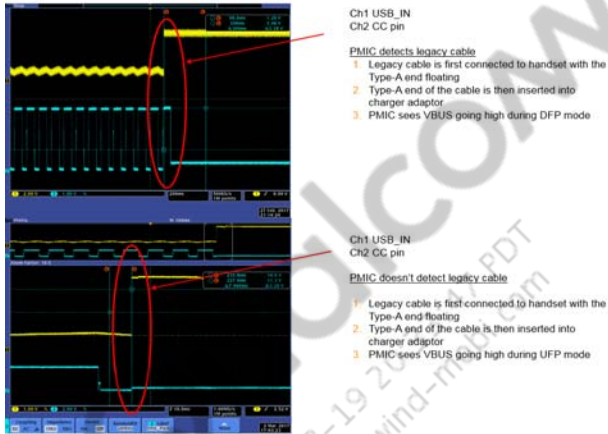
<p>Description</p>	<p>The PM660 device has the ability to detect a legacy (Type-A to Type-C) cable from a non-legacy (Type-C to Type-C) cable by looking at when VBUS is attached with respect to CC pin. Furthermore, if a cable is detected as legacy cable and charger type is SDP/CDP, the PM660 device looks at the pull-up resistance (R_p) from CC to VBUS to deem whether the cable is compliant ($R_p = 56\text{ K}$) or non-compliant ($R_p = 10\text{ K}$ or lower). If the cable is deemed non-compliant, then the hardware automatically limits the max input current limit to 500 mA/1500 mA in case of SDP/CDP. If a legacy cable is attached with a 10 K or lower R_p, then QC is blocked in HLOS by software to prevent damaging the CC pin.</p> <p>In HLOS software, PM660 is configured to operate in DRP mode where it continuously cycles between DFP and UFP mode. It is observed that PM660 fails to detect legacy cable in the following use case:</p> <ul style="list-style-type: none"> ■ Legacy cable is first connected to handset with the Type-A end floating ■ Type-A end of the cable is then inserted into the charger adapter ■ PM660 sees VBUS going high during UFP mode <p>If the PM660 device sees VBUS going high during DFP mode, then it detects the legacy cable successfully. See plots below for reference.</p>

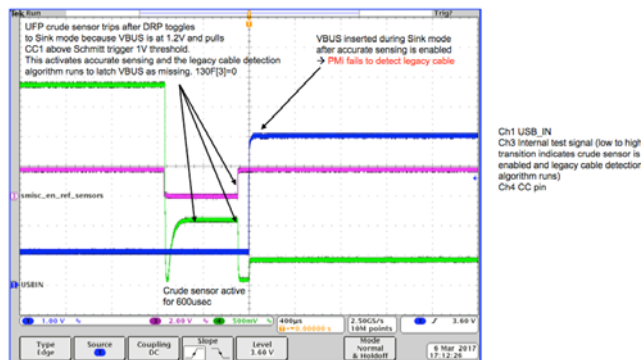
<p>The root cause of the issue is related to leakage present on USB_IN in the above use case. When the PM660 device goes in DFP mode, it charges the USB_IN cap through R_p pull-up in the legacy cable. When the PM660 transitions to UFP mode, the leakage present on USB_IN causes the crude sensor on CC to trip and accurate sensing gets enabled. The legacy cable detection algorithm runs when accurate sensing is enabled and it looks for USB_IN voltage. If USB_IN is greater than 3.6 V then PM660 deems the cable as legacy cable; otherwise, it is deemed as non-legacy cable.</p>

<p>Impact</p>	<p>This issue has two system impacts:</p> <ol style="list-style-type: none"> 1. If a non-compliant legacy cable ($R_p = 10\text{ K}$ or less) is connected to a legacy PC/laptop port and cable is misdetected as non-legacy, then PM660 may draw more current (as advertised by R_p) than what the port can provide. This may result in collapsing the ports. 2. If a non-compliant legacy cable with direct short from CC to VBUS ($R_p = 0\text{ Ohms}$) is connected to a Quick Charge adapter and cable is misdetected as non-legacy, then PM660 may request a voltage increment when load is high. A voltage higher than 6 V on VBUS can end up damaging the CC pin.

Workaround	A software workaround (CR 2015561) has been identified that mitigates this problem. The workaround limits the max input current to 500 mA before the charger is attached. Upon charge attach if the charger type is SDP or CDP, then the max input current is limited to 500 mA or 1500 mA respectively. Furthermore, if a QC adapter is detected, then it reruns Type-C detection, which causes legacy cable detection to re-run and detect legacy cable properly.
Affected revs	RR = 00, RR = 01, and RR = 02
