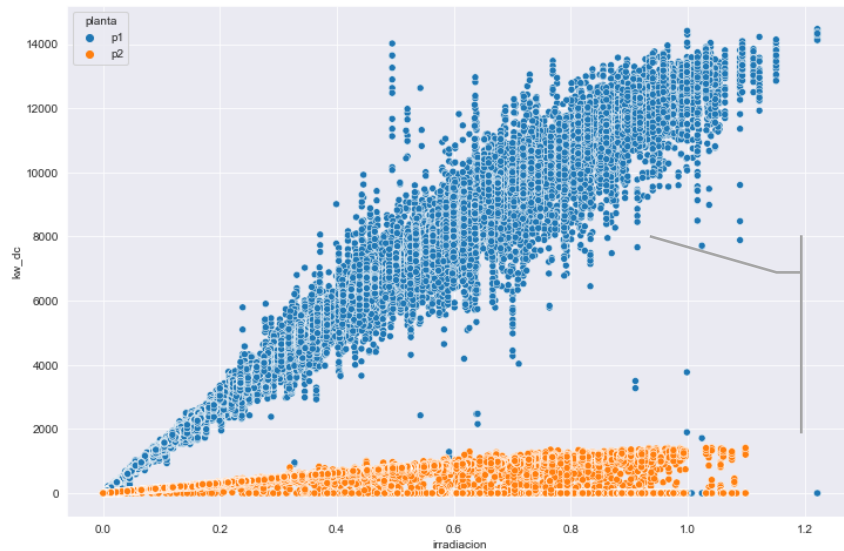
Continuous current generated in each plant (Kw)

DC generation is about 10 times higher in plant 1 than in plant 2

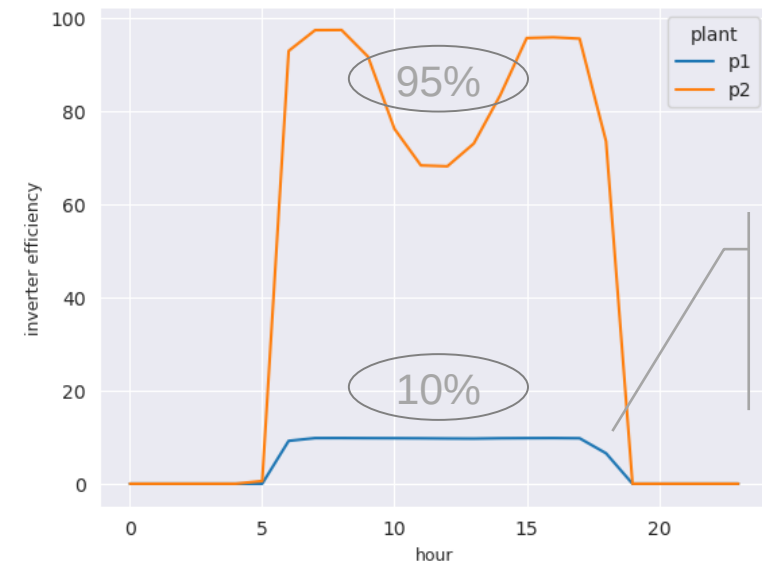
Efficiency of each plant (%)

Average efficiency in the period

The efficiency of plant 1 is around 10%

A new extraction of data from the meters has been requested to check if there may indeed have been data quality problems.

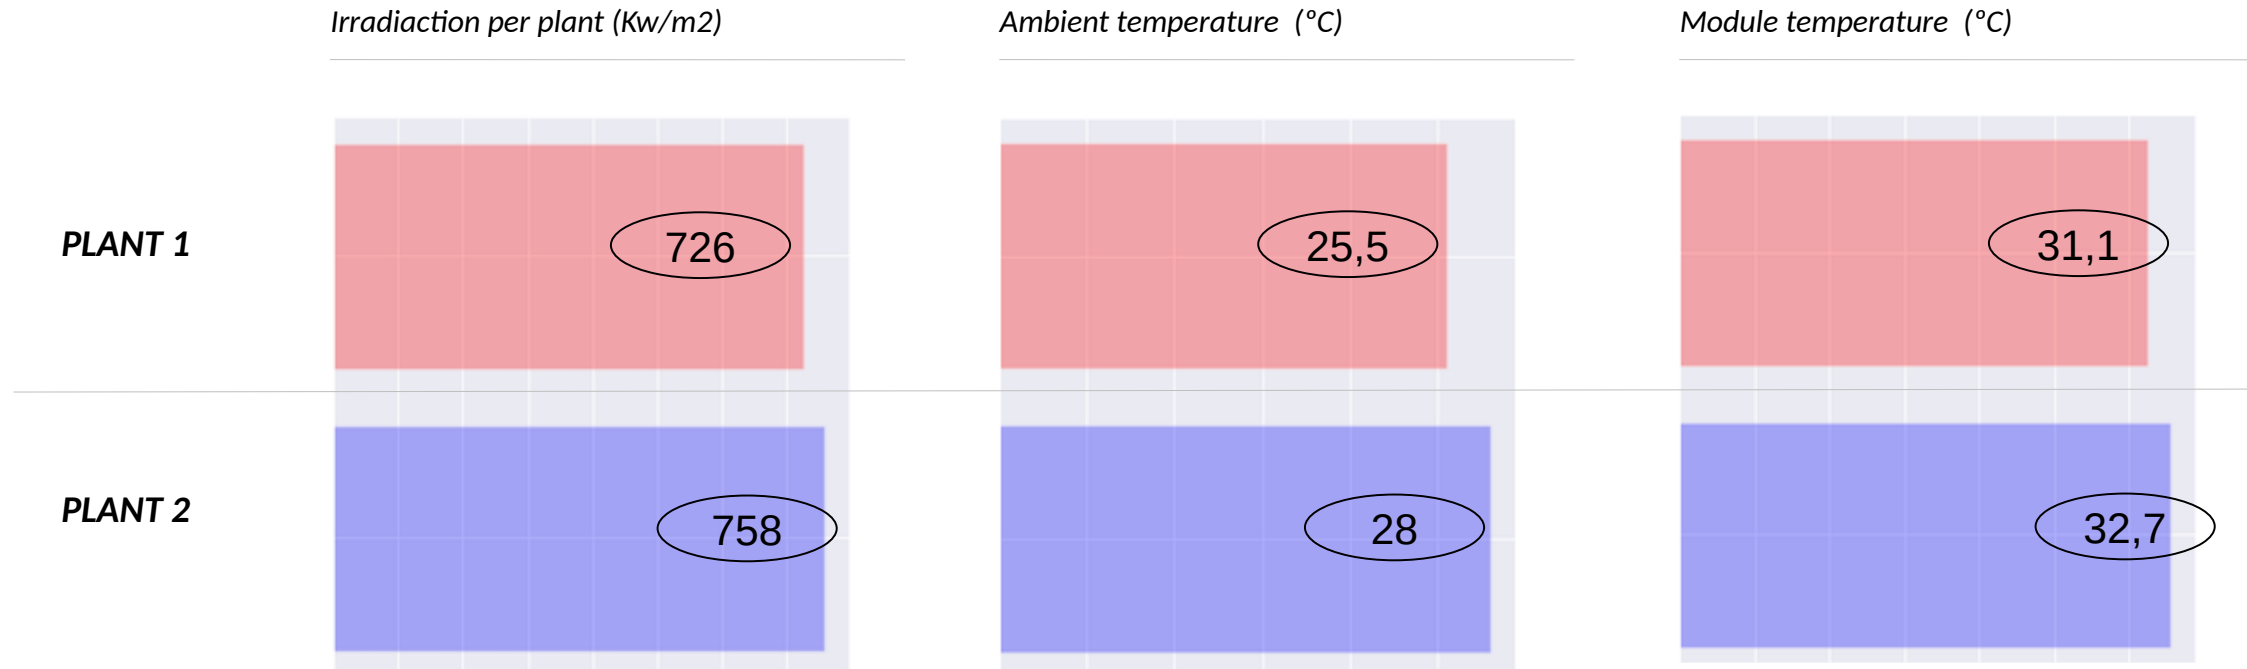
The two plants receive high and similar amounts of irradiation, with no sign of any problem at this point.

The average differences found between the plants do not allow us to think that there are great differences in the capacity to generate direct current.

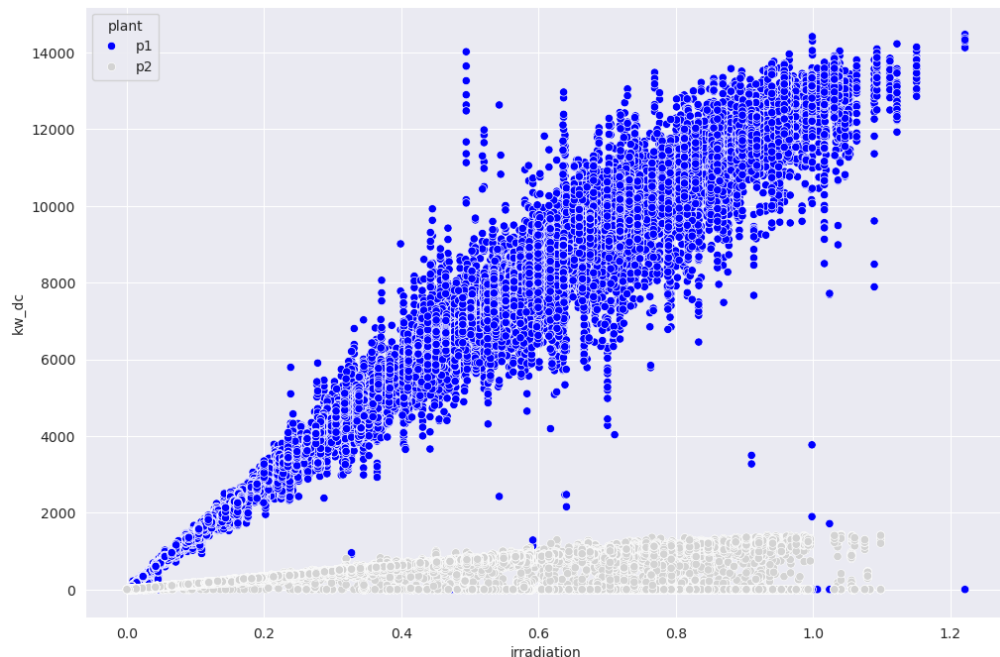
Continuous current generated in each plant (Kw)

The DC generation of plant 1 is correct, the modules seem to carry DC to the inverters

The **direction** of **DC generation** is **increasing** with greater solar irradiation in both plants.

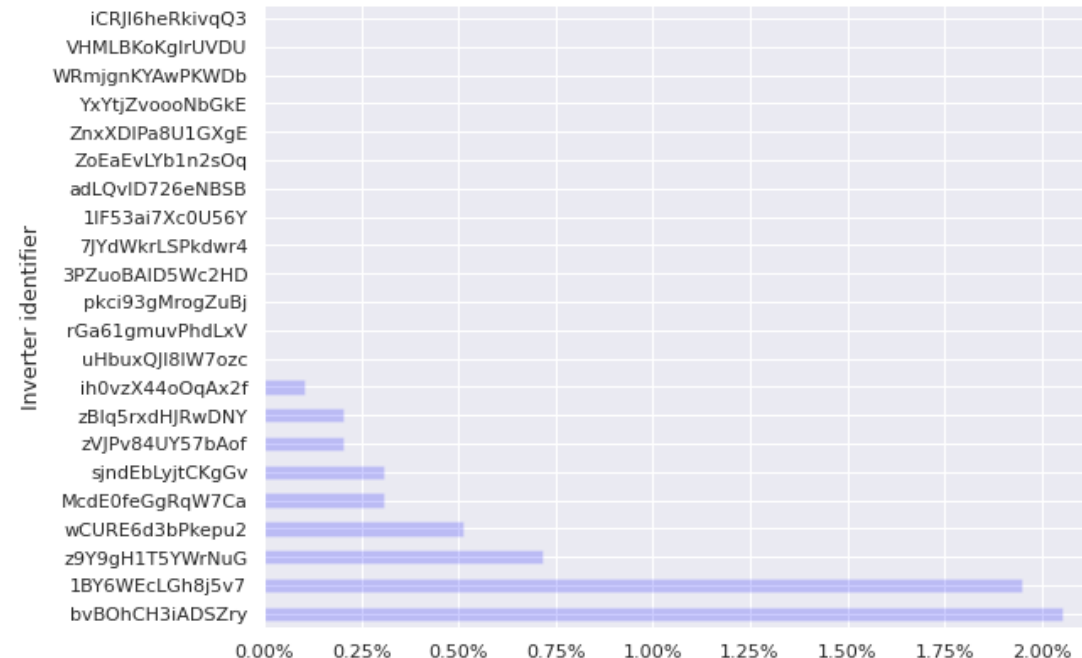
Percentage of failure in DC generation in the inverter of plant 1

We see that although there are some inverters that have had **failures in DC generation**, their magnitude is **less than 2%** of the measurements.

Review plant 1 sensor data to validate DC generation quantities

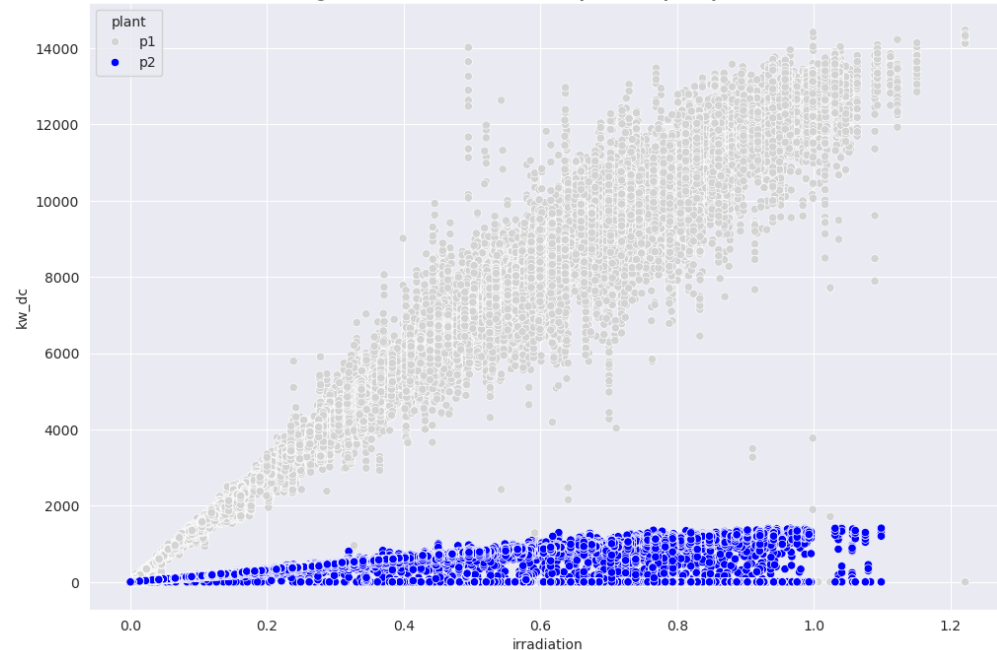
Continuous current generated in each plant (Kw)

The DC generation of plant 2 does NOT work well, the modules bring very little DC to the inverters even in the hours of greatest irradiation

Plant number 2 produces ten times less kW at the same irradiation levels than plant number 1.

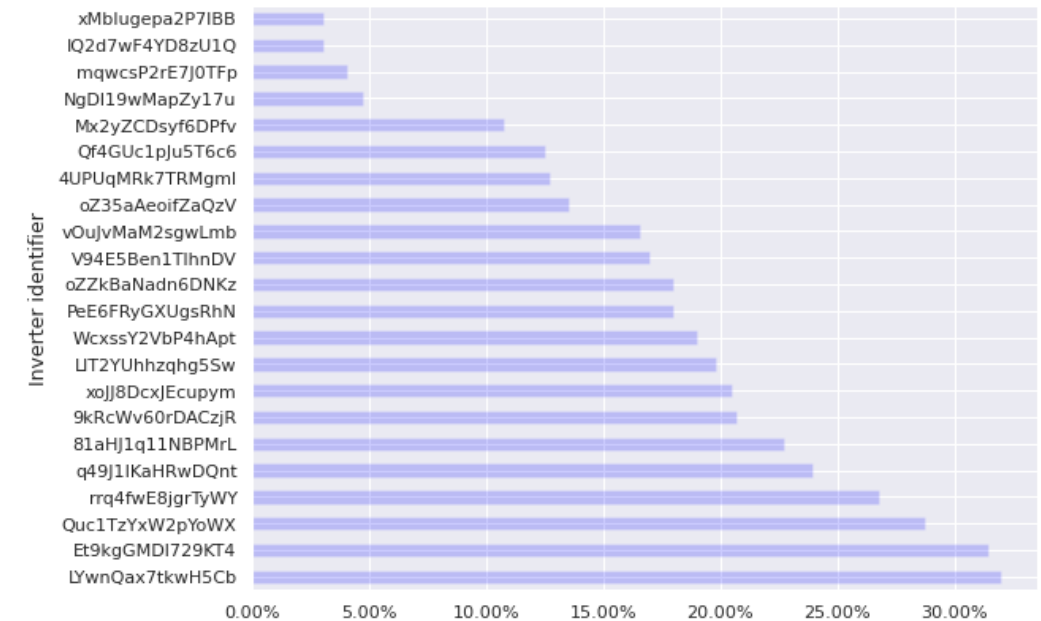
Percentage of failure in DC generation in the inverter of plant 2

We see that there is a **great difference** in the percentage of **failures in the generation of DC** by inverter, from some that have less than **5%** to those that exceed **30%** of the measurements.

Maintenance check on the inverter modules on plant 2 in which there are many moments of zero DC generation.

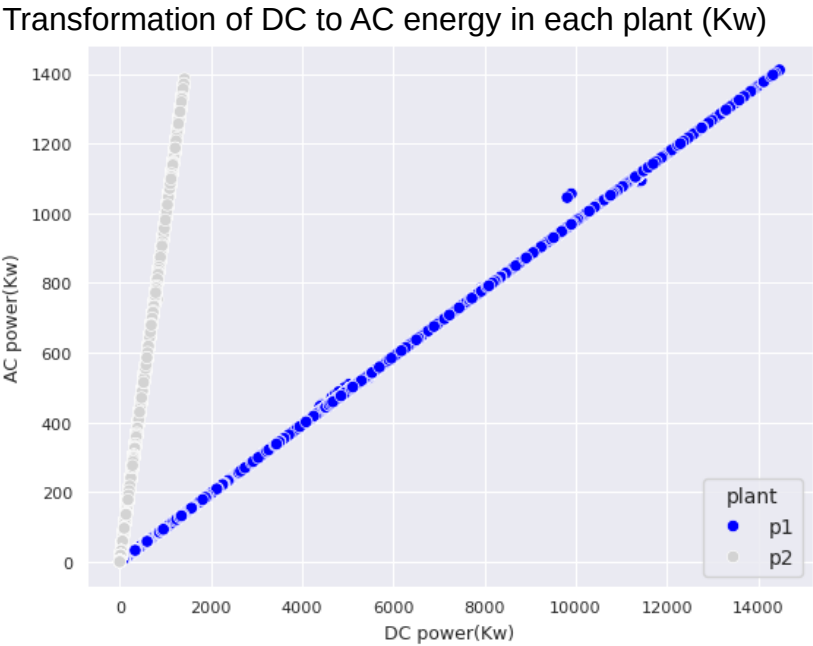
A malfunction has been detected in the inverters on plant 1, which only manage to transform around 10% of DC into AC.

It is notable that the **low efficiency** is not due to moments of non-reception from DC, but rather **seems more structural** (again, keep in mind that it could be due to a **data quality problem** in DC on plant 1).

Check the maintenance of the inverters on plant 1

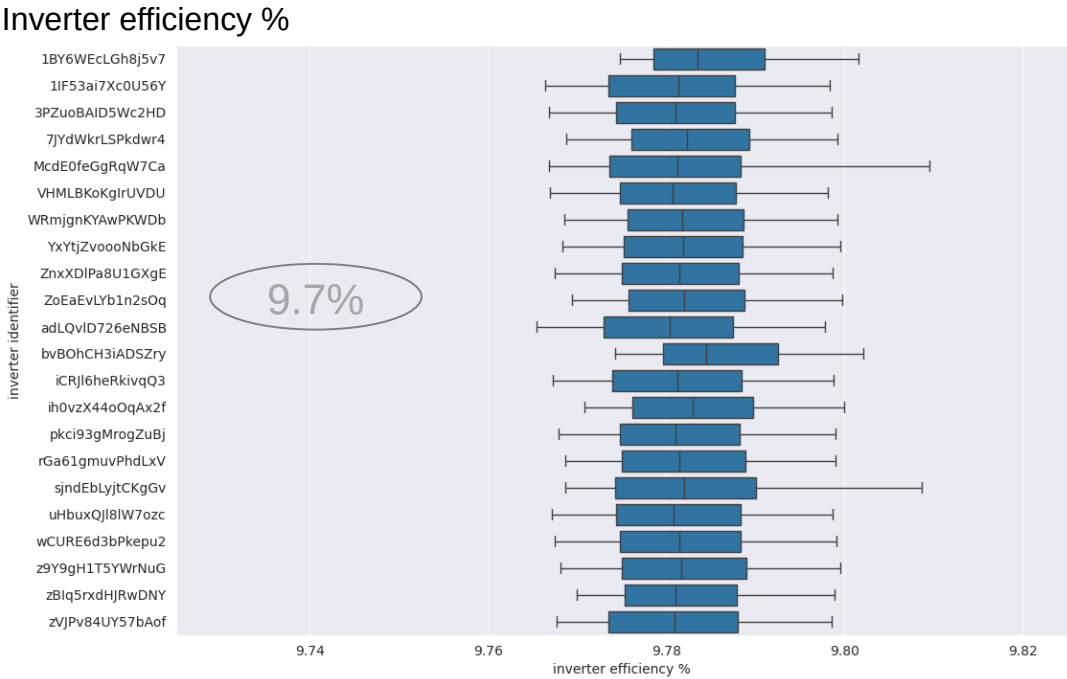
We see that the inverters on plant 1 maintain a low efficiency of around 10%

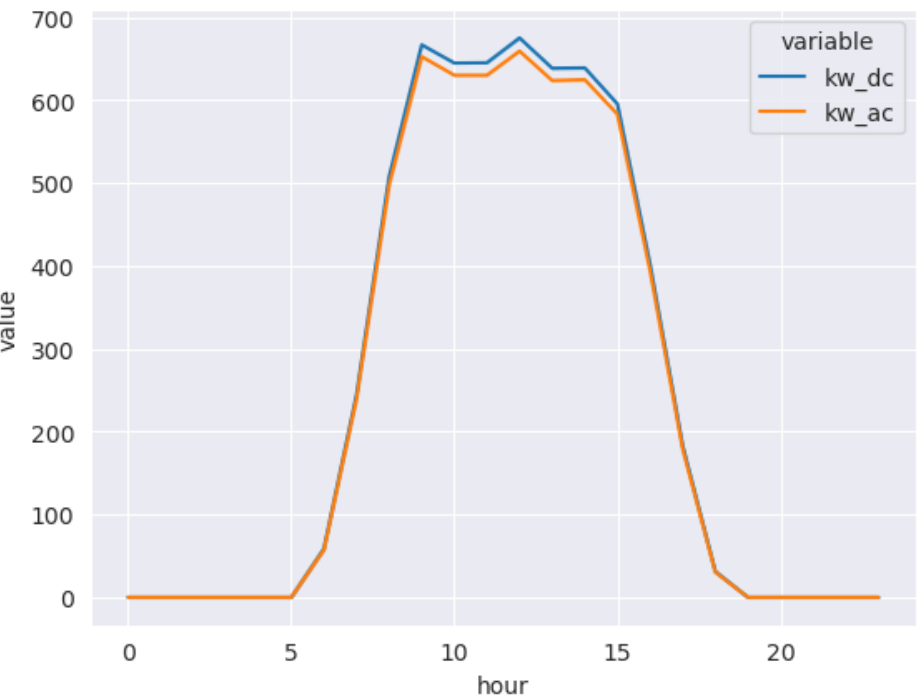
Transformation from DC to AC on plant 2 (Kw)

The transformation from DC to AC of plant 2 is correct, the inverters achieve an efficiency greater than 97%

We see that the **transformation** from DC to AC is continuous throughout the hours of the day **with low levels of loss**.

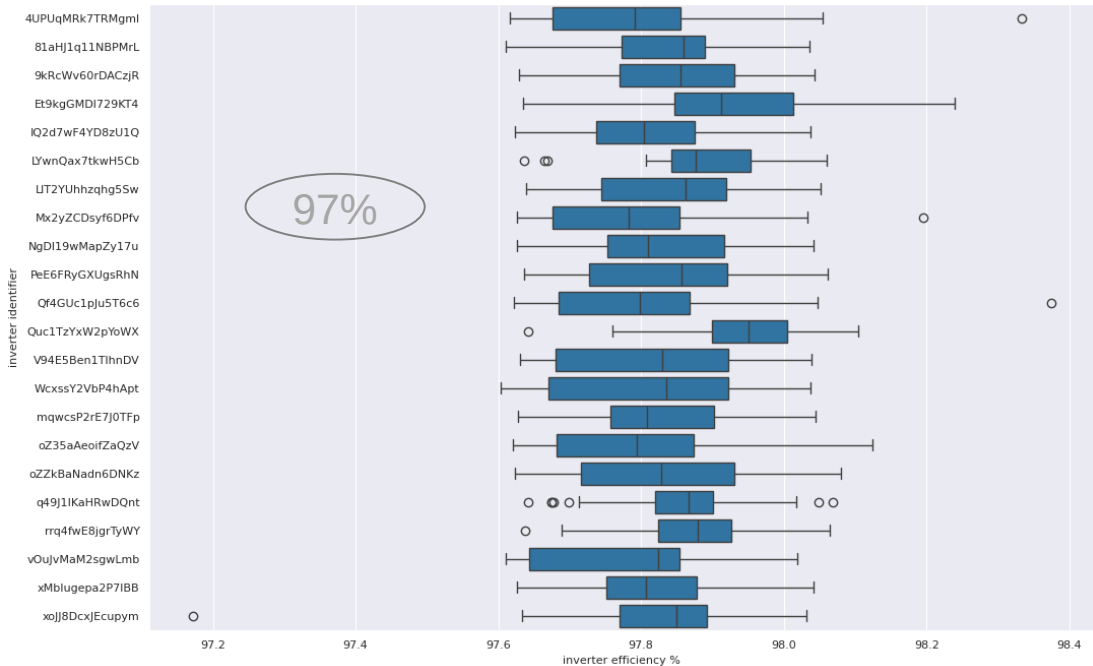
Inverter efficiency % en la planta 2

Once the problem of low DC generation is taken into account, the **inverters** on plant 2 do the job of **transforming to AC well**.

The efficiency of the inverters on plant 2 does not allow us to think that there are anomalies in the operation and state of the inverters.
