# Application of TG-100 risk analysis methods to the acceptance testing and commissioning process of a Halcyon linear accelerator

P. Troy Teo and Min-Sig Hwang

(Received 2 October 2018; revised 25 November 2018; accepted for publication 17 December 2018; published 4 February 2019)

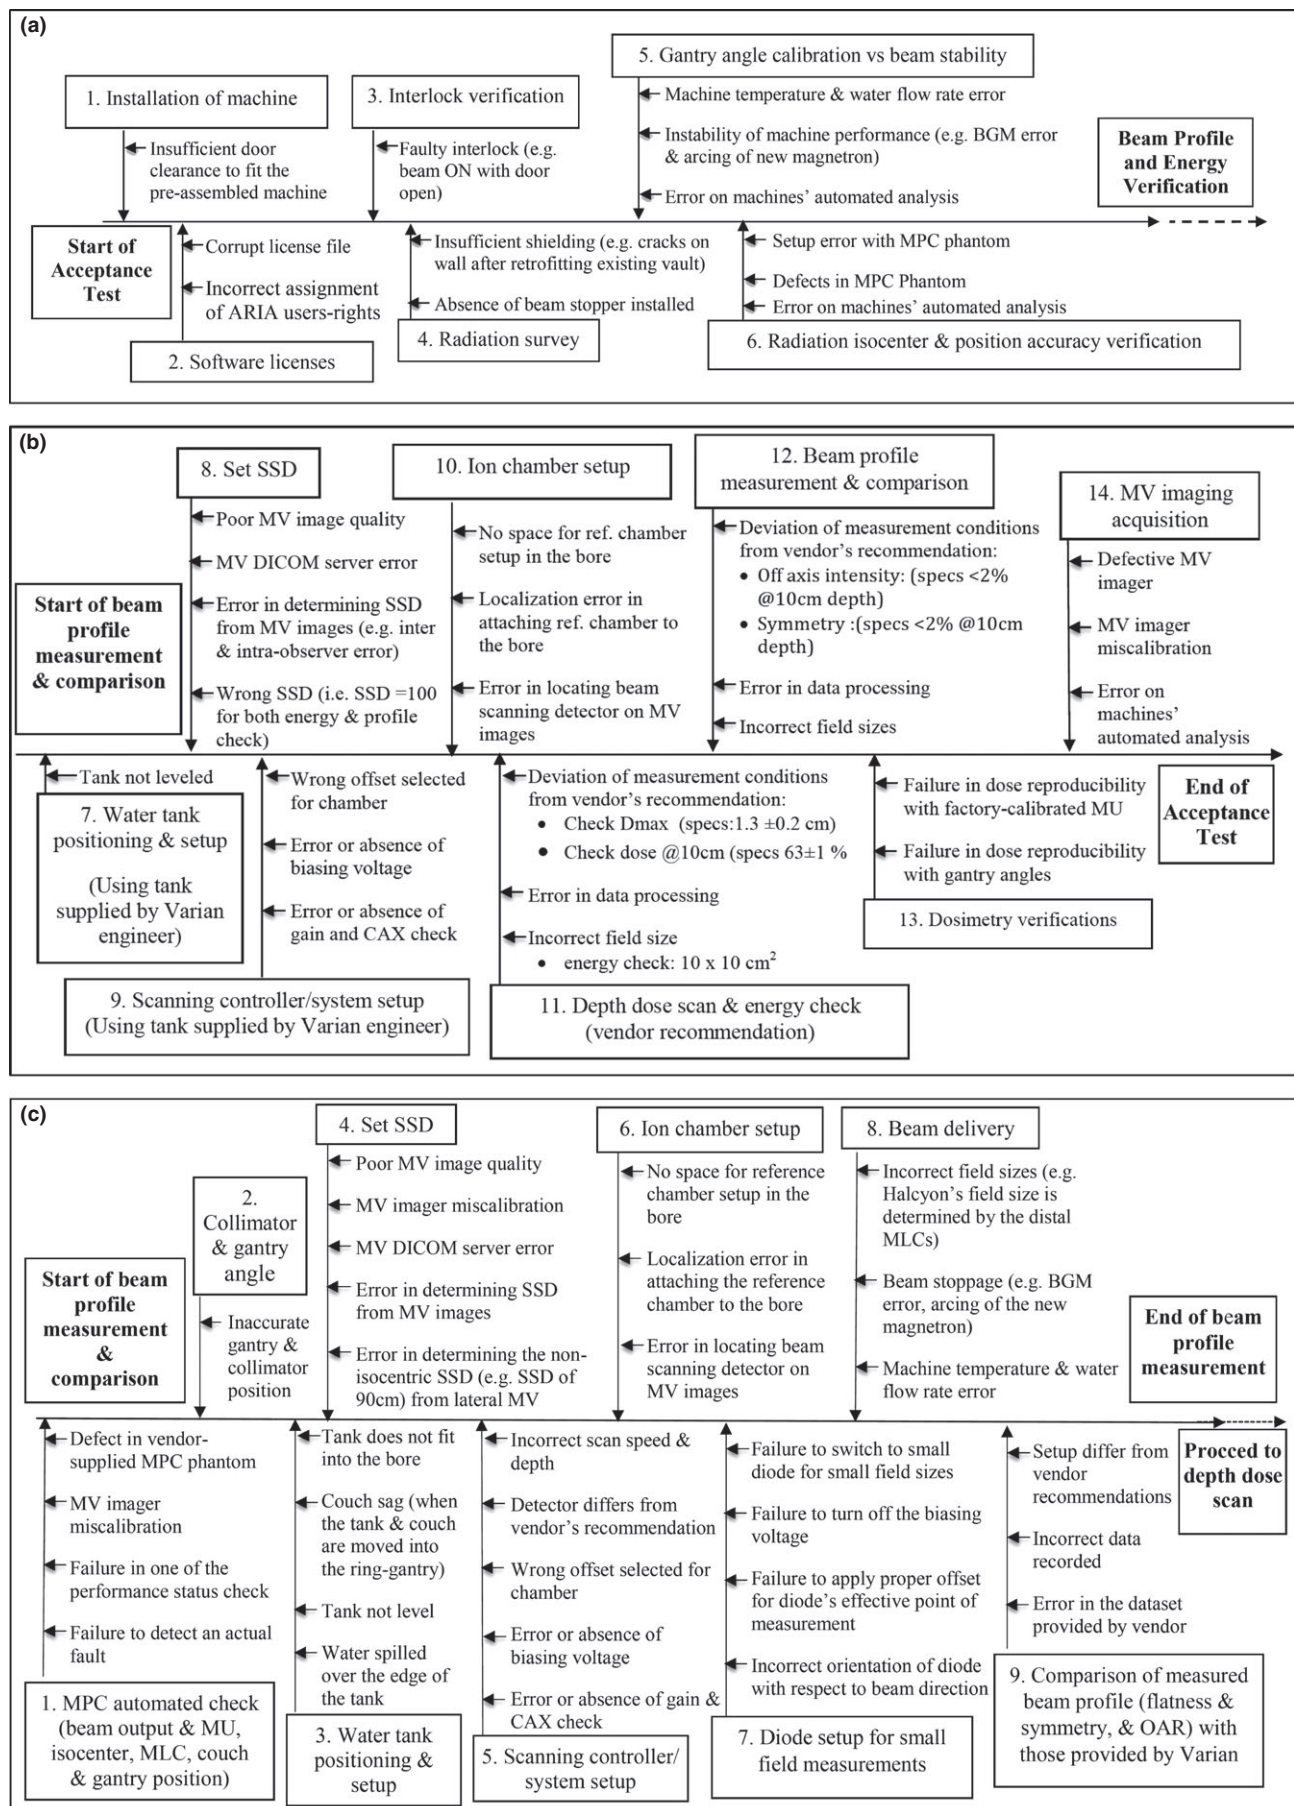
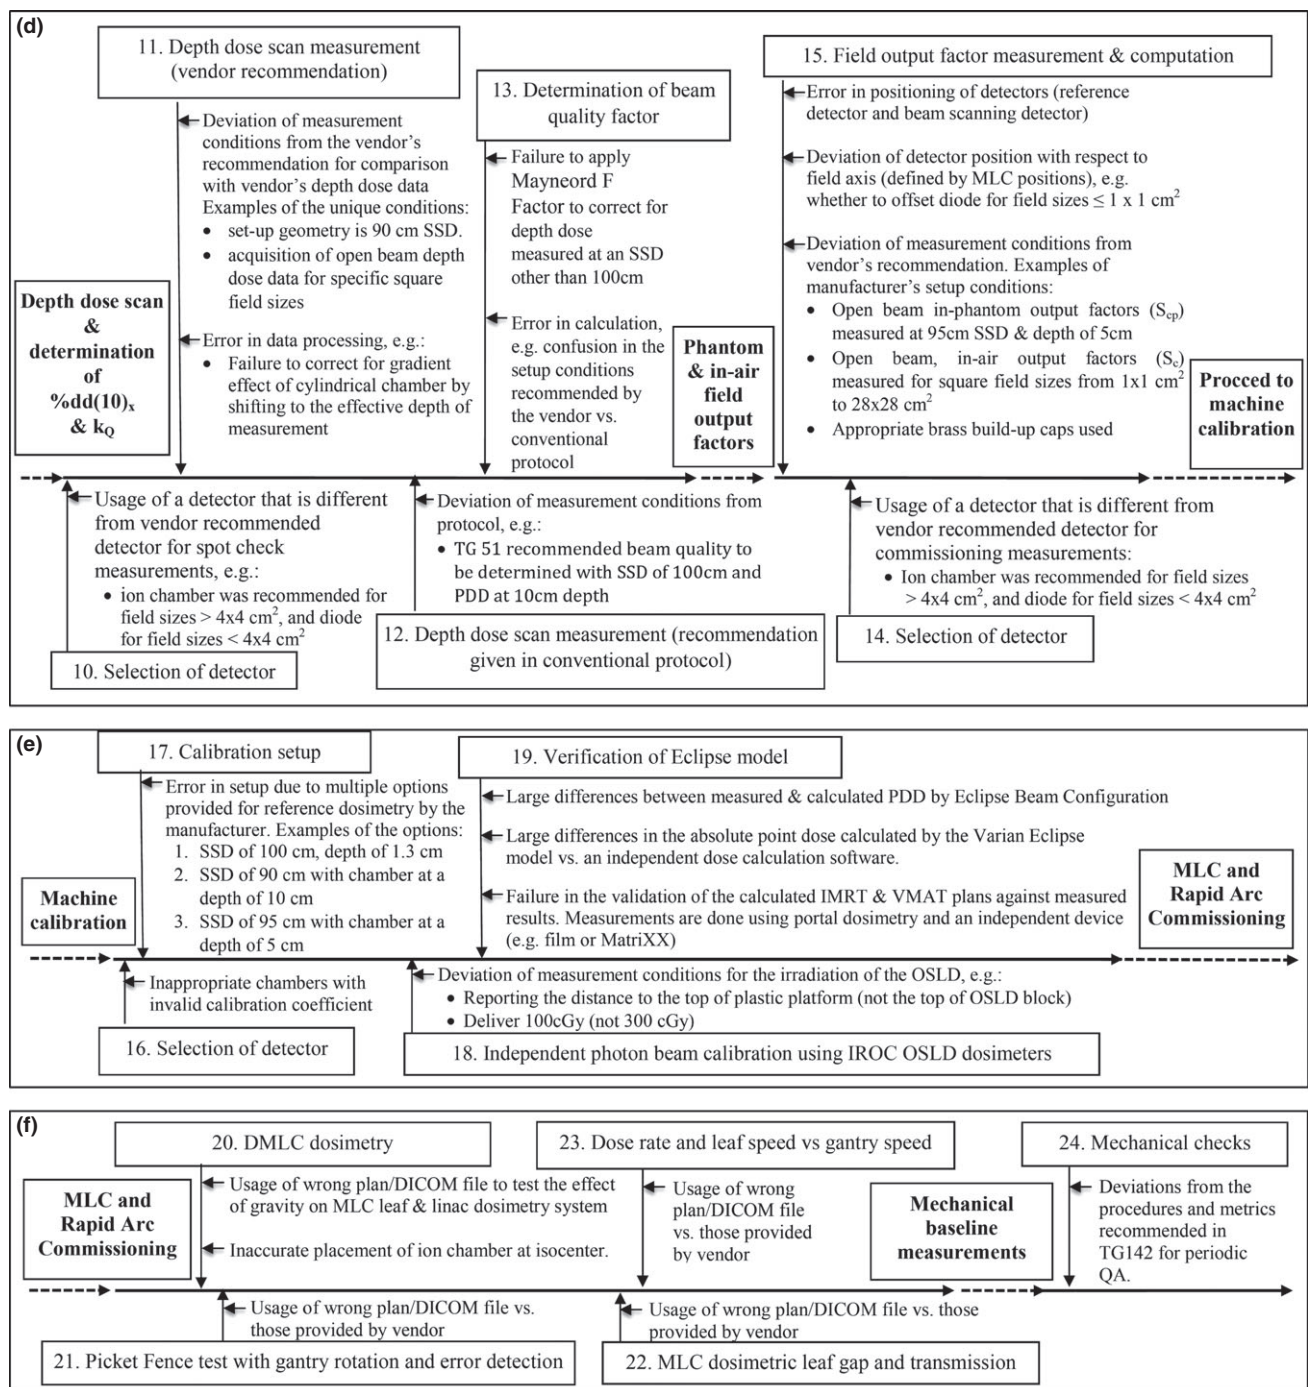
Six steps and twelve FMs were identified for the first phase of the acceptance testing subprocess [Fig. 1(a)]. An example of a FM for this segment of the process map [Fig. 1(a)] is insufficient door clearance to fit the preassembled linac [Fig. 1(a); step no.1: “Installation of the machine”]. This FM occurred because the movers decided to use a robust trolley and wooden pallet to support and move the entire preassembled machine. The height of the door through which the machine is supposed to be brought inside the vault was shorter than the combined height of the machine and trolley plus the wooden pallet. As a result, the machine could not be moved past the door entrance [see Fig. 2(a)]. The machine had to be brought back to the loading bay (from the vault) while effort was made to search for an alternative trolley/moving mechanism. Since this event occurred during a weekend (typical for machine installation in order to minimize disruptions to clinical operations), there was about 8 h of delay in locating the logistics personnel and a suitable trolley, unloading and loading the linac, and moving the linac back to the vault. Unlike the c-arm linacs, whereby the components of the linac are shipped individually and assembled inside the treatment vault, this insufficient door clearance FM will potentially occur to this new type of preassembled machines if prior considerations are not given to the overall clearance issue past the door inside the vault. The under-estimation of door clearance was due to inadequate communication/sharing of architectural drawings and other information between the hospital’s logistical support unit, the transportation company (i.e., the movers), and the machine manufacturer. Therefore, an effective quality control to overcome this FM is to establish communication among the different stakeholders, so that the design consideration of the door height is appropriately taken into considerations prior to moving the linac into the vault.

Three FMs were identified for the step “gantry angle calibration vs beam stability” [Fig. 1(a); step no. 5]. These FMs

are: machine temperature and water flow rate error, instability of machine performance (e.g., BGM error and arcing of new magnetron), and error on machines’ automated analysis. The FM “machine temperature and water flow rate error” occurred at one of our installation sites because the chilled water supply for the Halcyon machine was shared with that for an existing adjacent linac [TrueBeam™, see Fig. 2(b)]. Sharing the supply of chilled water led to overheating of the adjacent TrueBeam™ that is in clinical operation. Upon discussion with the vendor as well as the facility management team, it was established that the required supply of chilled water between Halcyon and TrueBeam is different from the supply of chilled water between the previous linac that had occupied the vault and the TrueBeam. As a result, rebalancing of the chilled water supply between the Halcyon linac and the adjacent TrueBeam linac was required. A delay in the acceptance occurred due to plumbing work required to modify the supply of chilled water to the two machines. Regarding the instability of machine performance (due to the arcing of new magnetron), this occurred at one of our installation sites. The potential FM, “error on machines’ automated analysis,” is an example of a FM that we envisioned could happen but did not actually occur during our ATC. Figure 1(a) also shows that two FMs, corrupt license file and incorrect assignment of ARIA users-rights, were identified for the step “Software licenses”. With Varian’s new log in method, a physicist will not be able to log on to the machine using a generic username and password, for example, “Service” and “Service.” At one of our installation sites, it took 2 days to acquire a username and password. This was an inconvenience since we had to have an installer or a service engineer available to log us in. While we encountered the FM of “incorrect assignment of ARIA users-rights,” we did not encounter the other FM — “corrupt license file” during our installations. This is one of those examples where the FM was generated based on the previous ATC experience of other linacs, that is, the FM was generated based on what the team envisioned could possibly happen. Figure 1(a) shows the FMs resulting from the other three steps. These are interlock verification, radiation survey, and radiation isocenter and position accuracy verification.

Figure 1(b) shows the segment of the process map for the second stage of acceptance, that is, “measurements of beam profile, beam energy and various dosimetric parameters and MV imager checks”. Eight steps (step nos. 7–14) and twenty-two potential FMs were identified during this second stage of

FIG. 1. (a) Segment 1 of the process map for the acceptance testing of Halcyon. The items in the boxes numbered 1–6 indicate the various steps involved for this part of the acceptance testing process; the failure modes (FMs) for each of the steps are identified by the arrows that correspond to each step. (b) Segment 2 of the process map for the acceptance of Halcyon — measurements of beam profile, beam energy, and various dosimetric parameters and MV imager checks. The items in the boxes numbered 7–14 indicate the various steps involved for this part of the acceptance testing process; the FMs for each of the steps are identified by the arrows that correspond to each step. (c) Process map for the beam profile measurement during the commissioning of Halcyon. The items in the boxes numbered 1–9 indicate the various steps involved for this part of the commissioning process; the FMs for each of the steps are identified by the arrows that correspond to each step. (d) Process map for depth dose scan, beam quality, and field output factor determination. The items in the boxes numbered 10–15 indicate the various steps involved for this part of the commissioning process; the FMs for each of the steps are identified by the arrows that correspond to each step. (e) Process map for absolute dosimetry calibration and verification of Varian Eclipse beam model. The items in the boxes numbered 16–19 indicate the various steps involved for this part of the commissioning process; the FMs for each of the steps are identified by the arrows that correspond to each step. (f) Process map for RapidArc commissioning with MLC and gantry rotation verification. The items in the boxes numbered 20–24 indicate the various steps involved for this part of the commissioning process; the FMs for each of the steps are identified by the arrows that correspond to each step.

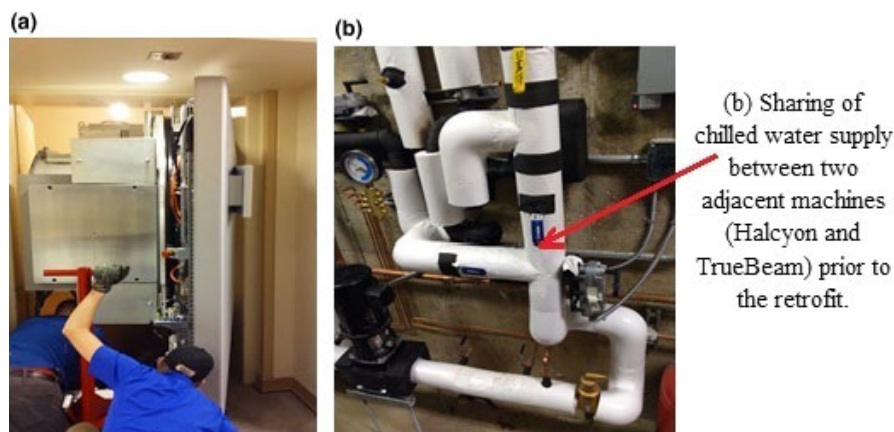
FIG. 2. Examples of FMs encountered — (a) insufficient door clearance to fit the preassembled machine due to extra height incurred by the trolley and wooden pallets; (b) machine temperature and water flow rate error, that is, failure to maintain a separate water supply to cool an adjacent linac leads to overheating and inconsistent machine operation. [Color figure can be viewed at [wileyonlinelibrary.com](http://wileyonlinelibrary.com)]

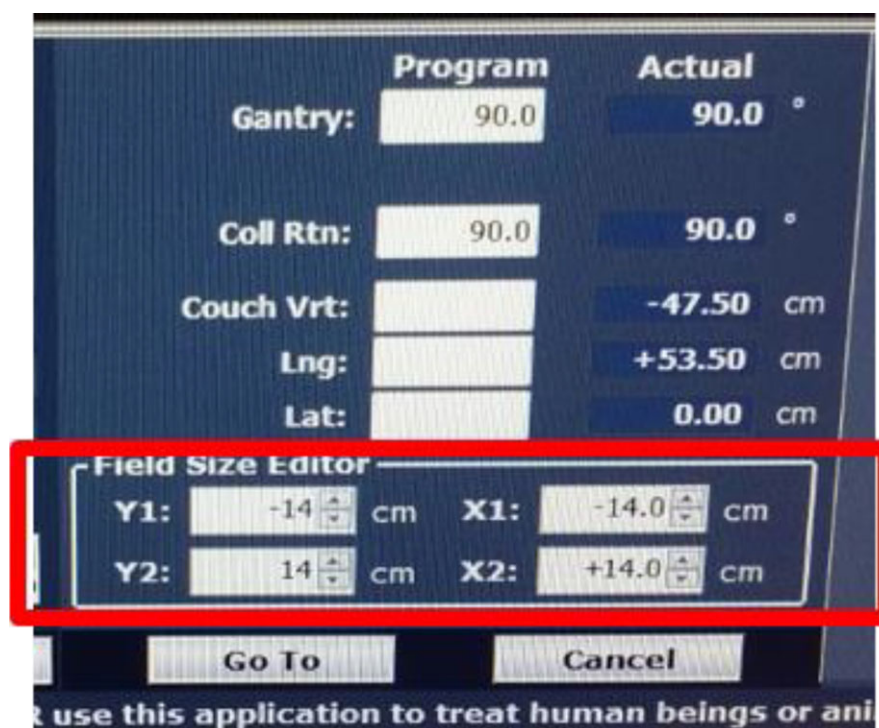
acceptance testing. One of the FMs generated for the step “beam profile measurement and comparison” is incorrect field sizes. According to the guidelines from the manufacturer, beam profiles for the standard dataset are to be measured for a field size of  $28 \times 28 \text{ cm}^2$ . Setting up of an “incorrect field size” by the user could potentially occur because of the following reason: the software is designed such that in the service mode the field size display does not provide feedback of the actual position reading of the multi-leaves if the user forgets to hit the “Go To” option (see

Fig. 3). The software allows the user to continue with beam delivery with the incorrect field size. In other words, in service mode the display does not make any distinction between the field size that was entered by the user vs the actual field size set by the physical locations of the multi-leaves when the user forgets to hit the “Go To” option. This is in contrast to the display of TrueBeam™ linac where distinction is made between the field sizes entered (i.e., “programmed”) and the actual field size defined by the updated physical location of the jaws (see Fig. 4). Since ATC measurements are done in

FIG. 3. Display of field sizes in the service mode in the Halcyon™ linac. There is no distinction between the field size that was entered vs the actual field size defined by the physical locations of the multileaves. The field size will not be updated if the user forgets to hit the “Go To” option. A potential FM is the “incorrect field sizes” used during the characterization of the linac performance. [Color figure can be viewed at [wileyonlinelibrary.com](http://wileyonlinelibrary.com)]

the service mode, an error occurred when we entered the desired field size but we did not hit “Go To” button to update the MLC positions. As a result, beam profiles were initially taken for one incorrect field size. A similar error occurred when measurements were made for field output factors. Overall, for the entire acceptance testing process [Figs. 1(a) and 1(b)], a total of 14 steps and 34 FMs were identified.

the FM encountered during acceptance testing (Fig. 3). It was observed that in service mode, the field size display does not provide feedback of the “actual” multileaves position readings. For the TrueBeam™ linacs, the computer displays show both “target” and “actual” field sizes (Fig. 4). As a quality control measure, feedback was given to the vendor about this issue so that the correct displays of field sizes can be incorporated in future upgrades of the linac.

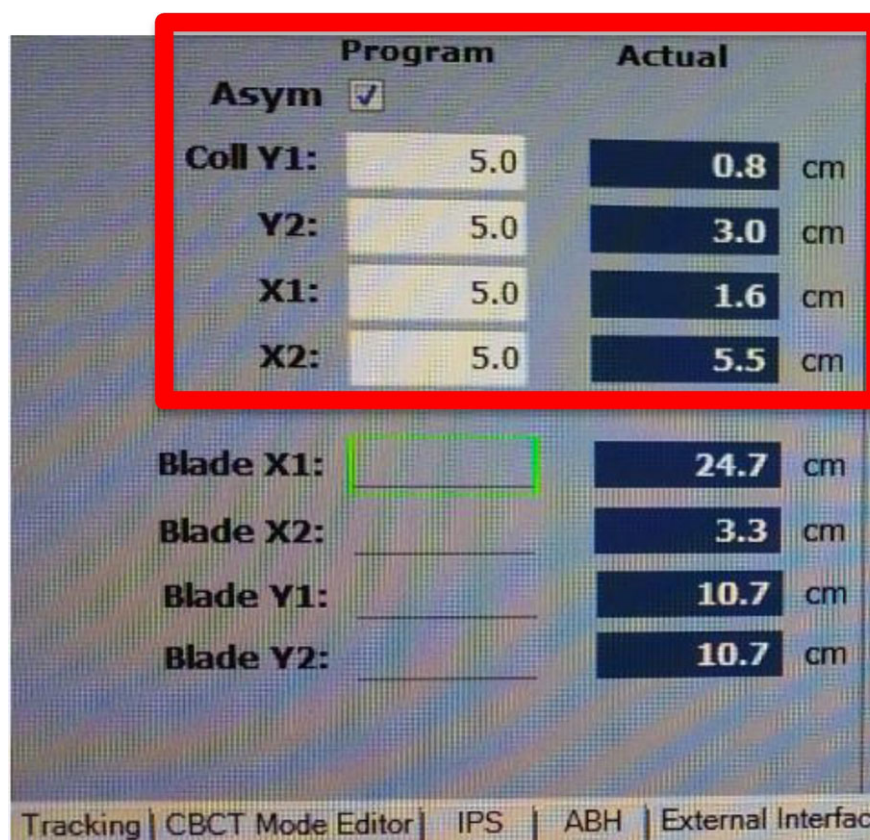
FIG. 4. Distinction between the field size that is entered (i.e., “programmed”) and the actual field size defined by the physical location of the jaws is indicated in the service-mode display of TrueBeam™ linac. [Color figure can be viewed at [wileyonlinelibrary.com](http://wileyonlinelibrary.com)]

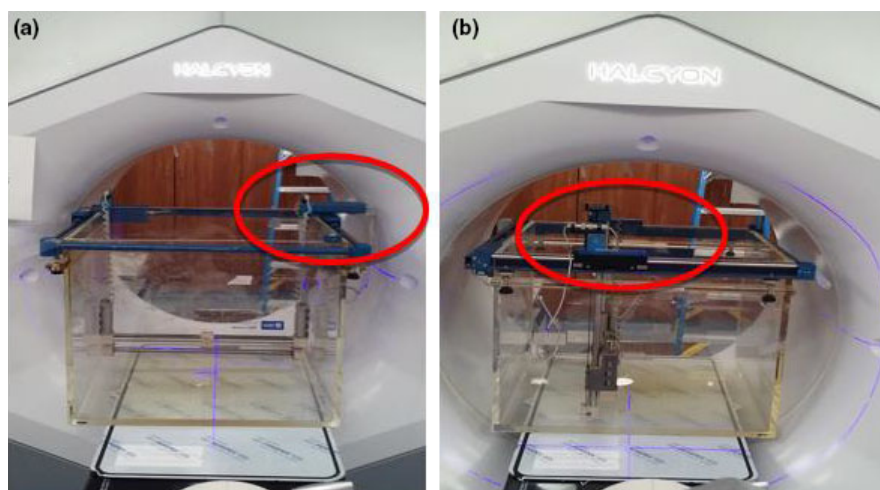
FIG. 5. Potential FM “tank does not fit into the bore” for the step of “water tank positioning and setup” during the beam profile measurements: (a) water tank does not fit into the treatment bore due to the protrusion of the controller beyond the tank; (b) a quality control measure for this FM is to rotate the tank such that the controller axis is parallel to the couch orientation. Care will need to be exercised to note down this orientation such that all measurements taken with this orientation are appropriately labeled. [Color figure can be viewed at [wileyonlinelibrary.com](http://wileyonlinelibrary.com)]

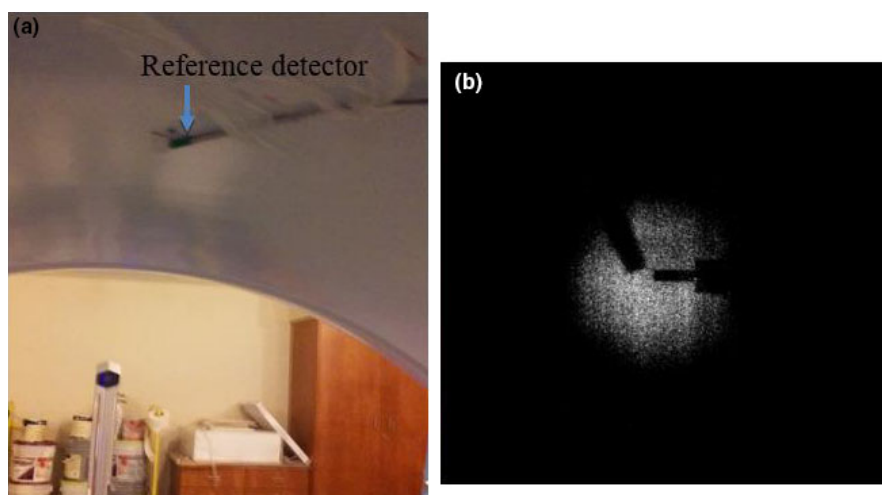
scanning detectors)”. This potential FM could occur because of the following reasons: since there are no light fields, no optical distance indicators (ODIs) and no internal lasers in the gantry bore, setting up of the beam scanning detector is accomplished with the water tank positioned outside the gantry bore prior to being driven inside the gantry via the couch. The weight of the water tank can cause the couch to sag, resulting in an error in the alignment of the detector axis with the beam axis. The positioning of the reference detector in the bore of the ring-gantry is challenging given the absence of the light field, ODI, and internal lasers. The positions of the beam scanning and reference detectors can only be verified by acquiring an MV image of the detectors. If these two detectors are not perfectly aligned during setup, many measurements need to be taken to be able to align these two detectors perfectly before any dosimetric measurements can be made (see Fig. 6). This process could be time-consuming. In addition, with a rotated water tank, it was difficult to attach a flexible arm to the tank for the purpose of holding the reference detector. The reference detector was attached to the interior of the gantry cover. It is again challenging given the absence of the light field. In addition, due to the curvature of the gantry bore, there is a need for extra caution in attaching an elongated detector onto the curved surface without the risk of breaking the detector.

FIG. 6. Potential FM “error in positioning of detectors (reference field and scanning detectors)” can result in incorrect signal measurement during the step “field output factor measurement and computation”. (a) The absence of a light field, ODI and laser in the bore to guide the placement of the reference detector; (b) the position of the detectors would have to be verified with MV image acquisition for each subsequent adjustment of either of the two detectors. [Color figure can be viewed at [wileyonlinelibrary.com](http://wileyonlinelibrary.com)]
