An Investigation of the Therac-25 Accidents

Nancy Leveson, University of Washington

Clark S. Turner, University of California, Irvine

Reprinted with permission, *IEEE Computer*, Vol. 26, No. 7, July 1993, pp. 18-41.

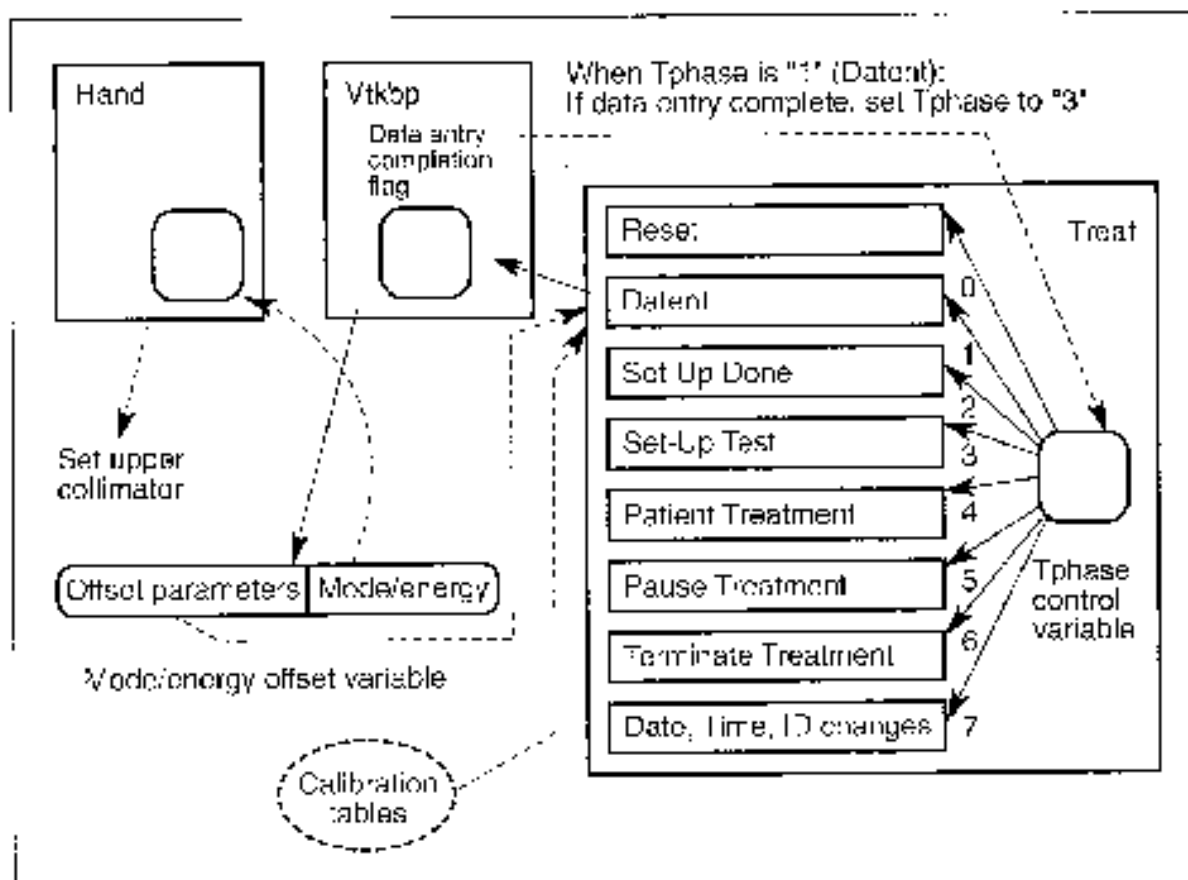
Figure 2

But this was not the only problem. Upon exit from the Magnet subroutine, the data-entry subroutine (Datent) checks the data-entry completion variable. If it indicates that data entry is complete, Datent sets Tphase to 3 and Datent is not entered again. If it is not set, Datent leaves Tphase unchanged, which means it will eventually be rescheduled. But the data-entry completion variable only indicates that the cursor has been down to the command line, not that it is still there. A potential race condition is set up. To fix this, AECL introduced another shared variable controlled by the keyboard handler task that

Figure 2. Tasks and subroutines in the code blamed for the Tyler accidents.

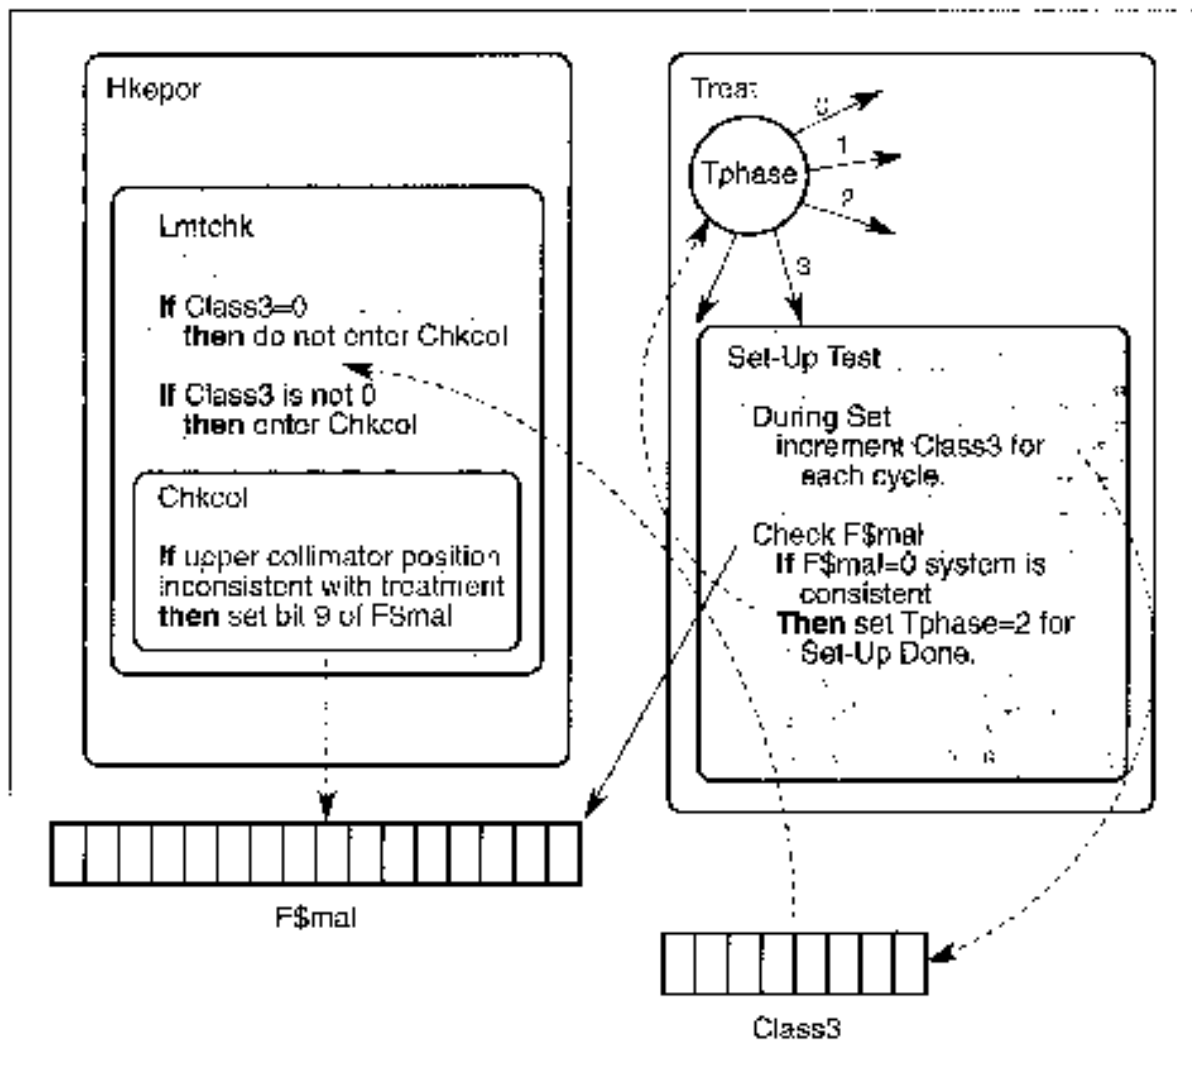
Figure 4

The second Yakima accident was again attributed to a type of race condition in the software - this one allowed the device to be activated in an error setting (a "failure" of a software interlock). The Tyler accidents were related to problems in the data-entry routines that allowed the code to proceed to Set-Up Test before the full prescription had been entered and acted upon. The Yakima accident involves problems encountered later in the logic after the treatment monitor Treat reaches Set-Up Test.

The overexposure occurred when the operator hit the "set" button at the precise moment that Class3 rolled over to zero. Thus Chkcol was not executed, and F\$mal was not set to indicate the upper collimator was still in field-light position. The software turned on the full 25 MeV without the target in place and without scanning. A highly concentrated electron beam resulted, which was scattered and deflected by the stainless steel mirror that was in the path.

Figure 4. Yakima software flaw.

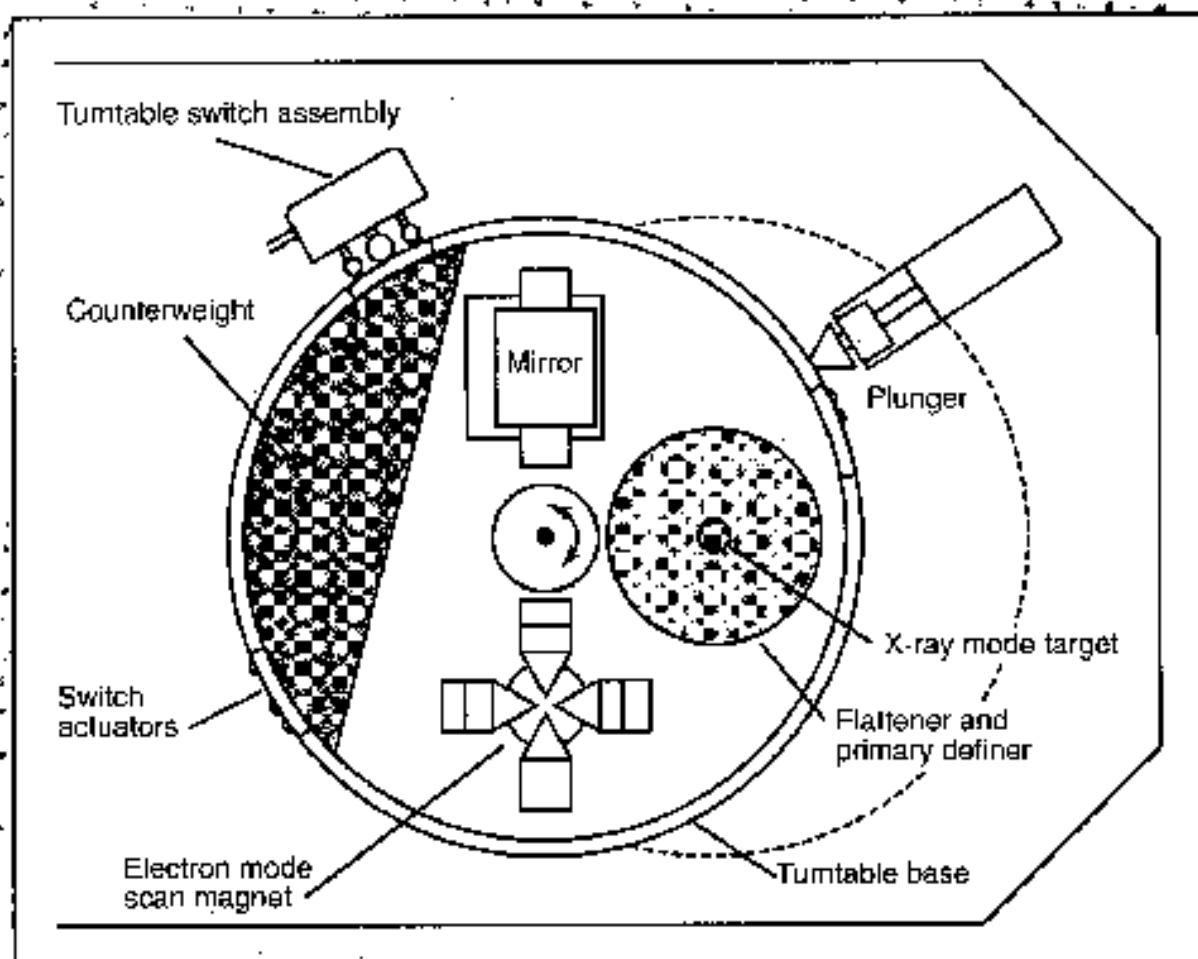
Figure B

The computer senses and controls turntable position by reading a 3-bit signal about the status of three microswitches in the turntable switch assembly (see the sidebar [Turntable positioning](#)). Essentially, AECL determined that a 1-bit error in the microswitch codes (which could be caused by a single open-circuit fault on the switch lines) could produce an ambiguous position message for the computer. The problem was exacerbated by the design of the mechanism that extends a plunger to lock the turntable when it is in one of the three cardinal positions: The plunger could be extended when the turntable was way out of position, thus giving a second false position indication. AECL devised a method to indicate turntable position that tolerated a 1-bit error: The code would still unambiguously reveal correct position with any one microswitch failure.

Figure B. 'Upper' turntable assembly.
