AQUA DOC

Lake & Pond Management and Supplies

October 13, 2011

POND DEPTHS (FT.)

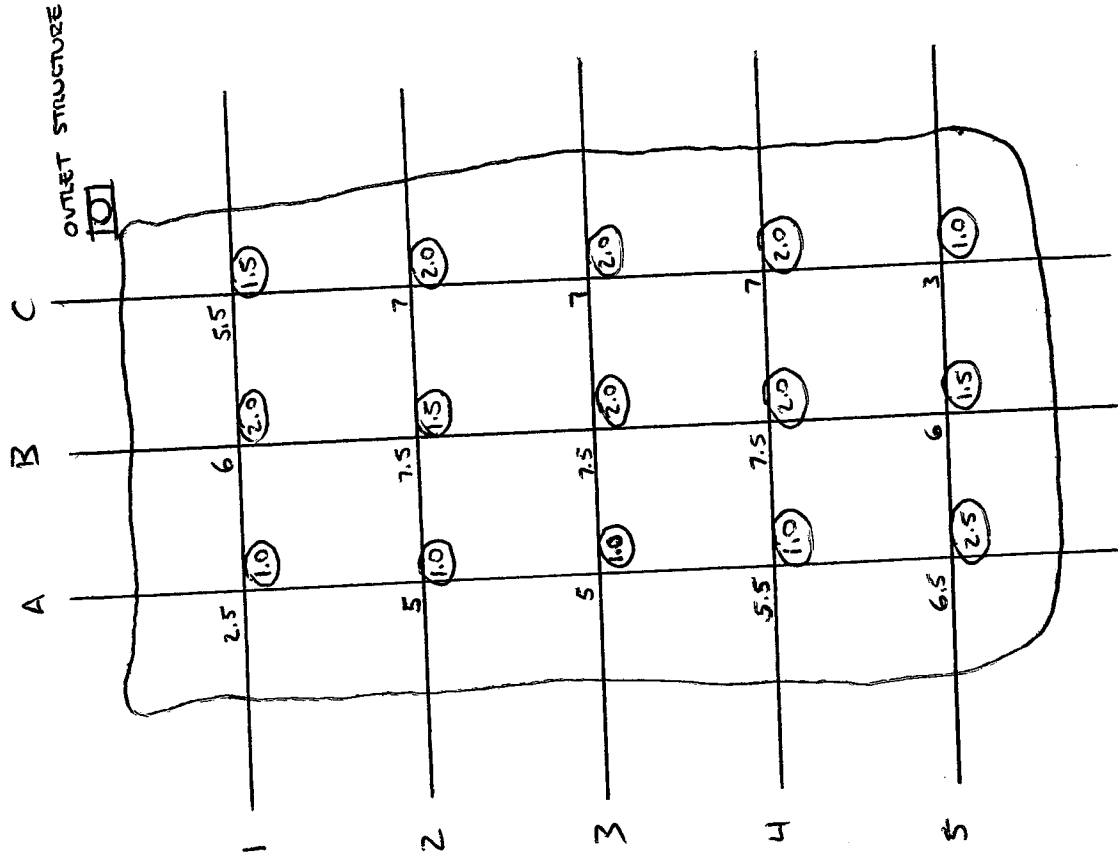
Enclosed are the results of the pond study. As you can see, there is some build-up on the east end, but otherwise there seems to be good depth overall.

MEASUREMENTS IN FEET
CIRCLED NUMBERS INDICATE SEDIMENT DEPTH
