Report Issue Number: 1  
 Report Issued Date: 01/06/2021  
 Project Number: P127182  
 Project Name: DigiPlex - DHAS-C (OSL21)  
 Unit Name: Support Area AHU (360.001)

Unit Name:	Support Area AHU (360.001)		
Unit Serial Number:	651987.0020	Unit Model:	CAIRplus 128
Unit Airstreams:	Supply/Extract	Unit Installation:	Internal Unit (Internal Environment)
Unit Handling:	Left

Unit Name:	Data Halls 1 & 2 AHU (360.002)		
Unit Serial Number:	651987.0015	Unit Model:	CAIRplus 160
Unit Airstreams:	Supply/Extract	Unit Installation:	Internal Unit (Internal Environment)
Unit Handling:	Left

Unit Name:	Data Halls 3 & 4 AHU (360.003)		
Unit Serial Number:	651987.0010	Unit Model:	CAIRplus 160
Unit Airstreams:	Supply/Extract	Unit Installation:	Internal Unit (Internal Environment)
Unit Handing:	Left

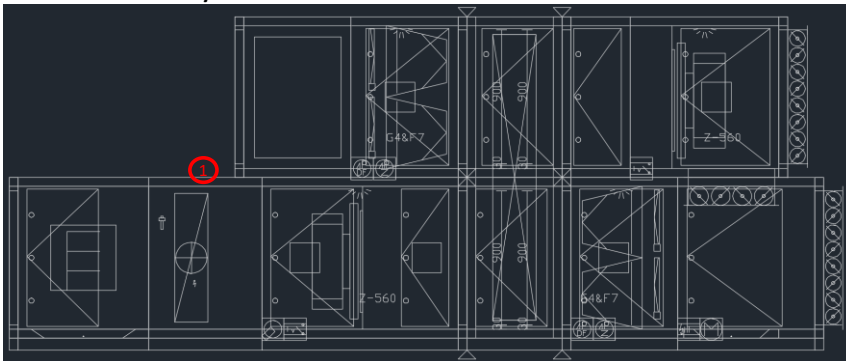
Service Side

Type (Damage, Seal or Corrosion)	Number	Comments
Damage	1	Screw Hole in the Frame.

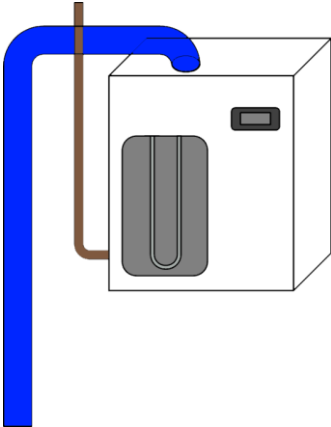
The old Cylinder has left some Brown marks in the steam lance/nozzles, to check during the next visit after it has run some steam with the new Cylinder.

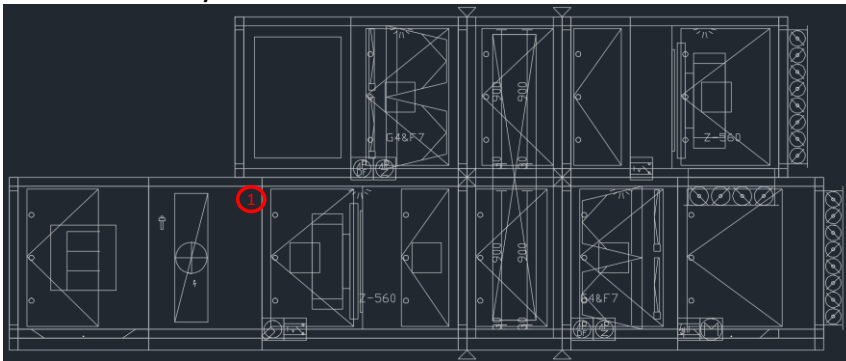
Service Side

Type (Damage, Seal or Corrosion)	Number	Comments
Damage	1	2 Screw Holes.
